AnIsl 46 (2013), p. 323-336

Amany Mohamed Bakr, Mona Fouad Ali, Abubakr Moussa, Amir Said

Characterization of Imitated Marble Used in Historical Buildings in Cairo – Egypt

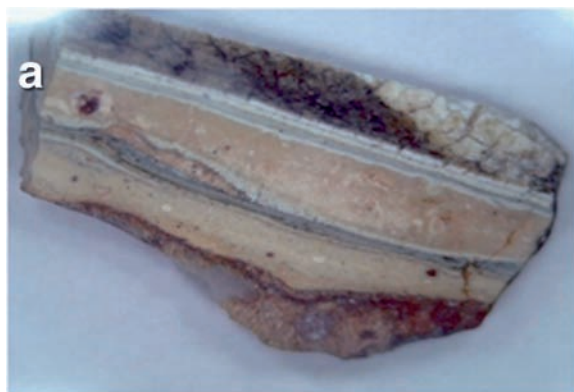
Fig. 3a. The polished cross section of the *sabīl*'s sample.

The preliminary observation of the collected samples showed the stratigraphic structure of the marble-imitating stucco. The polished cross section examination revealed the presence of three main layers (fig. 3a): inner, middle and outer layer (finishing layer). Secondary layers are seen within the middle layer of some samples.
