AnIsl 45 (2011), p. 321-338

Diagnosis of Pigment Materials Affected by Air Pollution and Clay Minerals in Sabil Alkazlar.

Diagnosis of Pigment Materials

Affected by Air Pollution and Clay Minerals in Sabil Alkazlar

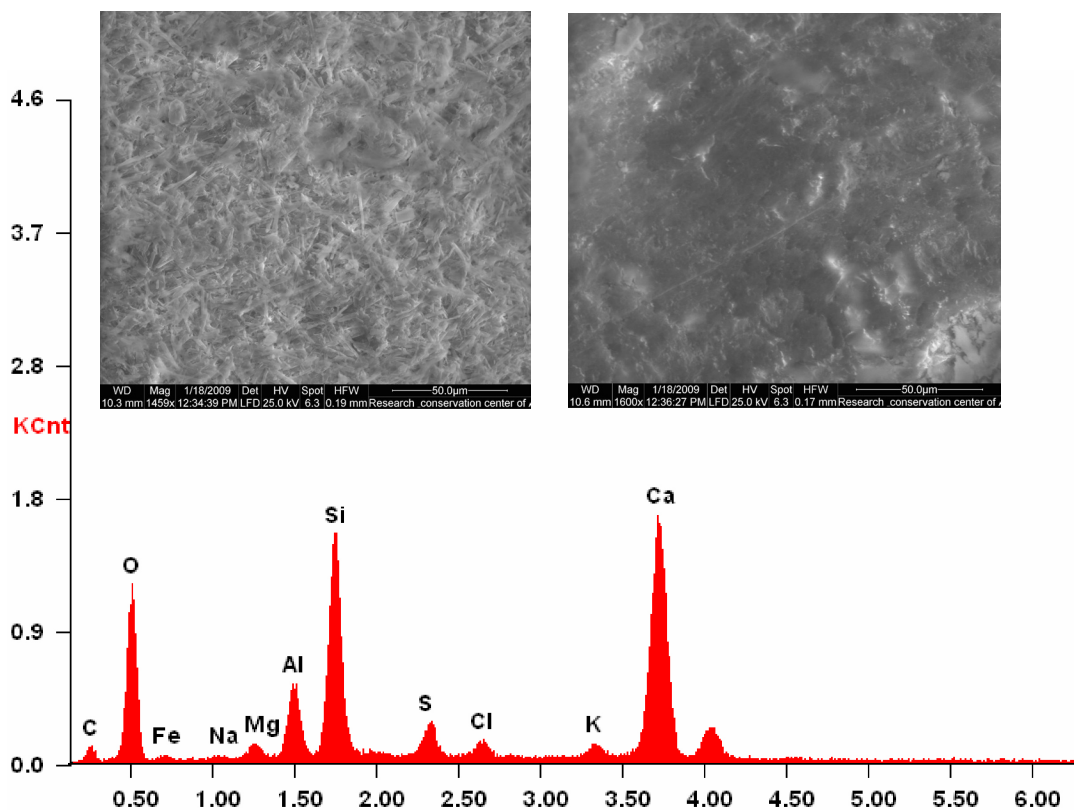
Fig. 3. SEM-EDAX spectra and micrographs of the studied plaster sample from the Sabil Alkazlar. The micrograph (left) shows the gypsum crystals which are the main components of the plaster, while the micrograph (right) shows the growth of anhydrite and halite crystals inside gypsum.

The XRD analysis of the rendering layer applied to the wooden ceiling of Sabil Alkazlar; revealed the presence of gypsum, anhydrite, dolomite, quartz, aluminum oxide, microcline, halite, bone black, yellow ochre and hematite (fig. 2). SEM-EDAX of the same sample showed the presence of: 43% oxygen, 18% calcium, 13% silicon, 11% carbon, 3% iron, 5% aluminum, 2% sulfur, 2% magnesium, 1% chlorine, 1% potassium and 1% sodium (fig. 3).
