AnIsl 45 (2011), p. 321-338

M.A. Mohie, Abubakr Moussa

Diagnosis of Pigment Materials Affected by Air Pollution and Clay Minerals in Sabil Alkazlar.

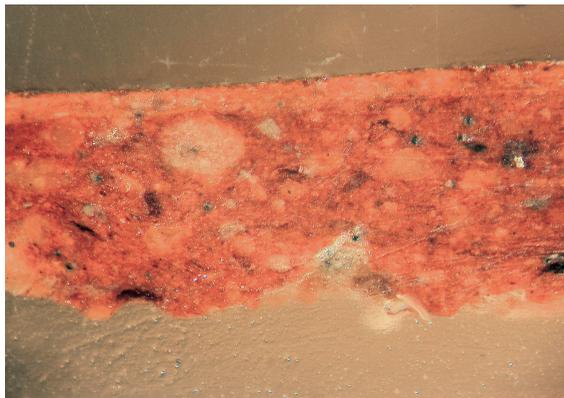
Fig. 13b. Cross section of the golden pigment in the Sabil Alkazlar (125X).

which the monument belongs.⁵ It is well-known that the decoration of ceilings is done through one of two techniques. The first and most common technique is the outlining of the design and the shape of ornamentation followed directly by the application of the pigments on the paint ground. The second technique which is rarely used involves applying different color grades and several pigments followed by coloring the upper layer with the desirable color grade. The latter technique is more advanced since it shows the experience and skill of the artist. In order to determine if the first or second technique was used, a bulk sample was taken from the ceiling's golden pigment (fig. 13a). The cross section of the golden sample (fig. 13b) revealed that the artist applied a thin sheet of gold over a thick layer of a red pigment which is composed of hematite and silica grains.

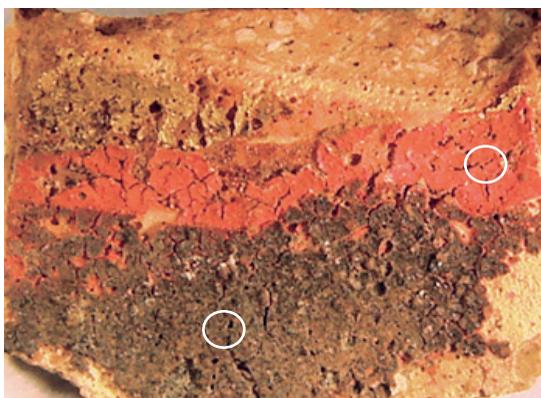
Fig. 14a. Shows the bulk sample of the ceiling's black and red pigments from which the cross section was prepared (the cycles shows the exact place).

A bulk sample of the ceiling's black and red pigments was tested (fig. 14a). The black pigment was examined under a light microscope (fig. 14b). The results showed that the layered structure consists of 5 layers: the upper layer is black; the fourth and third layers are gray; the second is creamy and the lowest layer is red. XRD analysis revealed that the black pigment is bone black and the red pigment is natural cinnabar. Both pigments appeared in all layers with variable ratios. This sample confirmed that the artist used the multi-layer technique. The sample from the red pigment (fig. 14c) revealed the presence of a thin red upper layer followed by a thicker layer; the third layer is creamy in color and is thicker than the previous two layers. The final lowest layer is the thickest layer and it is the plaster layer which precedes the paint ground. It can be concluded that the painting layers of the Sabil Alkazlar's ceiling was composed of a wooden support upon which the plaster layer was composed of two layers (*gesso grosso* and *gesso sottile*), and a pigment layer carried out using the tempera technique.
