AnIsl 46 (2013), p. 323-336

Characterization of Imitated Marble Used in Historical Buildings in Cairo – Egypt

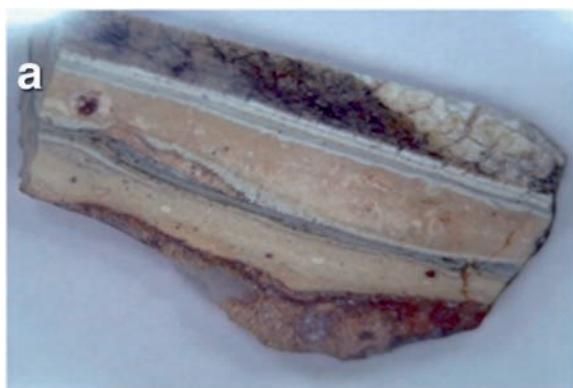
Fig. 3a. The polished cross section of the *sabil*'s sample.
Fig. 3b. Thin cross section image under plane polarised light $\times 20$.

The preliminary observation of the collected samples showed the stratigraphic structure of the marble-imitating stucco. The polished cross section examination revealed the presence of three main layers (fig. 3a): inner, middle and outer layer (finishing layer). Secondary layers are seen within the middle layer of some samples.

The PLM examination of the thin cross section showed the very compact fine grains structure of the layers. The outer layer is light colored and transparent under the plane polarized light (PPL). The middle layer is characterized by the dark opaque color and high density. The gradually alternation between low density light colored and high density dark colored is well observed within the contact area between this layer and the outer layer (fig. 3b). The high density of the middle layer is most probably due to the high content of glue that was used as an organic binder in this layer (corroborated by FTIR analysis). The outer layer is less dense than the middle layer, which indicates the low content of organic binder. Aggregates of secondary gypsum are seen within the outer and middle layers. The presence of secondary gypsum is most probably the result of remobilization of the primary gypsum or weathering alteration of calcite that are both intentionally used in the execution of the layers.
