AnIsl 50 (2017), p. 147-198

Dina Ishak Bakhoum

Mamluk Minarets in Modern Egypt. Tracing Restoration Decisions and Interventions

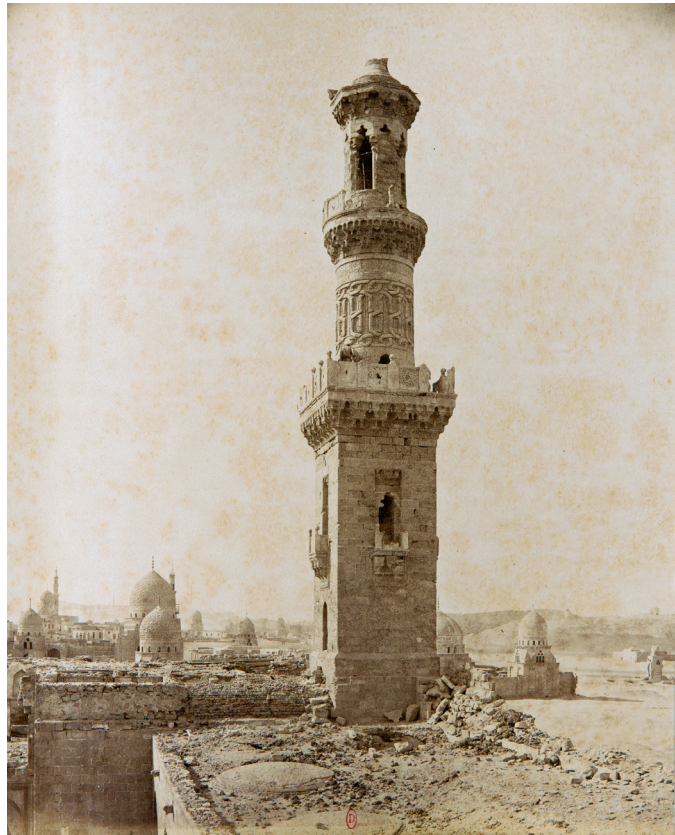
Minarets that appear in images of the late 19th century in quite a ruined state (fig. 1 & fig. 2) were endangered not only as a result of neglect and lack of maintenance, but also due to a number of recorded earthquakes.

northern one. The photographs show the ruined minaret with its bulb missing, as observed in other photographs, but here we can observe in more detail the condition of the minaret and what parts of the stone balustrades of the balconies are damaged, and in other parts what is completely missing (fig. 1). The last shaft composed of marble columns is intact and clearly supported with masonry between the columns, as represented earlier by Prisse d'Avennes.

From a structural perspective, minarets are not only a challenge to construct, but their restoration must have been a costly and difficult task for the *Comité*, especially as many of them suffered after a number of earthquakes that will be discussed below (fig. 1 & fig. 2).

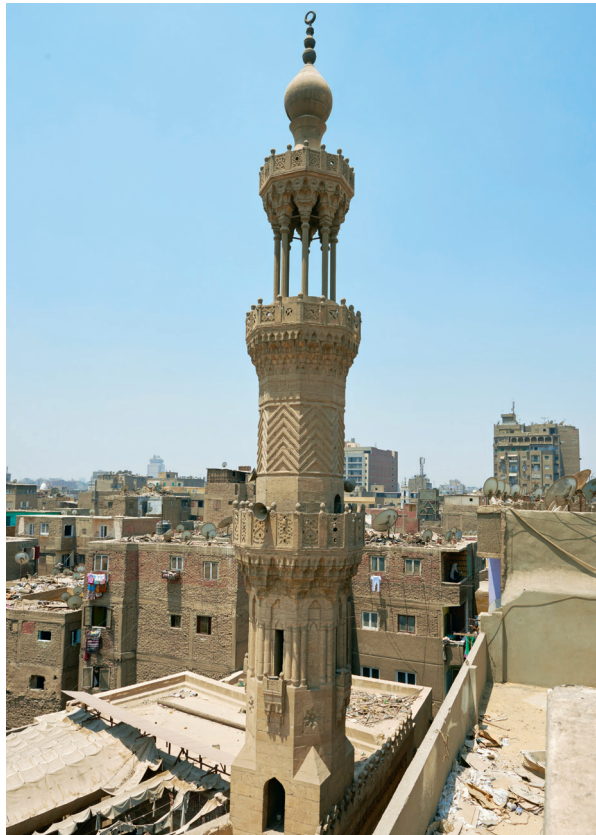
Fig. 5. [Minaret of Qāḍī 'Abd al-Bāsiṭ mosque], 2015.
Digital photograph. © Matjaž Kačičnik.

During the Ottoman period, some damaged upper pavilions of Mamluk minarets were reconstructed in Ottoman style with the pencil-like cap (fig. 3 & fig. 4). These additions were sometimes removed by the *Comité* and restored back to Mamluk style (fig. 5). From a political perspective, Sanders, when discussing this type of restoration work by the *Comité*, argues broadly that: “One of the most urgent tasks of the *Comité* was to identify and restore these dozens of monuments to proper dynastic style”¹⁹ arguing that the “*Comité* was decidedly anti-Ottoman”.²⁰

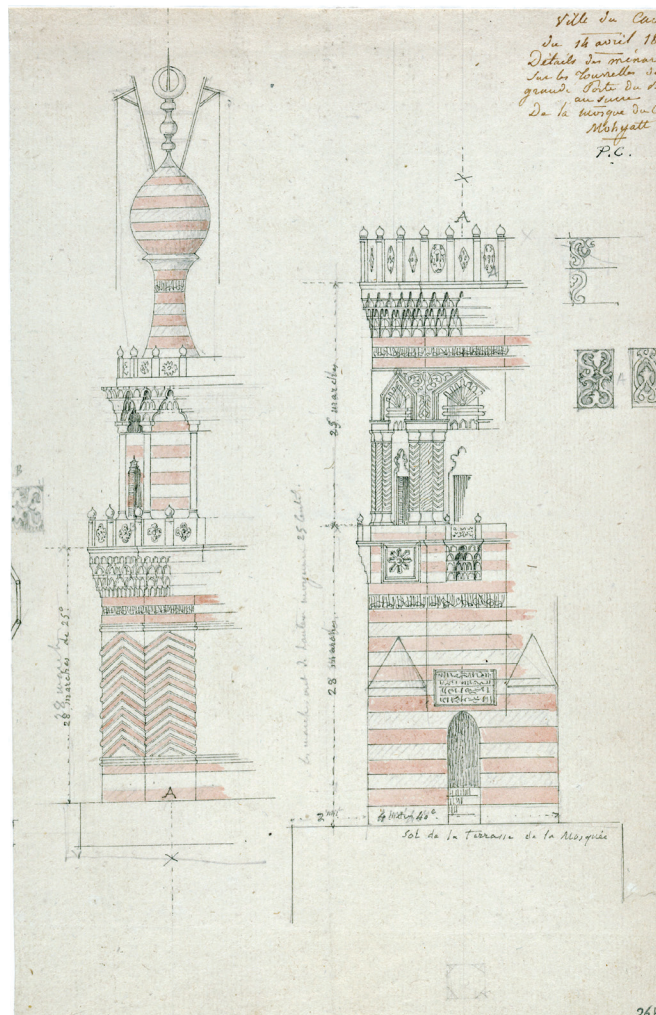
Fig. 6. Pascal Coste, *Ville du Caire*, [dessin ?] du 14 avril 182[2], *Détails des minarets sur les tourelles [sic] de [la] grande porte du [magasin ?] au sucre de la mosquée [sic] du Ca[lif]e Mohyatt*. Drawing, Bibliothèque de l'Alcazar, Marseille, Album MS 1310, Folio no. 26b. Courtesy of BMVR.

In some cases, the marble columns and masonry in-between could be clearly seen, such as in representations and photographs of the minarets of al-Mu'ayyad mosque (fig. 6).

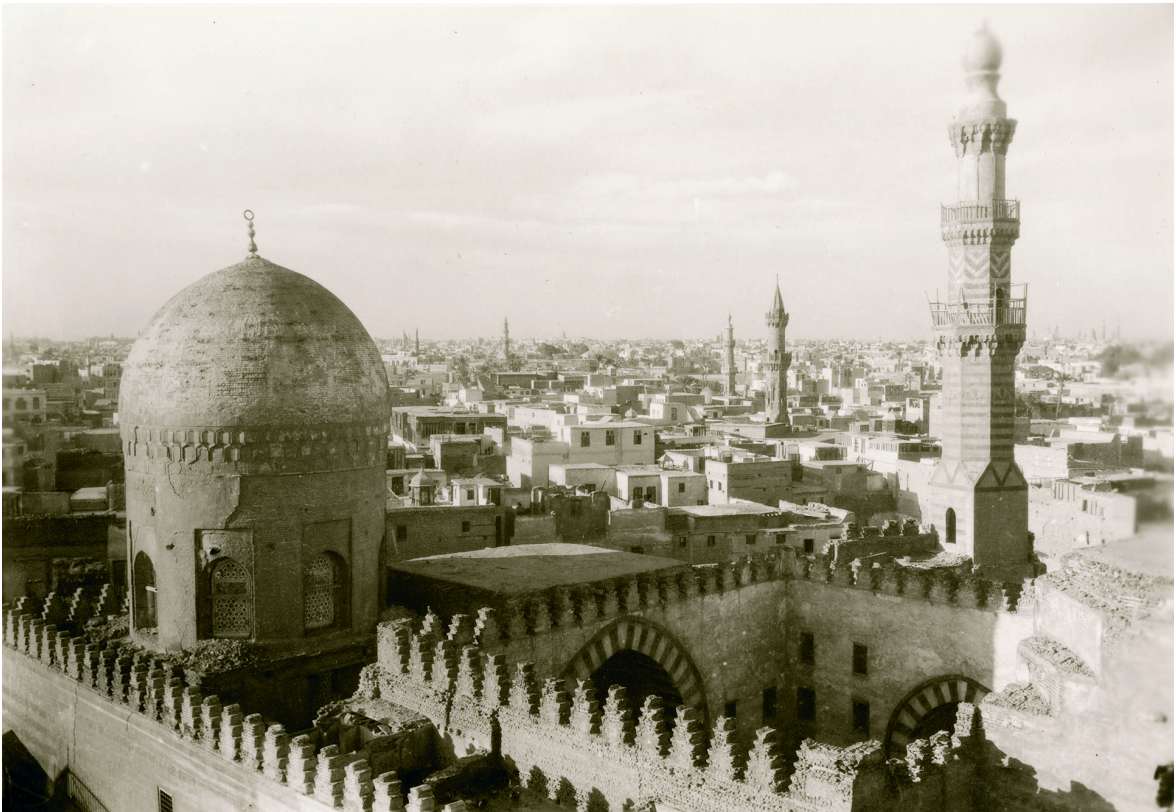
Fig. 8. Unknown photographer, [Mosque and minaret of the mosque of Şarġatmiş], post 1894 and before 1935. Silver print, Creswell Photographic Collection, The American University in Cairo. Album 22. Courtesy of RBSCCL.

What is clear from the careful investigation of photographic evidence is that a variety of interventions on minarets were carried out prior to the establishment of the *Comité*, but cannot always be accurately dated. The *Comité* acknowledged that some of these interventions were structurally useful, even if the work was not aesthetically and artistically pleasing. In one instance dating to 1894, when the *Comité* couldn't find a contractor to carry out the dismantling and reconstruction work on the minaret of Şarġatmiş (757/1356), a masonry wrapping for the upper pavilion was proposed as a consolidation measure and was executed (fig. 8).⁵⁴

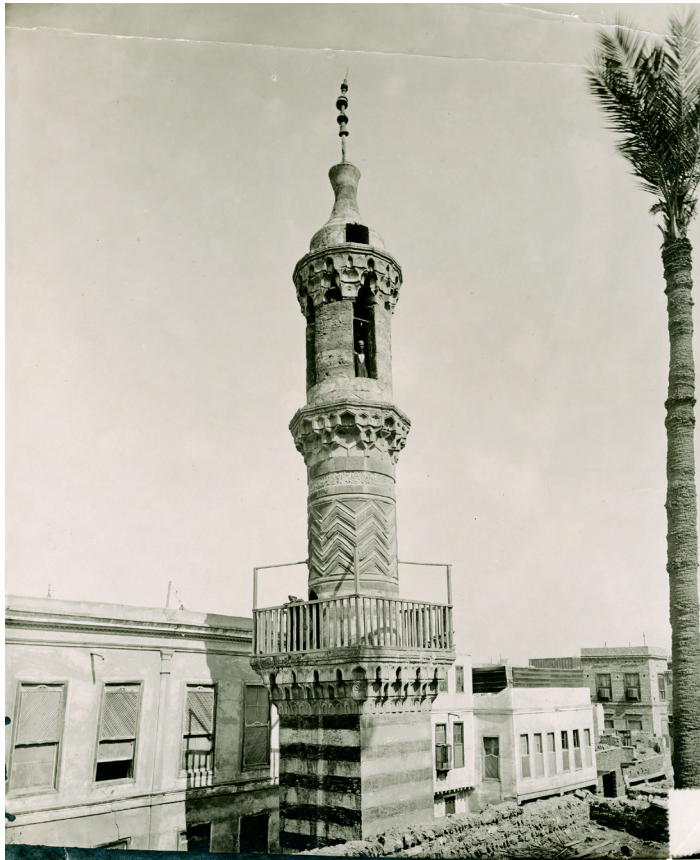
Fig. 9. Probably Giuntini, [Minaret of Qānībāy al-Šarkasī mosque], with manuscript mention at the back of the print: *Kānbāi el-Djarkassi (mosquée de): minaret, vue d'ensemble*, 1901. Silver print. Creswell Photographic Collection, The American University in Cairo, Album 24. Courtesy of RBSCL.

1. The second circular storey had a 25 cm inclination towards the eastern side in respect to the height of 5.4 meters.¹⁰⁷
2. The first square storey inclined 19 cm eastwards in respect to the 10.85 m height.
3. Excavations carried out to examine the minaret's foundations showed they were built of stone with a height of 1.6 m from the floor level. The footing was 2.3 × 2.3 m, the same as the minaret's first storey. Below that was another footing (also 2.3 × 2.3 m) built with small stones mixed with mud-mortar and gypsum that was disintegrated.
4. The ablution area and drainage tank, both adjacent to the minaret, were not connected to the public sewage system. Excavations from the side of the minaret closest to the ablution area revealed moist soil.
5. Given its current inclination and condition, as well as the impact of the wind pressure, the minaret is dangerously out of plumb.

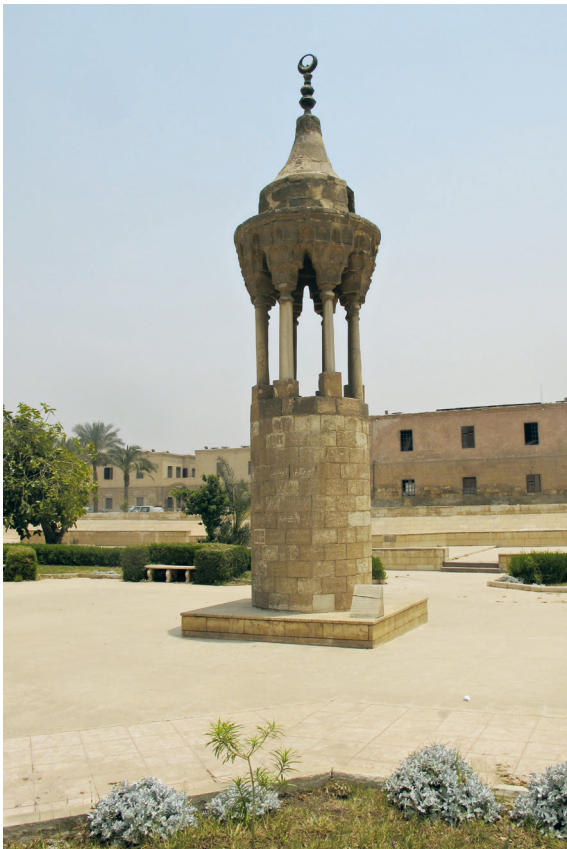
Fig. 10. [Upper part of the Minaret of Qānībāy al-Šarkasī mosque, now at the Cairo citadel], 2015. Digital photograph. © Dina Bakhoun.

In 1910, the *Comité* allocated money for the following year for the reconstruction works.¹⁰¹ In October 1911, the contract with *al-mu'allim* (the master) Ibrāhīm Mabruk was signed and the works were completed in February 1912.¹⁰² As noted by Ormos, the upper part of the minaret of the mosque of Qānībāy al-Šarkasī as well as that of the mosque of Aydamur al-Bahlawān (also called Baydar al-Aydamurī, 747/1346), appear in an early-mid 20th century photograph from the Creswell photographic collection at the American University in Cairo, depicting the courtyard of the mosque of al-Ḥākīm, where they were reconstructed.¹⁰³

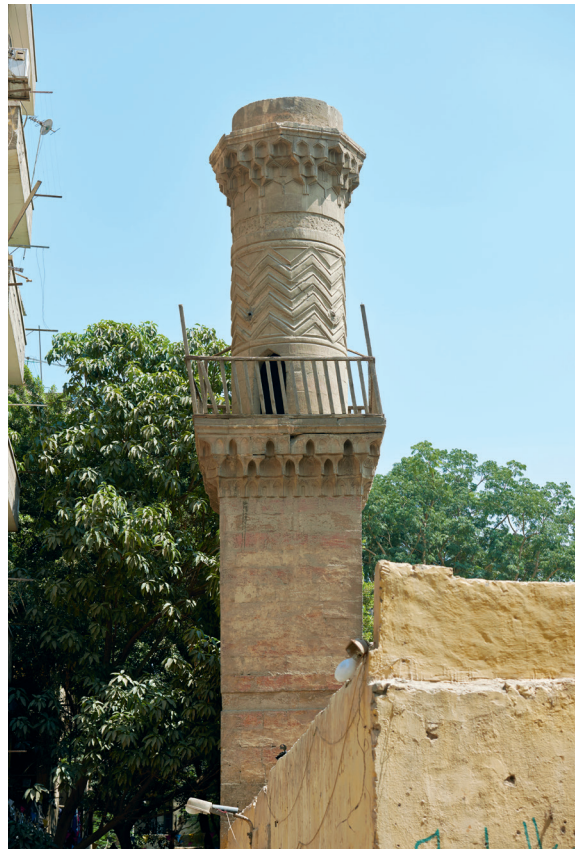
Fig. 11. [Minaret of Qānībāy al-Šarkasī mosque], 2015. Digital photograph. © Matjaž Kačičnik.

The *Comité* decided to delay the minaret's reconstruction while requesting that the Ministry of *Awqāf* take measures to connect the ablution area to the public sewer.¹⁰⁸ The upper part of the minaret of Qānībāy al-Šarkasī was eventually moved from the courtyard of al-Ḥākīm mosque to its present location behind the offices containing the *Comité's* photographic and architectural archives at the Citadel in Cairo (fig. 10). It is labelled with its name and a 15th century date, however its story since its dismantling from the mosque of Qānībāy al-Šarkasī in 1901 remains untold. Today, the mosque still stands with an incomplete minaret (fig. 11).

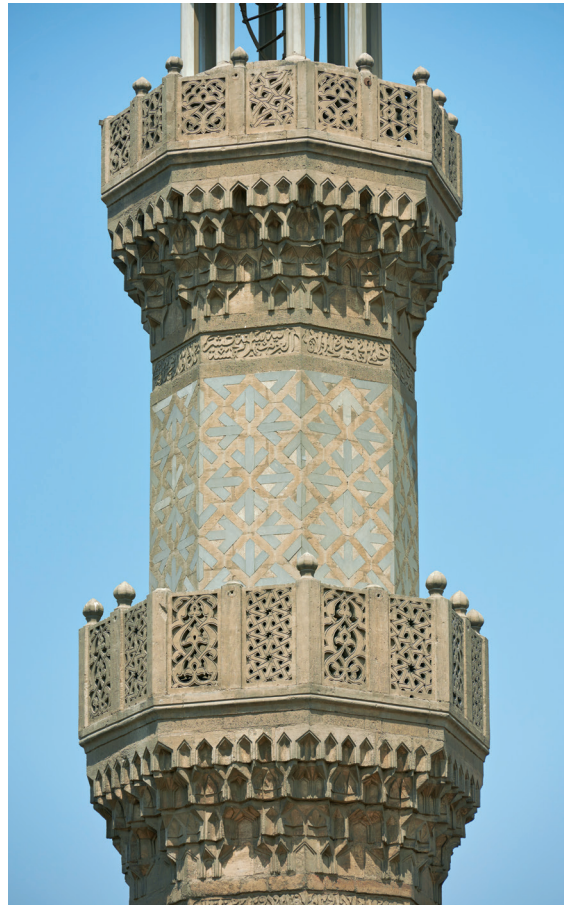
Fig. 12. [Upper part of the Minaret of Qāḍī Yaḥyā Zayn al-Dīn mosque, showing the *Comité*'s inscription], 2015. Digital photograph. © Matjaž Kačičnik.

Today, the complete minaret might appear to the regular viewer as a 15th century Mamluk minaret; however, an inscription band running along the top of the new second storey carries valuable information. The inscription states that the restoration of the second shaft and what is above it was carried out during the reign of ‘Abbās Ḥilmī II under the supervision of the *Comité* in 1315 AH—hence—AD 1897–1898 (fig. 12).

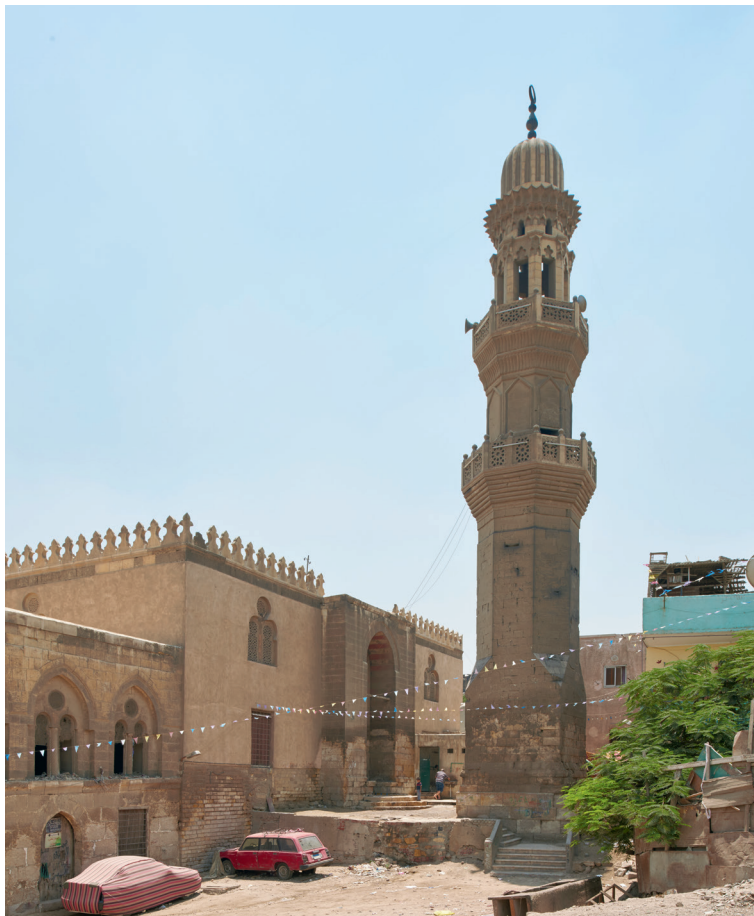
Fig. 13. [Minaret of Maṅḡak al-Yūsufi mosque], 2015. Digital photograph.
© Matjaž Kačičnik.

Decades later, during the *Comité's* meeting of January 17, 1939, the engineer Maḥmūd Aḥmad noted the discovery of original stone blocks of the minaret, buried in the land west of the mosque and suggested that the *Comité* undertake the completion of the minaret. The project was approved unanimously by the members¹²⁰ and the pavilion was reconstructed by January 1941 (fig. 13).

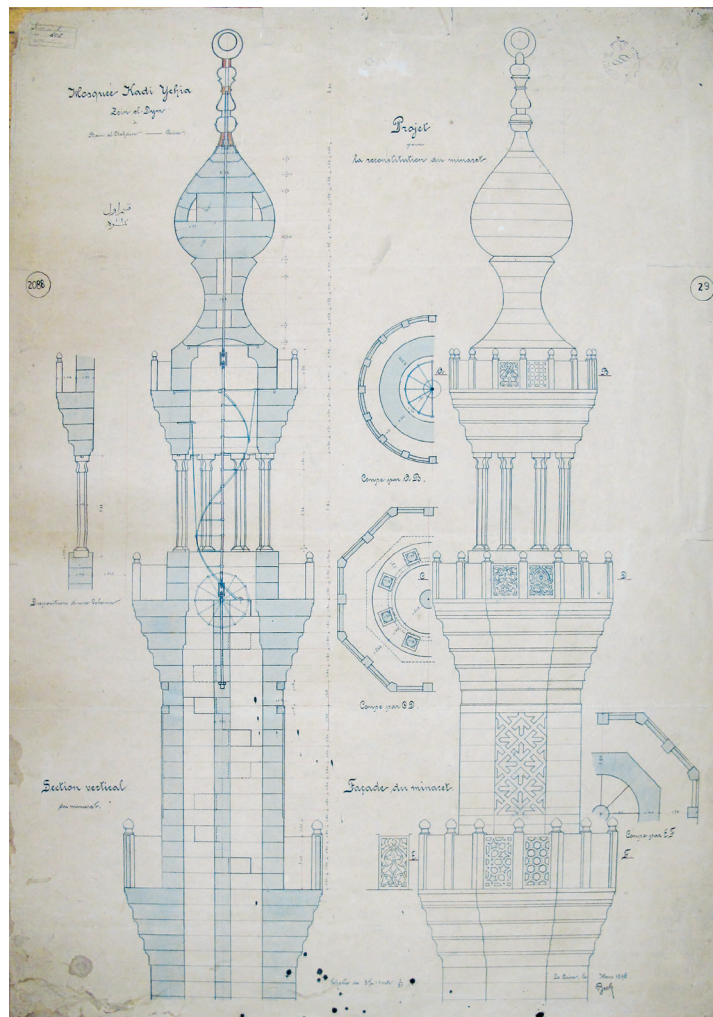
Fig. 14. Steyrer, [Reconstruction drawing of the Minaret of Ġānim al-Bahlawān mosque], Cairo, 1903. *Markaz taṣṣīl al-āṭār al-islāmiyya wa-l-qibṭiyya*, Archives of the Supreme Council of Antiquities. Courtesy of the Ministry of Antiquities.

Herz's monograph demonstrates that initially the *Comité's* plan was not to remove the Ottoman cap and that their aim was to simply consolidate the minaret. It was the discovery of original blocks that triggered the restoration of the balustrades and the replacement of the Ottoman top with a Mamluk one. Herz was keen to note that the pieces found were used to trace the shape of the bulb with accuracy, and also to make sure that the two existing shafts were structurally safe to support the new construction.

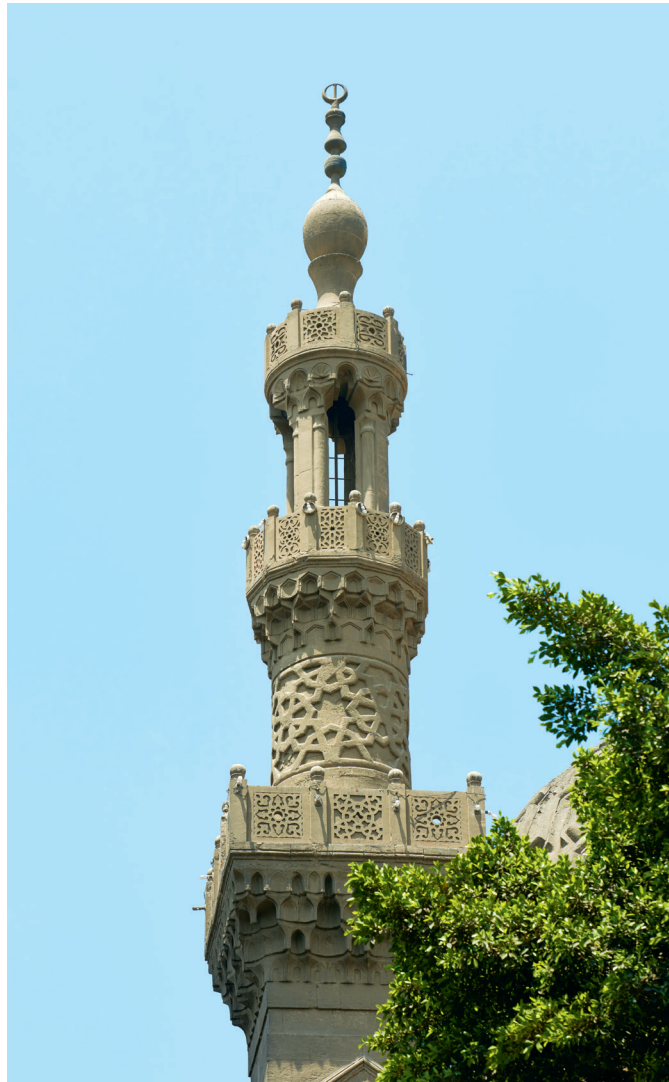
Fig. 15. Minaret of Tağrī Birdī mosque, 2015. Digital photograph.
© Matjaž Kačičnik.

It must be noted, however, that the design didn't follow the eight marble columns, but instead used stone piers with attached columns (fig. 15).

the top part (the pencil-like part) had detached and was falling, and that considering that the minaret's top is modern the director prepared a project for the reconstruction of the upper part inspired by contemporary ones. After examining the project, the *Comité* approved it.¹⁶⁸
