AnIsl 50 (2017), p. 147-198

Dina Ishak Bakhoum

Mamluk Minarets in Modern Egypt. Tracing Restoration Decisions and Interventions

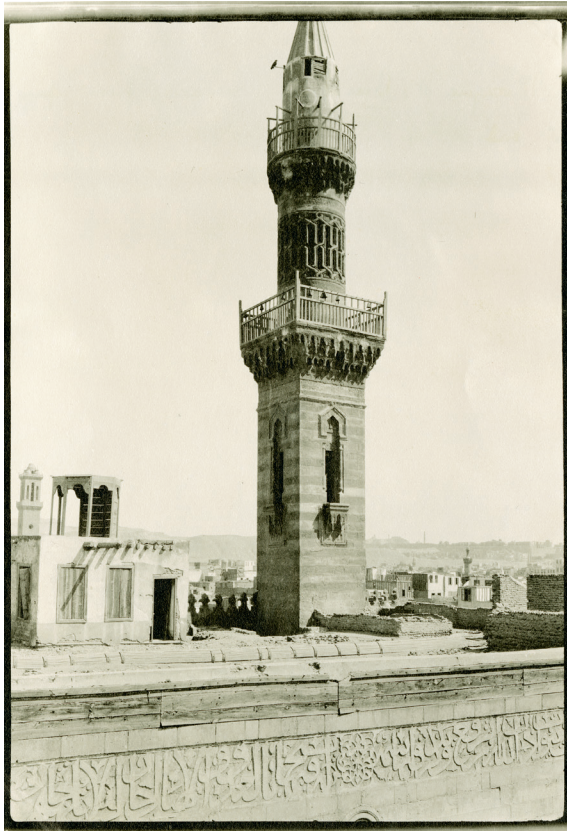
Fig. 3. K.A.C. Creswell, with manuscript mention at the back of the print: *Mosque of Barsbâi: minaret, from coping of şahn*, before 1944. Creswell Photographic Collection, The American University in Cairo, Album 24. Courtesy of the RBSCL.

During the Ottoman period, some damaged upper pavilions of Mamluk minarets were reconstructed in Ottoman style with the pencil-like cap (fig. 3 & fig. 4). These additions were sometimes removed by the *Comité* and restored back to Mamluk style (fig. 5). From a political perspective, Sanders, when discussing this type of restoration work by the *Comité*, argues broadly that: “One of the most urgent tasks of the *Comité* was to identify and restore these dozens of monuments to proper dynastic style”¹⁹ arguing that the “*Comité* was decidedly anti-Ottoman”.²⁰

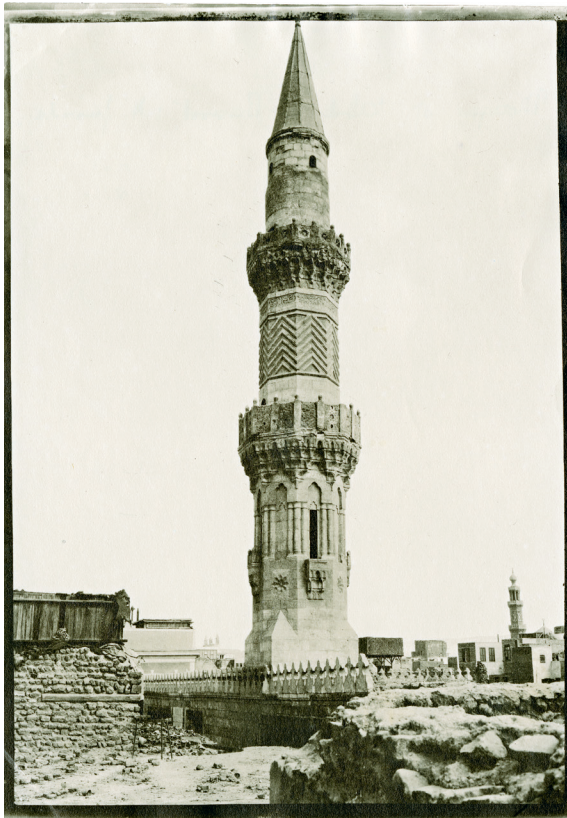
Fig. 4. K.A.C. Creswell, [Minaret of Qāḍī ‘Abd al-Bāsiṭ mosque], with manuscript mention at the back of the print: *Mosque of ‘Abd el-Basset: N. façade*, prior to 1936–1940. Creswell Photographic Collection, The American University in Cairo, Album 24. Courtesy of RBSCL.
