AnIsl 50 (2017), p. 147-198

Dina Ishak Bakhoun

Mamluk Minarets in Modern Egypt. Tracing Restoration Decisions and Interventions

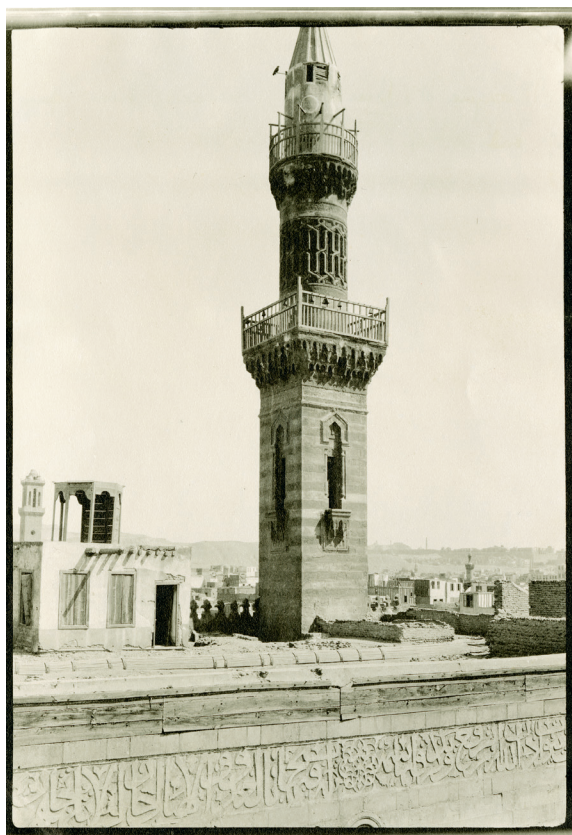
Fig. 3. K.A.C. Creswell, with manuscript mention at the back of the print: *Mosque of Barsbâi: minaret, from coping of şahn*, before 1944. Creswell Photographic Collection, The American University in Cairo, Album 24. Courtesy of the RBSCL.

During the Ottoman period, some damaged upper pavilions of Mamluk minarets were reconstructed in Ottoman style with the pencil-like cap (fig. 3 & fig. 4). These additions were sometimes removed by the *Comité* and restored back to Mamluk style (fig. 5). From a political perspective, Sanders, when discussing this type of restoration work by the *Comité*, argues broadly that: “One of the most urgent tasks of the *Comité* was to identify and restore these dozens of monuments to proper dynastic style”¹⁹ arguing that the “*Comité* was decidedly anti-Ottoman”.²⁰

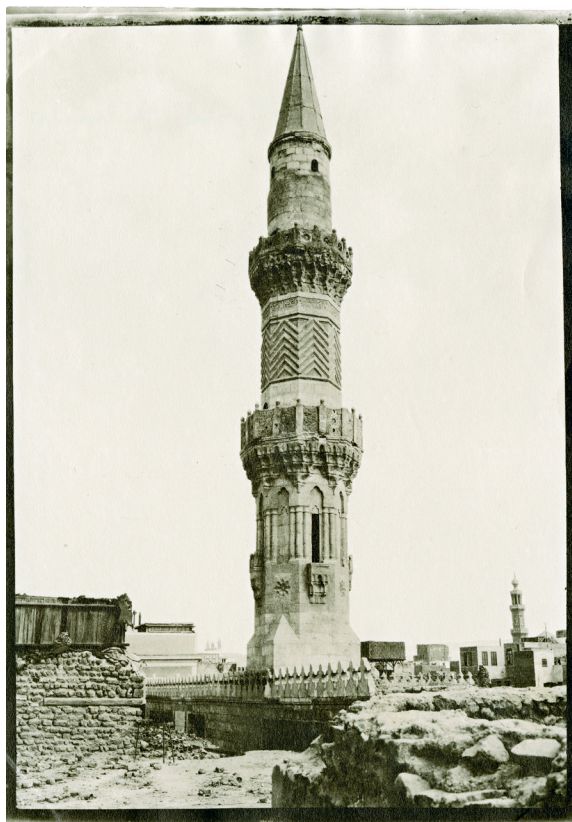
Fig. 4. K.A.C. Creswell, [Minaret of Qāḍī ‘Abd al-Bāsiṭ mosque], with manuscript mention at the back of the print: *Mosque of ‘Abd el-Basset: N. façade*, prior to 1936–1940. Creswell Photographic Collection, The American University in Cairo, Album 24. Courtesy of RBSCL.

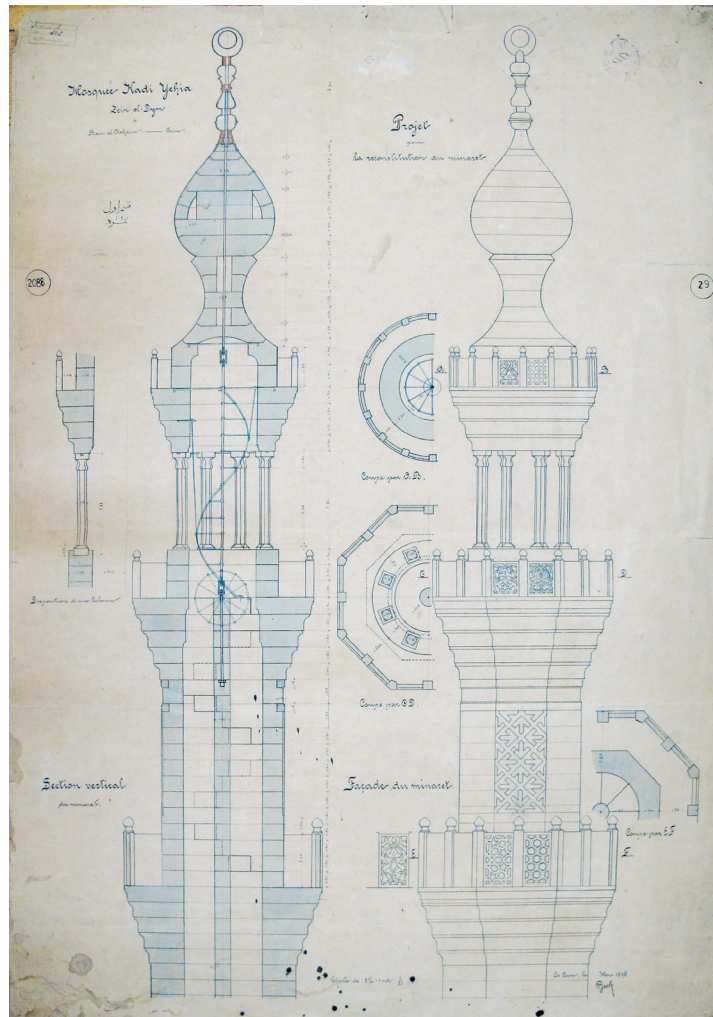
Fig. 14. Steyrer, [Reconstruction drawing of the Minaret of Ġānim al-Bahlawān mosque], Cairo, 1903. *Markaz taṣṣīl al-āṭār al-islāmiyya wa-l-qibṭiyya*, Archives of the Supreme Council of Antiquities. Courtesy of the Ministry of Antiquities.

Herz's monograph demonstrates that initially the *Comité's* plan was not to remove the Ottoman cap and that their aim was to simply consolidate the minaret. It was the discovery of original blocks that triggered the restoration of the balustrades and the replacement of the Ottoman top with a Mamluk one. Herz was keen to note that the pieces found were used to trace the shape of the bulb with accuracy, and also to make sure that the two existing shafts were structurally safe to support the new construction.
