AnIsl 45 (2011), p. 321-338

M.A. Mohie, Abubakr Moussa

Diagnosis of Pigment Materials Affected by Air Pollution and Clay Minerals in Sabil Alkazlar.

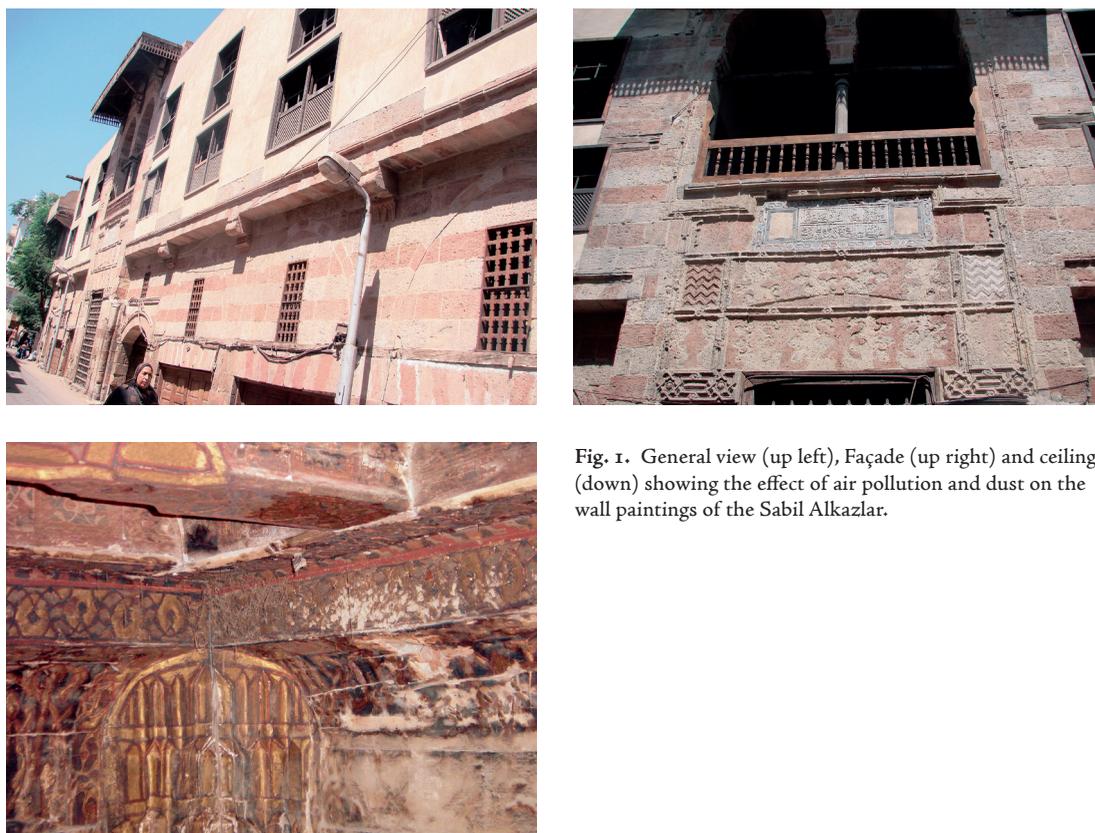
Fig. 1. General view (up left), Façade (up right) and ceiling (down) showing the effect of air pollution and dust on the wall paintings of the Sabil Alkazlar.

THE Arabic word Sabil stands for public drinking fountain. Sabil Alkazlar (fig. 1) is one of the Ottoman historical buildings that have survived in historic Cairo. It is located at 30° 01' 59.42" N and 31° 15' 13.29" E; in Alsoyofeyya Street behind Alsultan Hassan mosque. It was established in 1617 AD by Mustafa Agha Pasha Alkazlar. The façade, internal units and the ceiling of the building are exposed to different weathering agents.

in those samples that have no black pigment material. The complex physical and chemical interactions of these agents with the mineral material have dramatically accelerated the decay of the building materials.¹⁹ Particulate pollutants vary enormously in size and are especially dangerous to objects because they attract moisture and gaseous pollutants. Dust can be an abrasive agent. Removing dust involves washing, wiping, or shaking, all of which accelerates deterioration and increases the risk of physical damage to wall paintings.²⁰ Dust precipitated on the wall paintings of the Sabil (fig. 1) and in the micro cracks (fig. 9).

- a. The solubility factor of the salt and its ability to transfer from the groundwater into the building materials.
- b. The porosity of the building materials.²⁴ Chemically, salts in reaction with the pigment components play a role as a catalyst in the discoloring phenomenon (fig. 1).

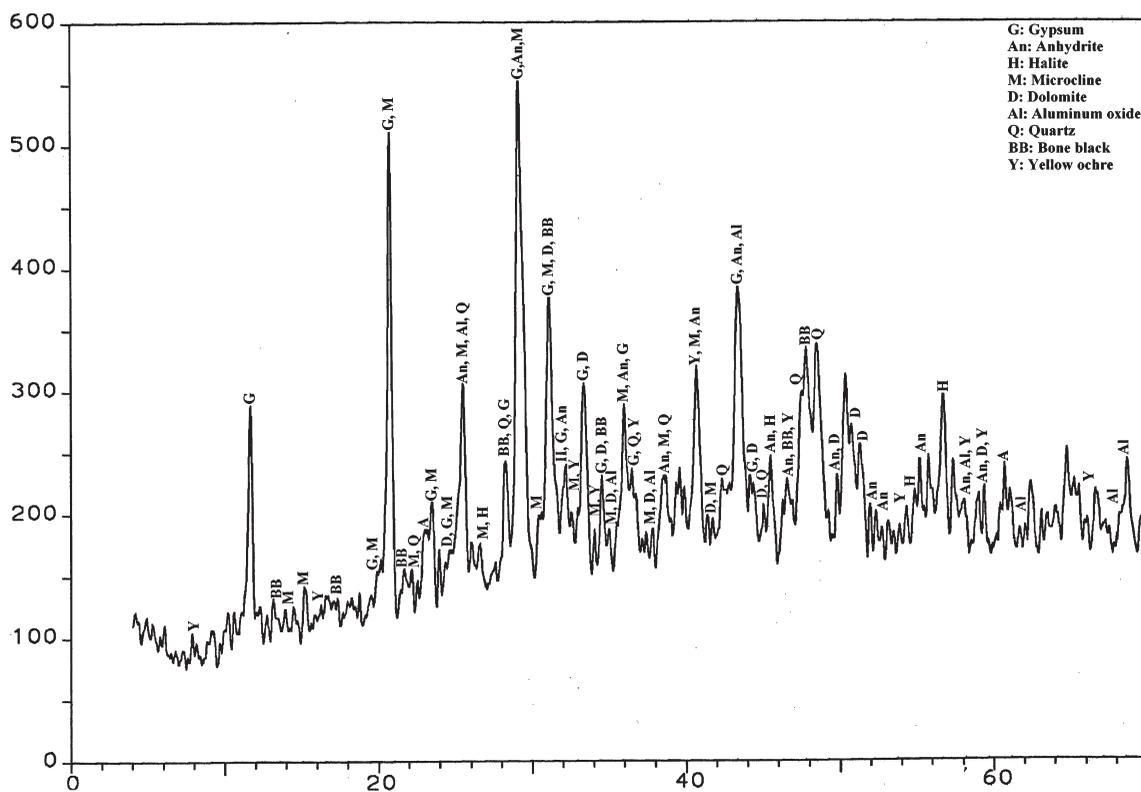
Fig. 2. XRD pattern of the studied plaster sample from the Sabil Alkazlar.

The XRD analysis of the rendering layer applied to the wooden ceiling of Sabil Alkazlar; revealed the presence of gypsum, anhydrite, dolomite, quartz, aluminum oxide, microcline, halite, bone black, yellow ochre and hematite (fig. 2). SEM-EDAX of the same sample showed the presence of: 43% oxygen, 18% calcium, 13% silicon, 11% carbon, 3% iron, 5% aluminum, 2% sulfur, 2% magnesium, 1% chlorine, 1% potassium and 1% sodium (fig. 3).

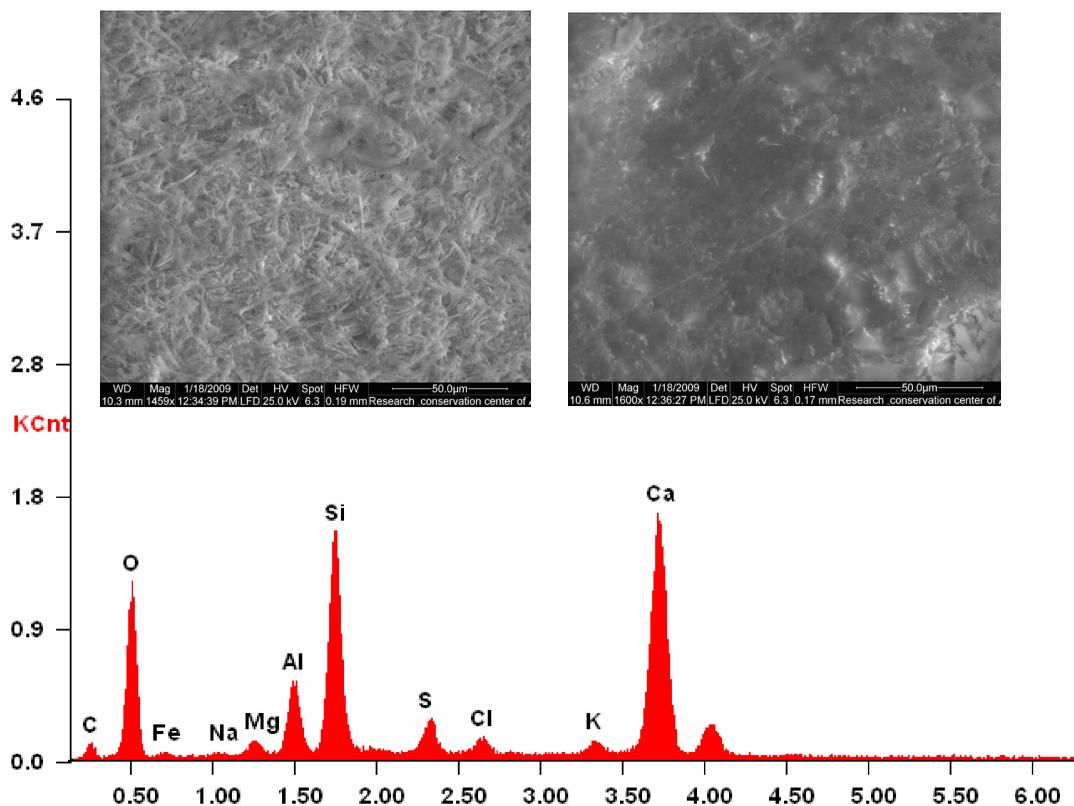
Fig. 3. SEM-EDAX spectra and micrographs of the studied plaster sample from the Sabil Alkazlar. The micrograph (left) shows the gypsum crystals which are the main components of the plaster, while the micrograph (right) shows the growth of anhydrite and halite crystals inside gypsum.

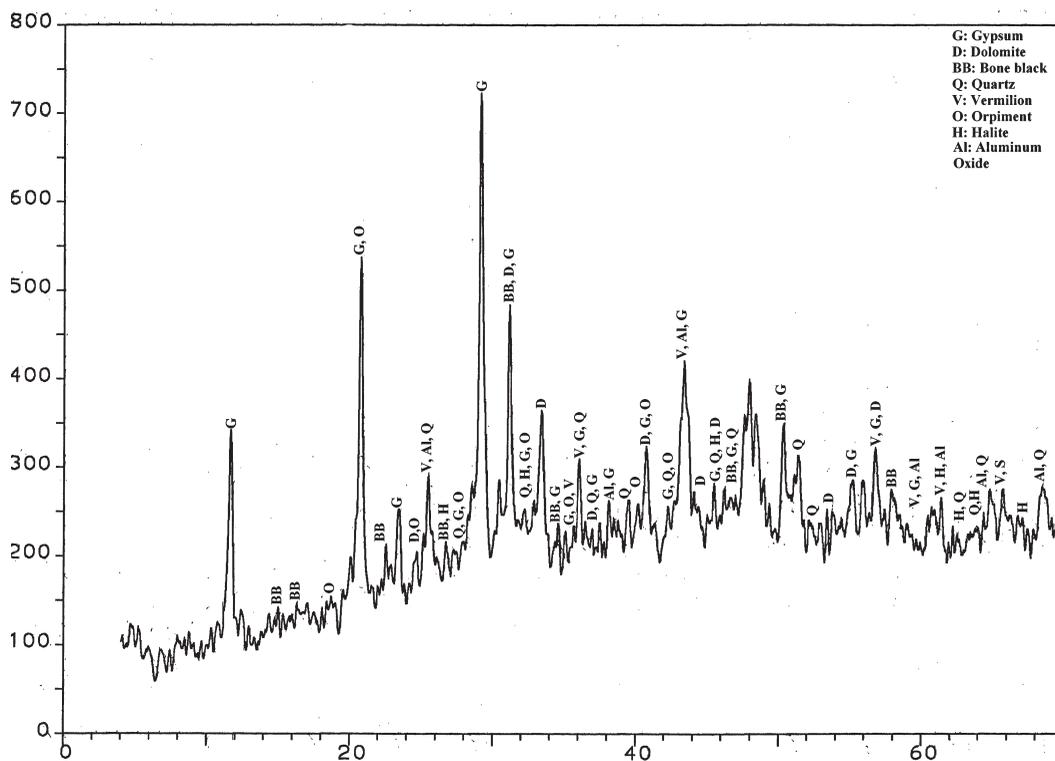
Fig. 4. XRD pattern of the studied black pigment sample from the Sabil Alkazlar.

XRD analysis of a black pigmented plaster sample from the ceiling proved that the used pigment material is bone black [$\text{C}\cdot\text{Ca}_3(\text{PO}_4)_2$]. The sample contains also gypsum, dolomite, quartz, halite, orpiment, cinnabar and aluminum oxide (fig. 4). The SEM-EDAX of the sample revealed the presence of about 65% carbon, 28% oxygen, 1% chlorine, 1% sodium, 1% calcium, 1% phosphate, 1% sulfur and traces of aluminum, silicon and magnesium (fig. 5).

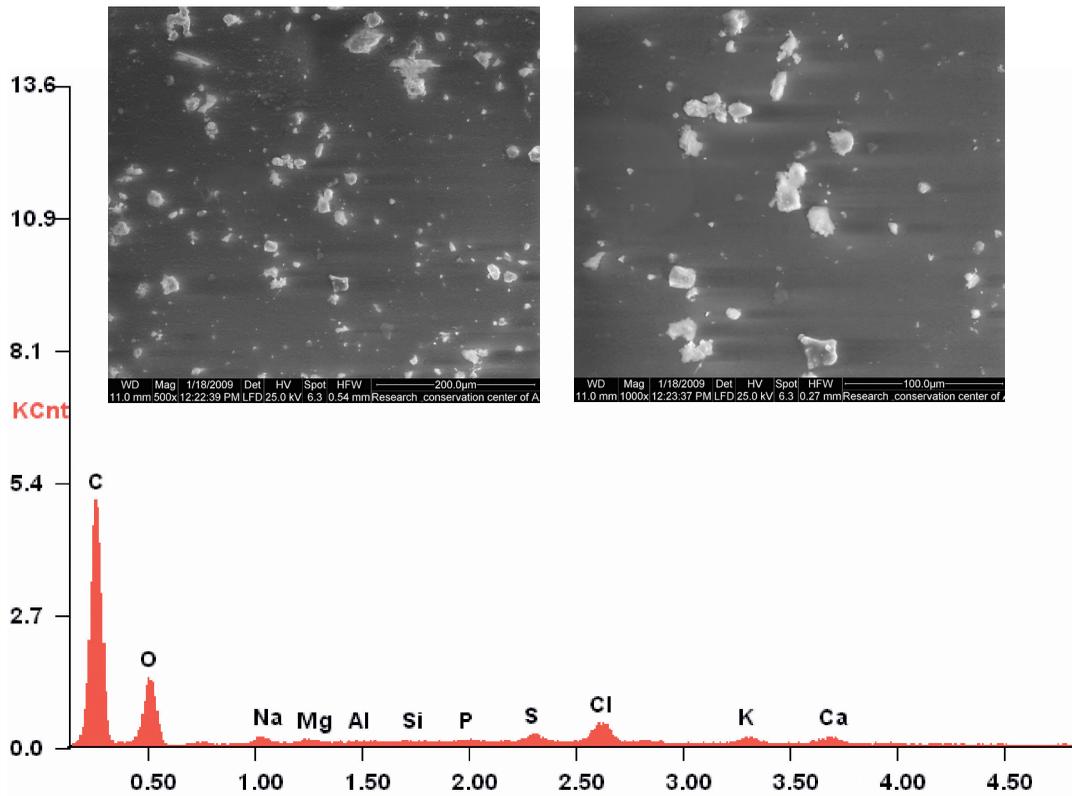
Fig. 5. SEM-EDAX spectra and micrographs of the studied black pigment from the Sabil Alkazlar. The micrographs show the growth of halite crystals upon pigment surface (efflorescence).

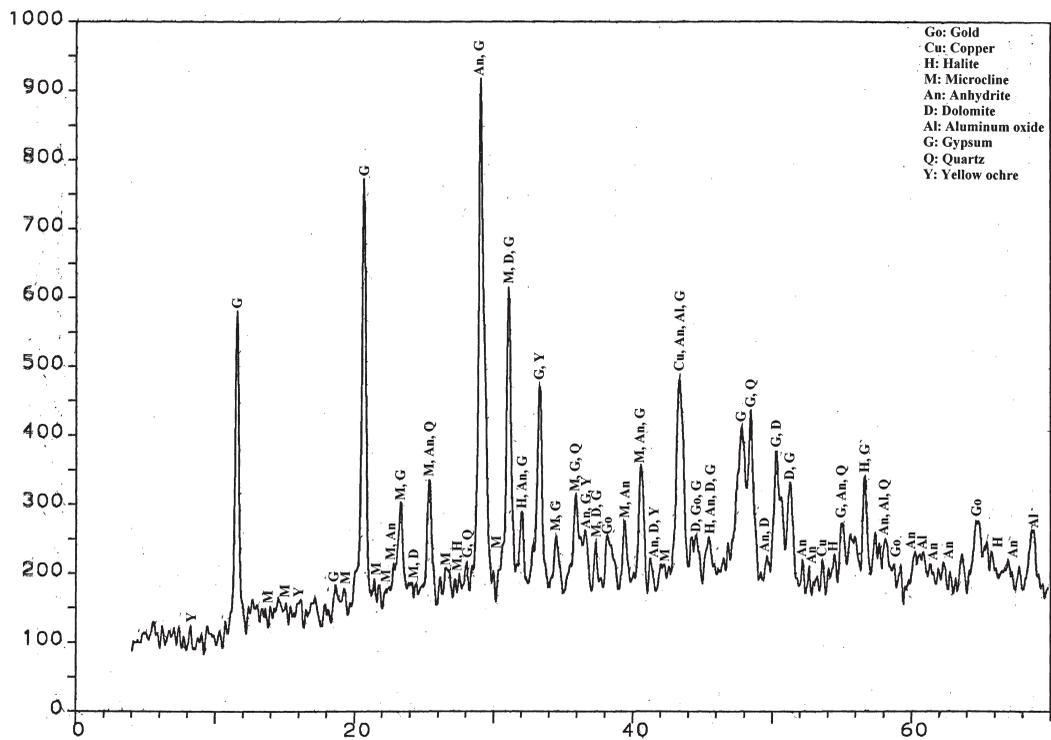
Fig. 6. XRD pattern of the studied golden pigment sample from the Sabil Alkazlar.

Based on the XRD analysis, the golden pigment material used in Sabil Alkazlar's ceiling is gold (Au) mixed with traces of copper. The analyzed sample contains gypsum as a major constituent, in addition to anhydrite, dolomite, quartz, aluminum oxide, microcline, halite, yellow ochre and hematite (fig. 6). The SEM-EDAX of the same sample detected the presence of about 47% gold, 23% carbon, 18% oxygen, 7% calcium, 1% potassium, 1% quartz, 1% sodium, 1% iron and traces of copper, aluminum and magnesium (fig. 7).

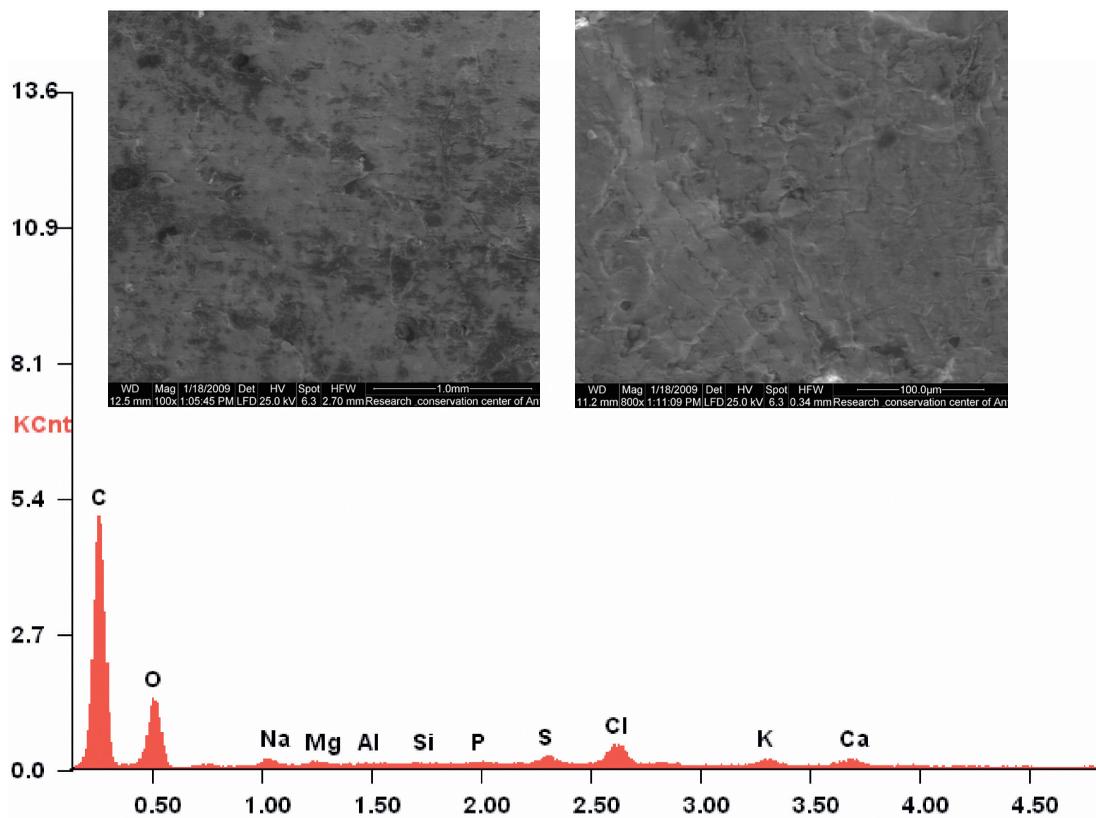
Fig. 7. SEM-EDAX spectra and micrographs of the studied golden pigment from the Sabil Alkazlar. The micrographs show the presence of blisters which can be explained due to hammering of gold leaves.

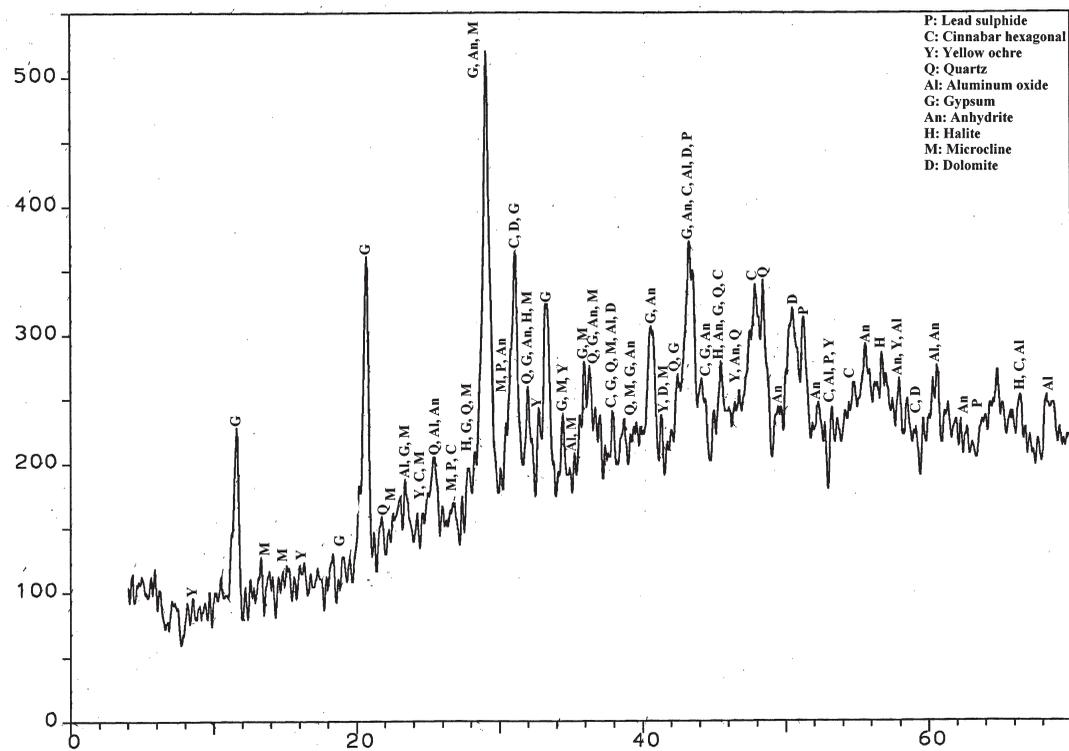
Fig. 8. XRD pattern of the studied red pigment sample from the Sabil Alkazlar.

XRD analysis of the red pigment material in Sabil Alkazlar's ceiling revealed the presence of natural cinnabar (HgS). The sample also contains gypsum, anhydrite, dolomite, quartz, aluminum oxide, microcline, halite, lead sulfide, yellow ochre and hematite (fig. 8). The SEM-EDAX for the same sample detected the presence of about 30% carbon, 19% mercury, 17% oxygen, 15% lead, 6% sulfur, 3% calcium, 3% chlorine, 2% potassium, 1% sodium, 1% iron, 1% silicon, 1% magnesium and 1% aluminum (fig. 9).

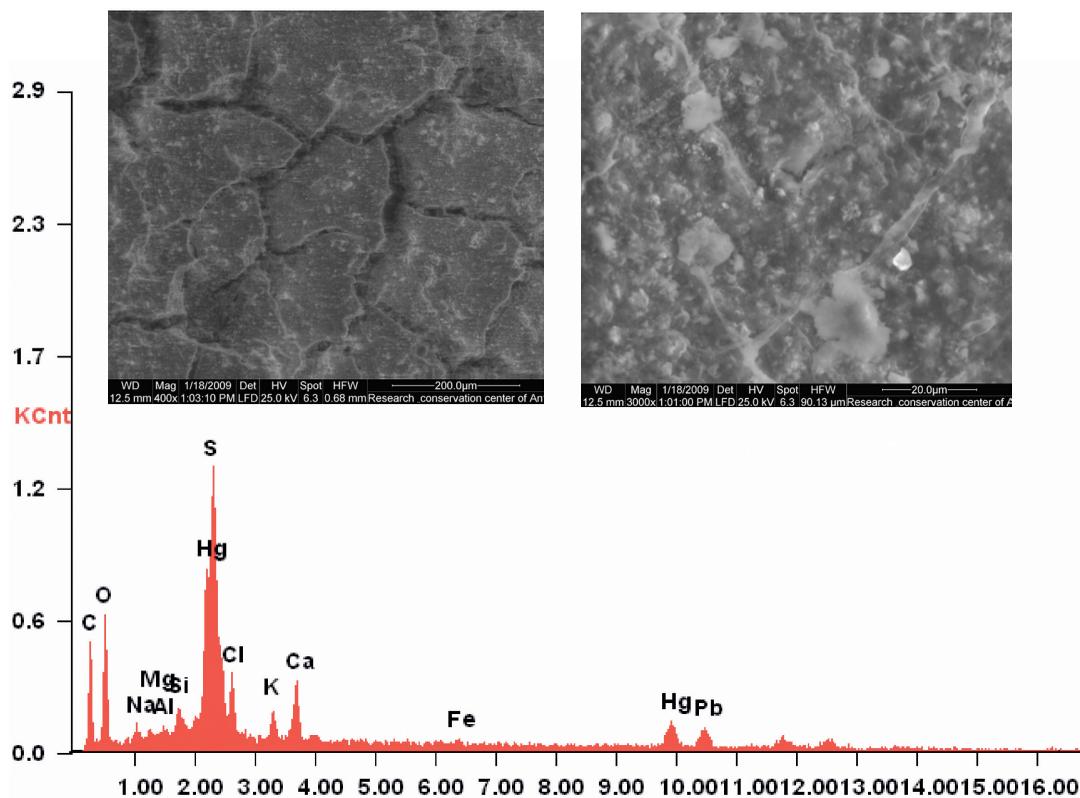
Fig. 9. SEM-EDAX spectra and micrographs of the studied red pigment from the Sabil Alkazlar. The micrographs show a net of micro cracks in the pigment surface due to clay minerals effect; these cracks are filled with salt crystals and dust.

16. Smectite-illite mixed layers are able to swell more than kaolinite according to the 2:1 composition. When water is absorbed, swelling starts to appear on the wall paintings surfaces in microscopic cracks and fractures. This is shown in the SEM micrographs of the red pigment (fig. 9).

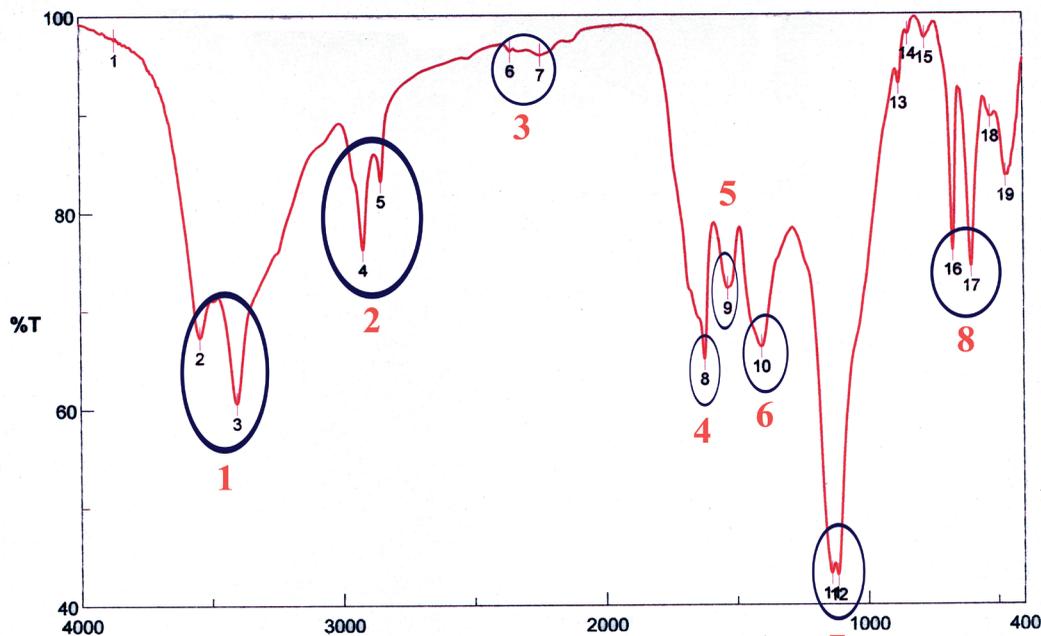
Fig. 10. FTIR spectrum of the binding medium used with the red pigment in the Sabil Alkazlar.

- [1] Asymmetric and symmetric OH stretching bands of both animal glue and gypsum (splitting of the band is due to presence of gypsum). N-H stretching band of animal glue is over lapped by OH bands.
- [2] Asymmetric and symmetric CH stretching bands of aliphatic groups of animal glue.
- [3] Combination or overtones bands.
- [4] Carbonyl stretching band of animal glue (amide I) + S=O stretching of SO_4^{2-} of gypsum.
- [5] Combination of C-N stretching band and N-H bending band (amide II) of animal glue.
- [6] C-H bending + OH bending band. [7] Asymmetric SO_4^{2-} stretching band of gypsum.
- [8] SO_4^{2-} bending band of gypsum.

Four samples were analyzed using FTIR in order to identify the medium used in both the rendering layer and pigments in Sabil Alkazlar. Functional groups and wave numbers were measured. Animal glue binding was found on the FTIR charts. Based upon the results, it has been proved that rabbit skin glue was the paint medium used to mix and fix the pigments to the plaster, and it was also used to mix the components of the plaster layer together and fix them to the wooden ceiling (fig. 10). A standard sample of rabbit skin glue was prepared for comparison (fig. 11). The result was also emphasized by the UV analysis (fig. 12) which proved that the used medium was rabbit skin glue.

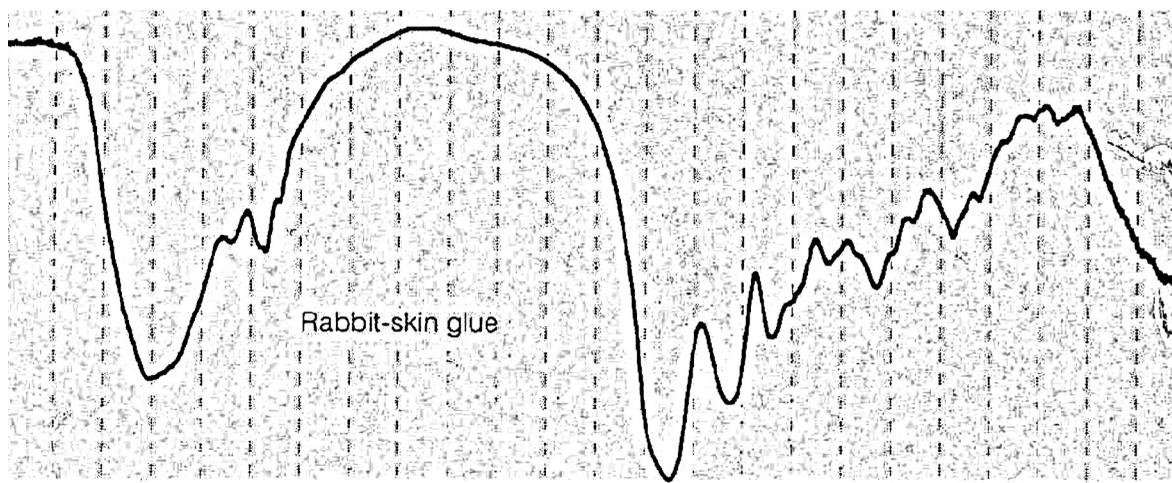
Fig. 11. FTIR standard of rabbit skin glue.

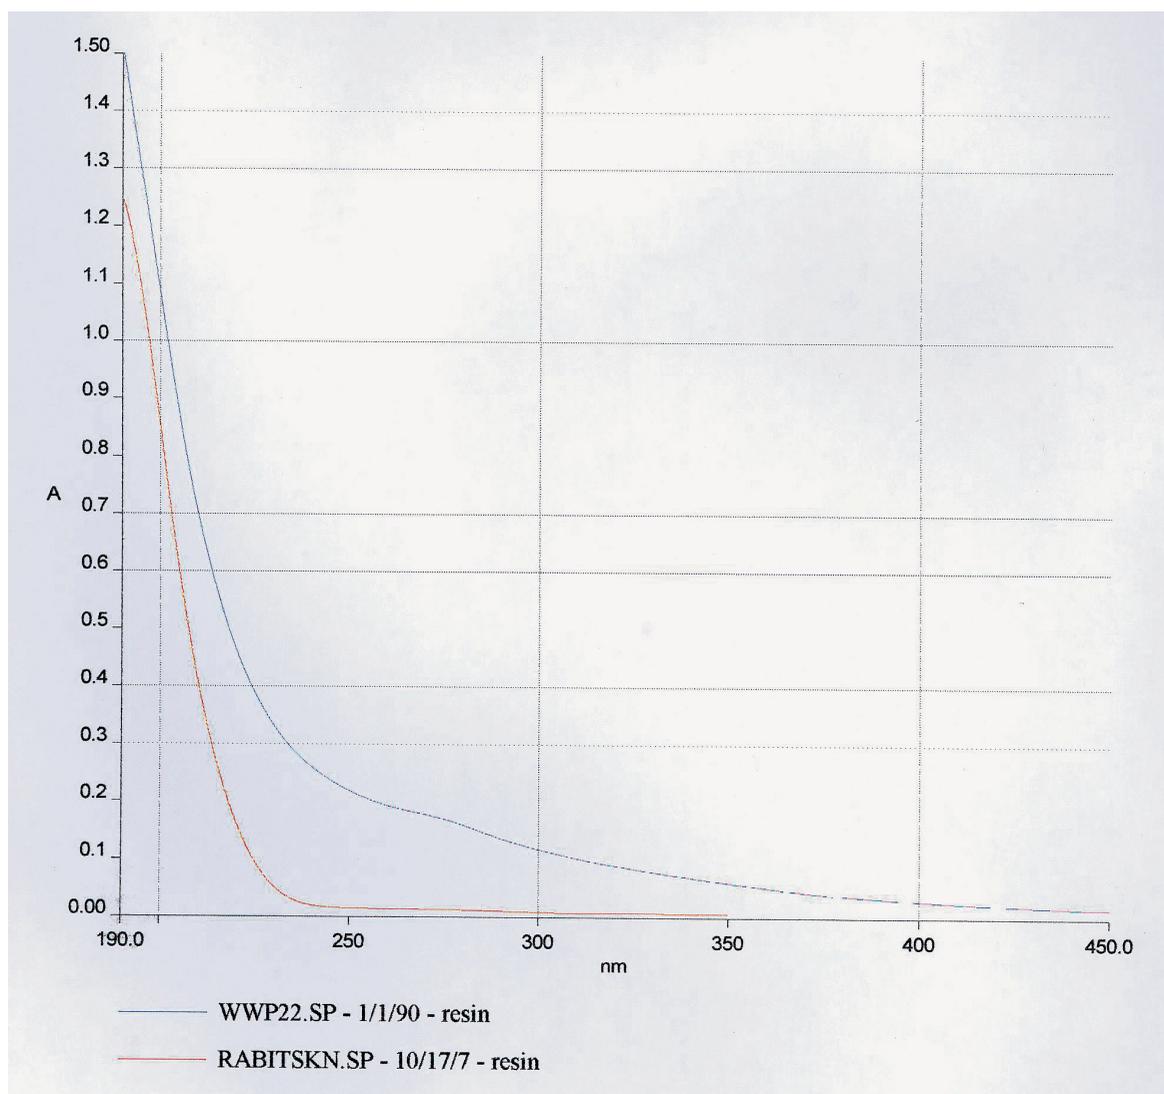
Fig. 12. UV spectrum of the binding medium used with the red pigment in the Sabil Alkazlar, proves that it is rabbit skin glue.

[1] Analyzed sample.

[2] Standard of rabbit skin glue.

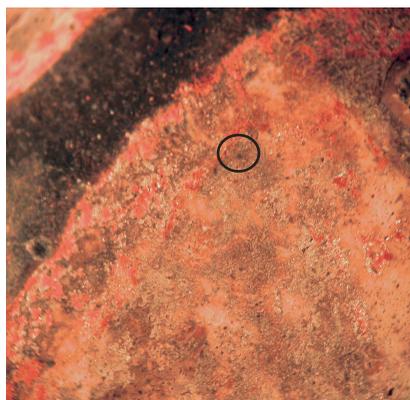
Fig. 13a. Shows the bulk sample of the ceiling's golden pigment from which the cross section was prepared (the cycles shows the exact place).

which the monument belongs.⁵ It is well-known that the decoration of ceilings is done through one of two techniques. The first and most common technique is the outlining of the design and the shape of ornamentation followed directly by the application of the pigments on the paint ground. The second technique which is rarely used involves applying different color grades and several pigments followed by coloring the upper layer with the desirable color grade. The latter technique is more advanced since it shows the experience and skill of the artist. In order to determine if the first or second technique was used, a bulk sample was taken from the ceiling's golden pigment (fig. 13a). The cross section of the golden sample (fig. 13b) revealed that the artist applied a thin sheet of gold over a thick layer of a red pigment which is composed of hematite and silica grains.

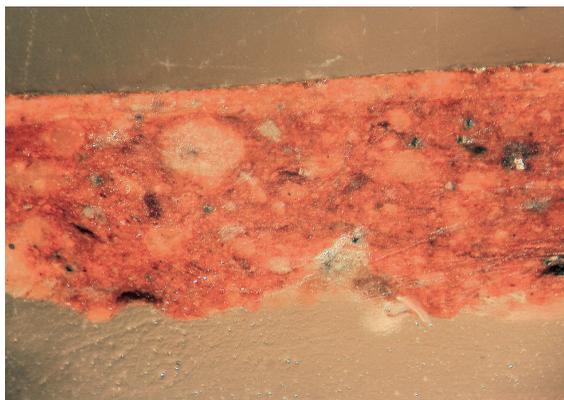
Fig. 13b. Cross section of the golden pigment in the Sabil Alkazlar (125X).

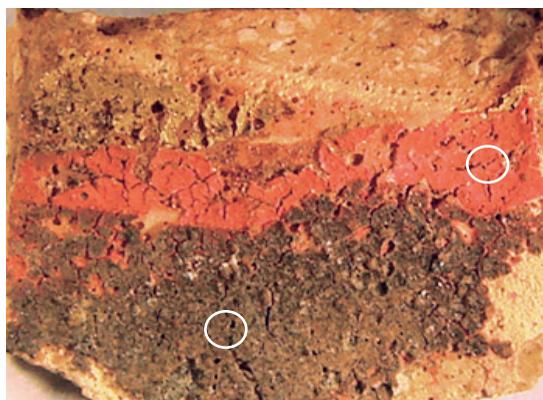
Fig. 14a. Shows the bulk sample of the ceiling's black and red pigments from which the cross section was prepared (the cycles shows the exact place).

A bulk sample of the ceiling's black and red pigments was tested (fig. 14a). The black pigment was examined under a light microscope (fig. 14b). The results showed that the layered structure consists of 5 layers: the upper layer is black; the fourth and third layers are gray; the second is creamy and the lowest layer is red. XRD analysis revealed that the black pigment is bone black and the red pigment is natural cinnabar. Both pigments appeared in all layers with variable ratios. This sample confirmed that the artist used the multi-layer technique. The sample from the red pigment (fig. 14c) revealed the presence of a thin red upper layer followed by a thicker layer; the third layer is creamy in color and is thicker than the previous two layers. The final lowest layer is the thickest layer and it is the plaster layer which precedes the paint ground. It can be concluded that the painting layers of the Sabil Alkazlar's ceiling was composed of a wooden support upon which the plaster layer was composed of two layers (*gesso grosso* and *gesso sottile*), and a pigment layer carried out using the tempera technique.

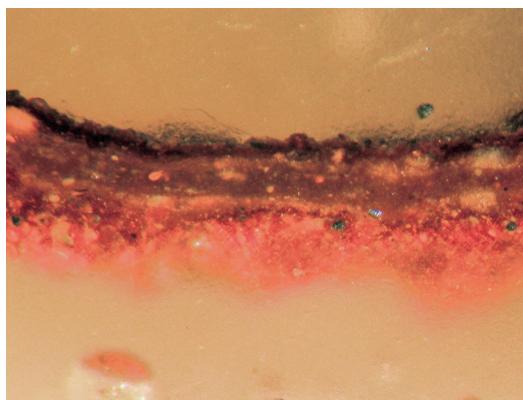
Fig. 14b. Cross section of the black pigment in the Sabil Alkazlar (125X).

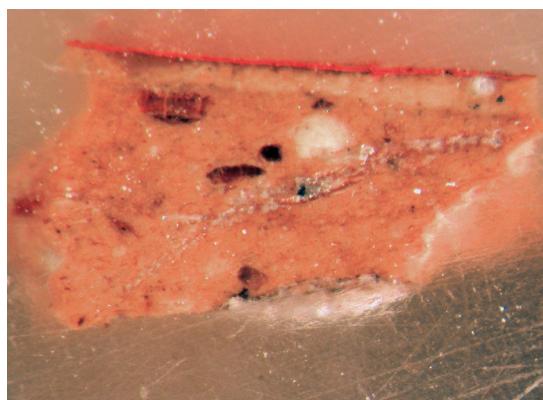
Fig. 14c. Cross section of the red pigment in the Sabil Alkazlar (125X).
