M.A. Mohie, Abubakr Moussa

Diagnosis of Pigment Materials Affected by Air Pollution and Clay Minerals in Sabil Alkazlar.

Diagnosis of Pigment Materials

Affected by Air Pollution and Clay Minerals in Sabil Alkazlar

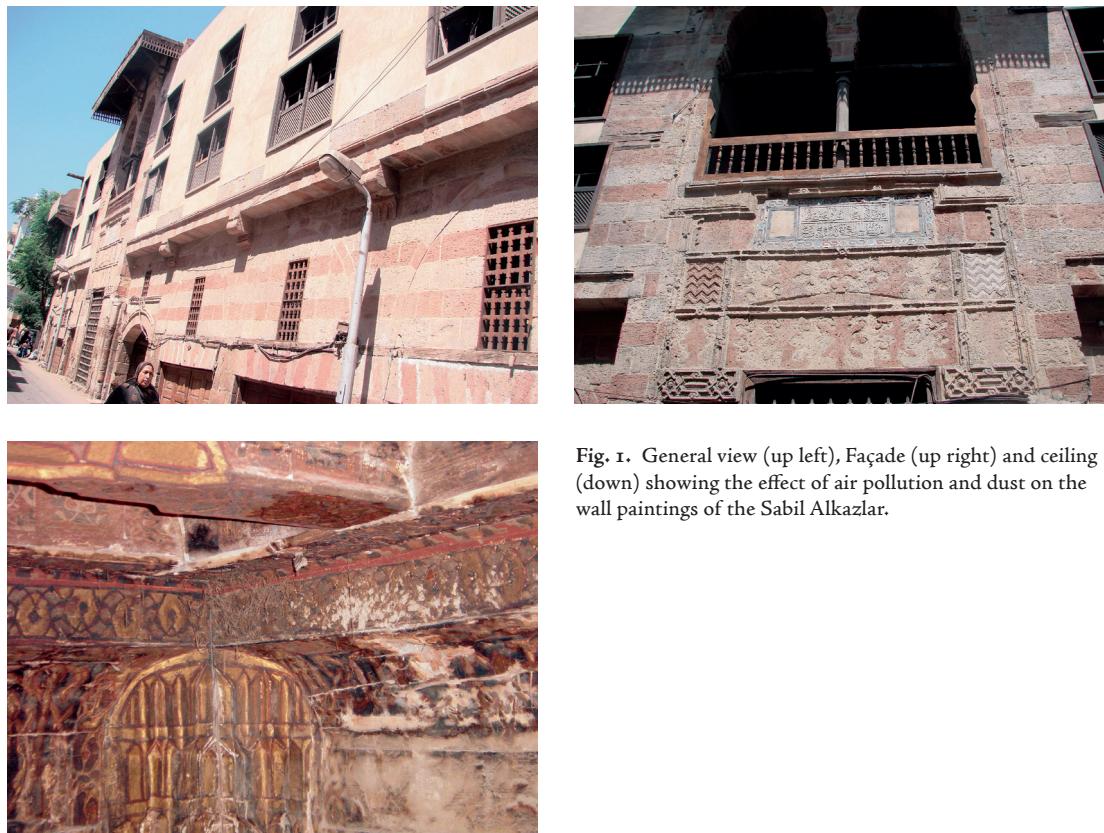
Fig. 1. General view (up left), Façade (up right) and ceiling (down) showing the effect of air pollution and dust on the wall paintings of the Sabil Alkazlar.

THE Arabic word Sabil stands for public drinking fountain. Sabil Alkazlar (fig. 1) is one of the Ottoman historical buildings that have survived in historic Cairo. It is located at $30^{\circ} 01' 59.42''$ N and $31^{\circ} 15' 13.29''$ E; in Alsoyofeyya Street behind Alsultan Hassan mosque. It was established in 1617 AD by Mustafa Agha Pasha Alkazlar. The façade, internal units and the ceiling of the building are exposed to different weathering agents.

in those samples that have no black pigment material. The complex physical and chemical interactions of these agents with the mineral material have dramatically accelerated the decay of the building materials.¹⁹ Particulate pollutants vary enormously in size and are especially dangerous to objects because they attract moisture and gaseous pollutants. Dust can be an abrasive agent. Removing dust involves washing, wiping, or shaking, all of which accelerates deterioration and increases the risk of physical damage to wall paintings.²⁰ Dust precipitated on the wall paintings of the Sabil (fig. 1) and in the micro cracks (fig. 9).

- The solubility factor of the salt and its ability to transfer from the groundwater into the building materials.
- The porosity of the building materials.²⁴ Chemically, salts in reaction with the pigment components play a role as a catalyst in the discoloring phenomenon (fig. 1).

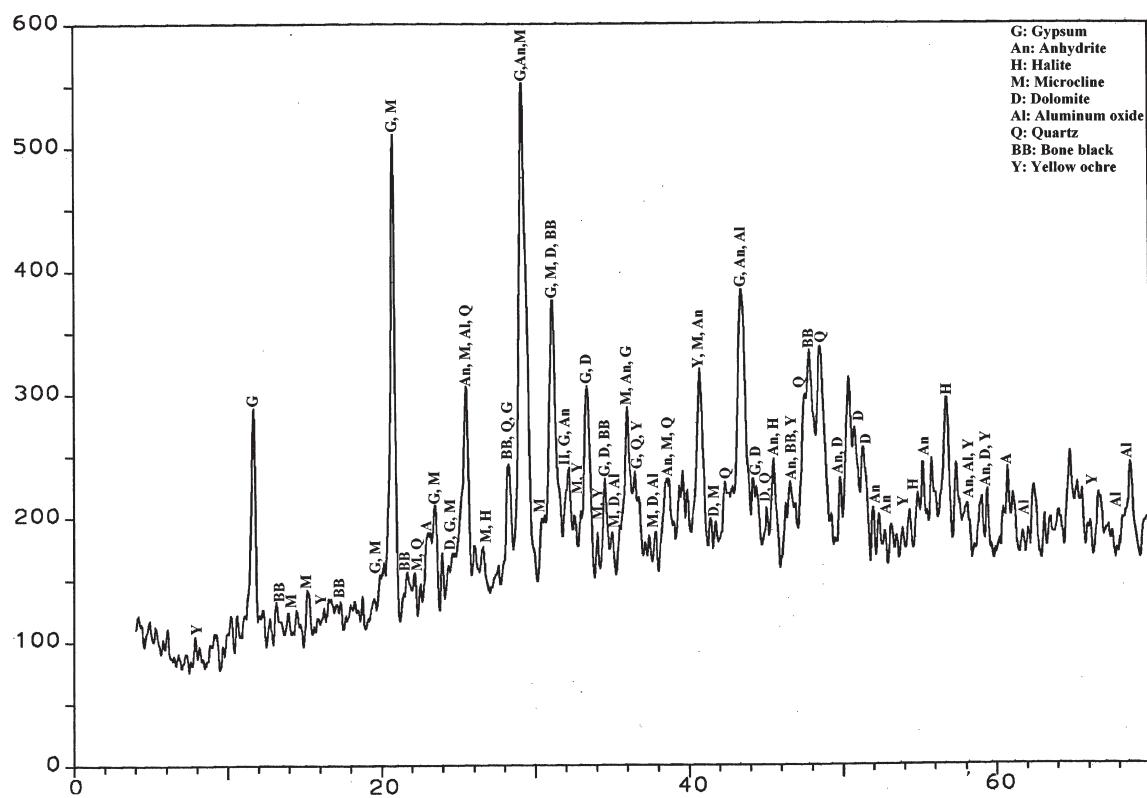
Fig. 2. XRD pattern of the studied plaster sample from the Sabil Alkazlar.

The XRD analysis of the rendering layer applied to the wooden ceiling of Sabil Alkazlar; revealed the presence of gypsum, anhydrite, dolomite, quartz, aluminum oxide, microcline, halite, bone black, yellow ochre and hematite (fig. 2). SEM-EDAX of the same sample showed the presence of: 43% oxygen, 18% calcium, 13% silicon, 11% carbon, 3% iron, 5% aluminum, 2% sulfur, 2% magnesium, 1% chlorine, 1% potassium and 1% sodium (fig. 3).

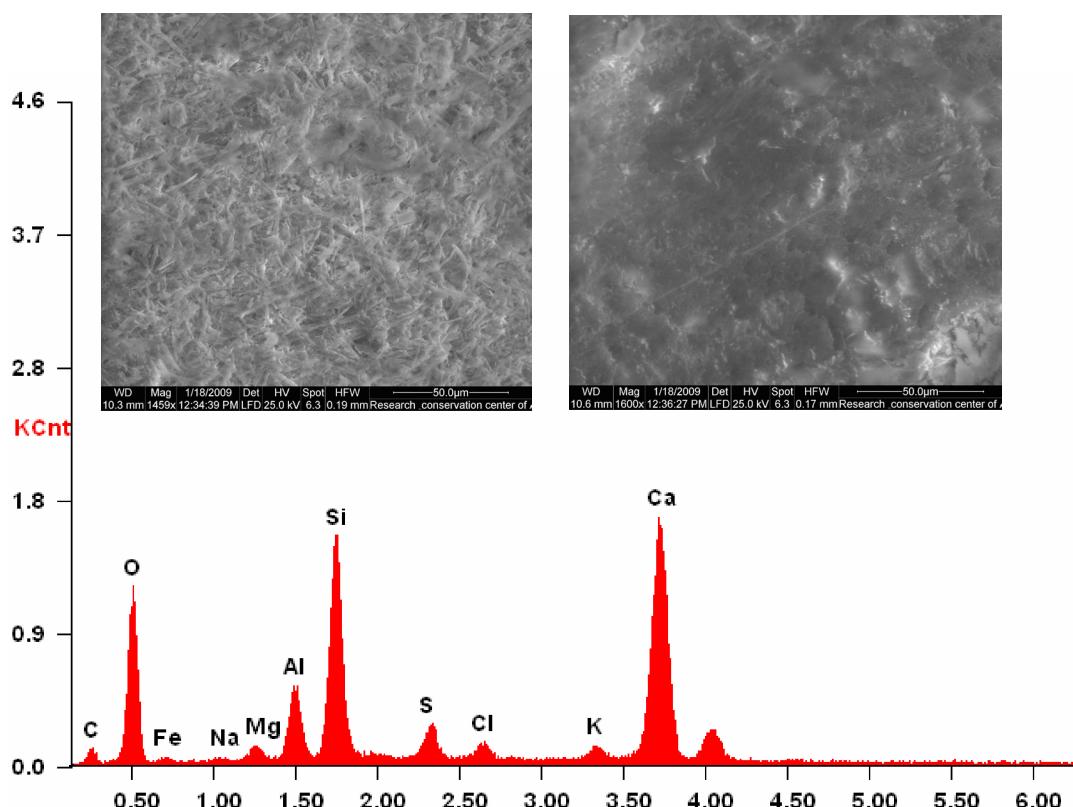
Fig. 3. SEM-EDAX spectra and micrographs of the studied plaster sample from the Sabil Alkazlar. The micrograph (left) shows the gypsum crystals which are the main components of the plaster, while the micrograph (right) shows the growth of anhydrite and halite crystals inside gypsum.

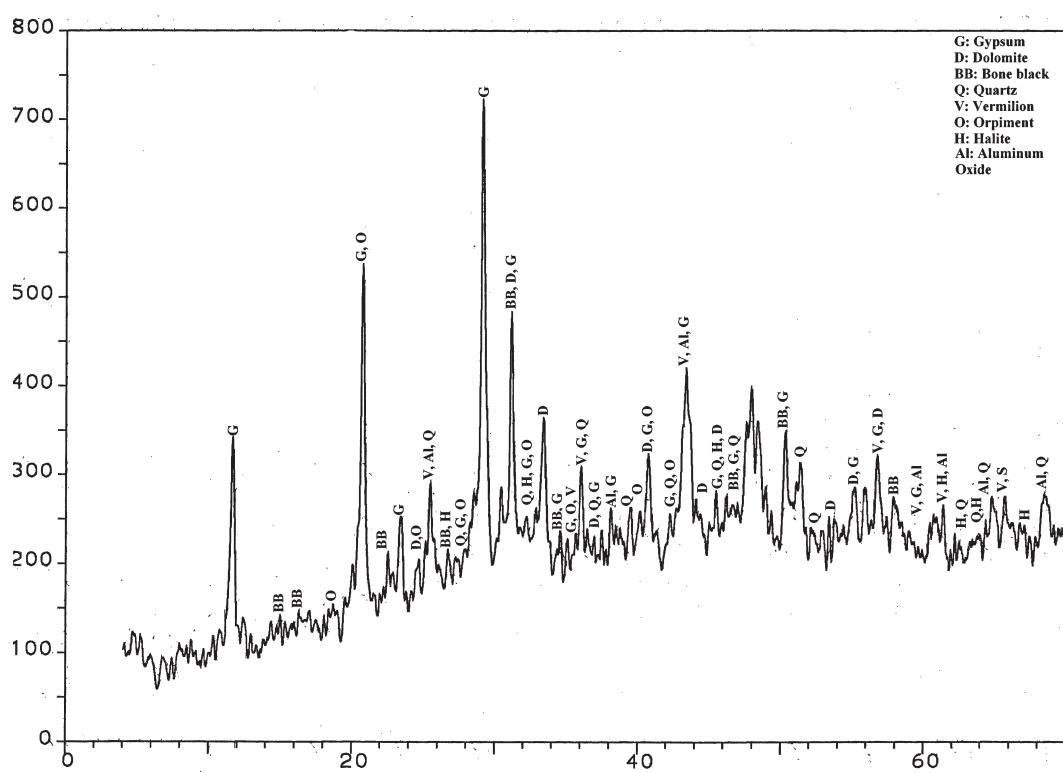
Fig. 4. XRD pattern of the studied black pigment sample from the Sabil Alkazlar.

XRD analysis of a black pigmented plaster sample from the ceiling proved that the used pigment material is bone black [C.Ca₃(PO₄)₂]. The sample contains also gypsum, dolomite, quartz, halite, orpiment, cinnabar and aluminum oxide (fig. 4). The SEM-EDAX of the sample revealed the presence of about 65% carbon, 28% oxygen, 1% chlorine, 1% sodium, 1% calcium, 1% phosphate, 1% sulfur and traces of aluminum, silicon and magnesium (fig. 5).

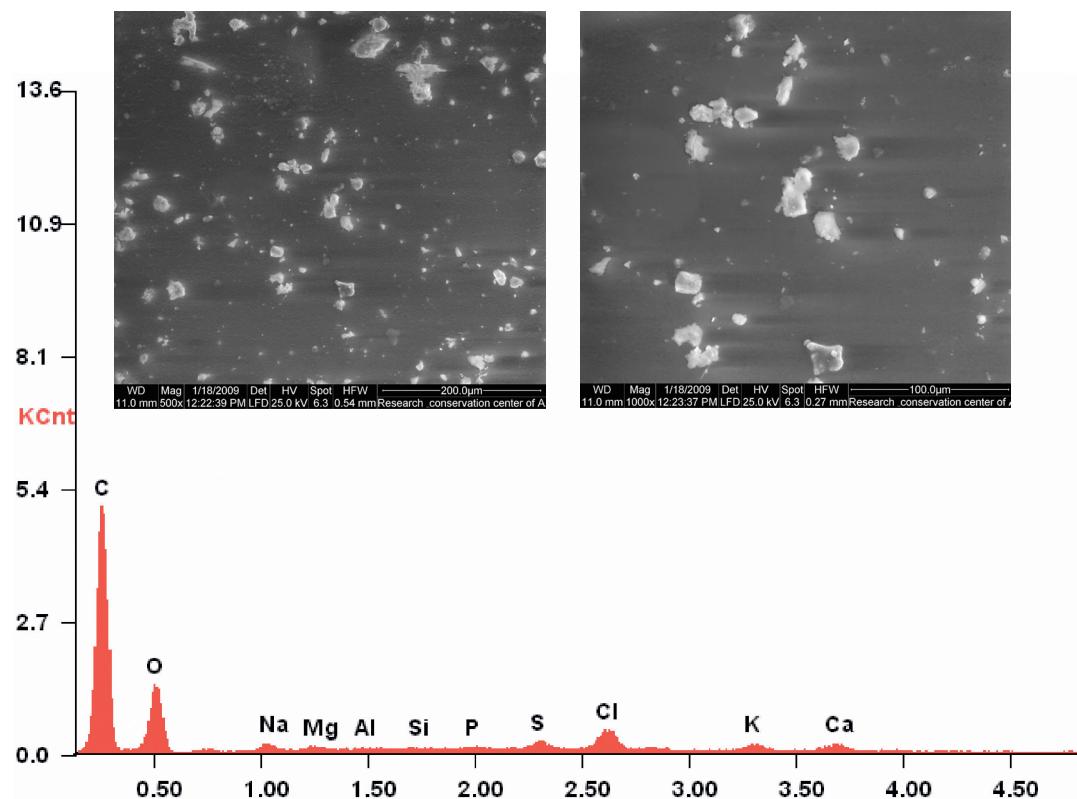
Fig. 5. SEM-EDAX spectra and micrographs of the studied black pigment from the Sabil Alkazlar. The micrographs show the growth of halite crystals upon pigment surface (efflorescence).

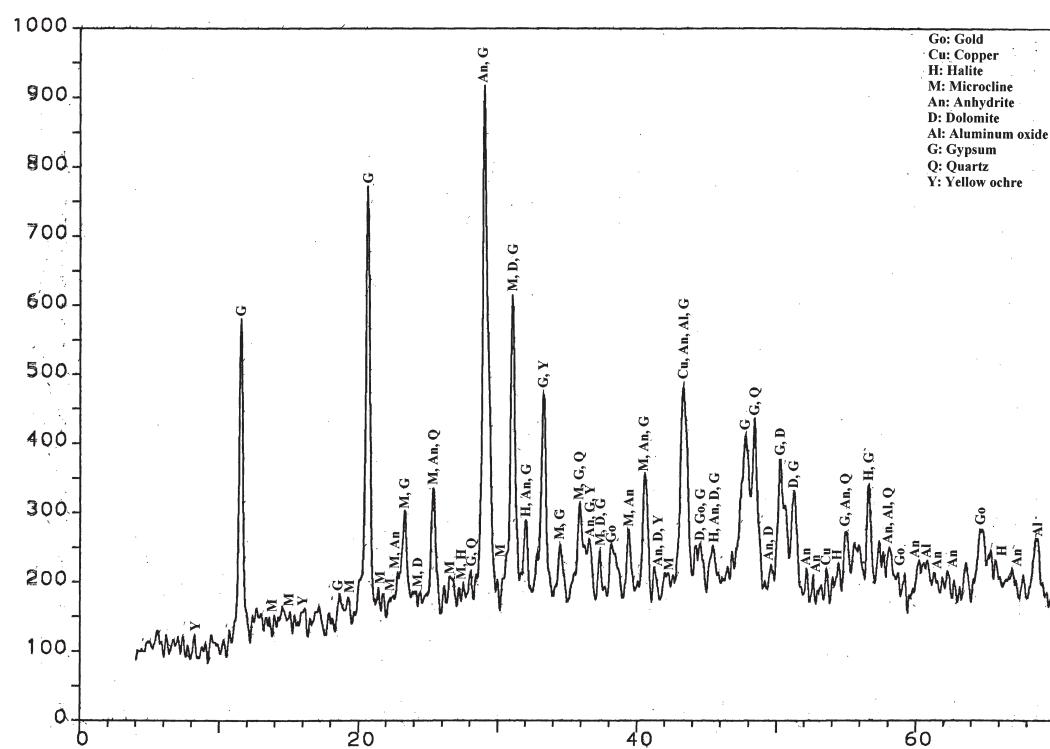
Fig. 6. XRD pattern of the studied golden pigment sample from the Sabil Alkazlar.

Based on the XRD analysis, the golden pigment material used in Sabil Alkazlar's ceiling is gold (Au) mixed with traces of copper. The analyzed sample contains gypsum as a major constituent, in addition to anhydrite, dolomite, quartz, aluminum oxide, microcline, halite, yellow ochre and hematite (fig. 6). The SEM-EDAX of the same sample detected the presence of about 47% gold, 23% carbon, 18% oxygen, 7% calcium, 1% potassium, 1% quartz, 1% sodium, 1% iron and traces of copper, aluminum and magnesium (fig. 7).

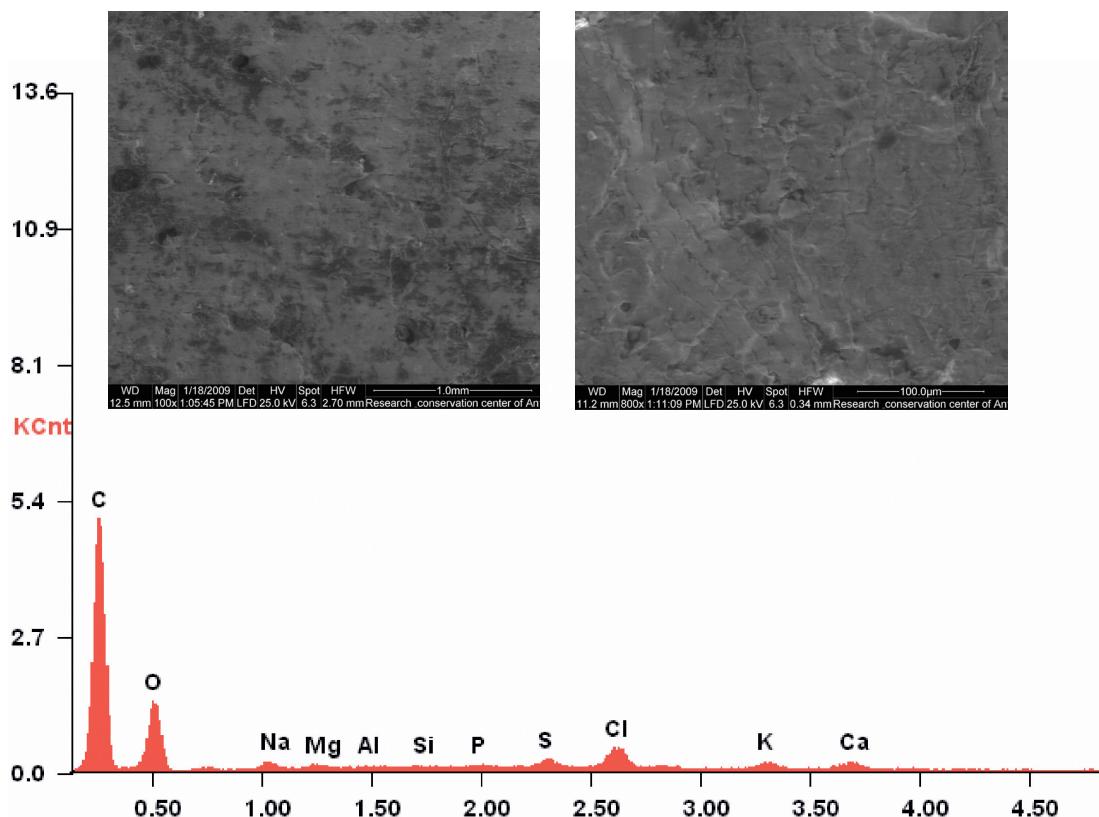
Fig. 7. SEM-EDAX spectra and micrographs of the studied golden pigment from the Sabil Alkazlar. The micrographs show the presence of blisters which can be explained due to hammering of gold leafs.

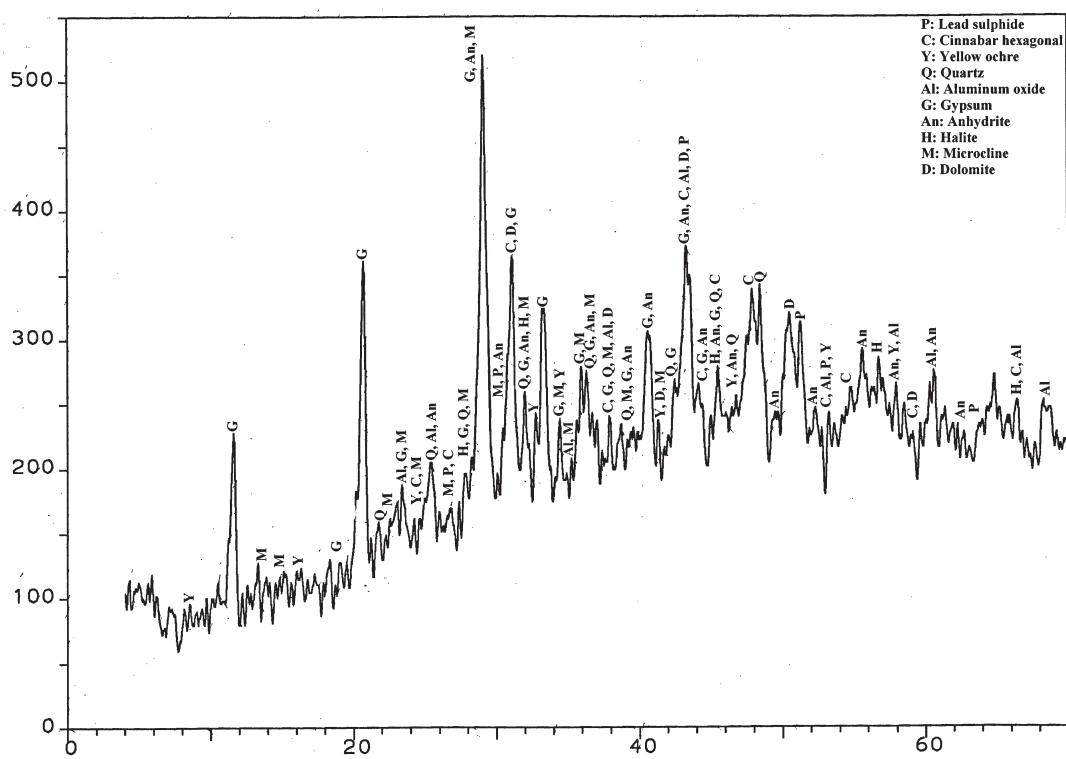
Fig. 8. XRD pattern of the studied red pigment sample from the Sabil Alkazlar.

XRD analysis of the red pigment material in Sabil Alkazlar's ceiling revealed the presence of natural cinnabar (HgS). The sample also contains gypsum, anhydrite, dolomite, quartz, aluminum oxide, microcline, halite, lead sulfide, yellow ochre and hematite (fig. 8). The SEM-EDAX for the same sample detected the presence of about 30% carbon, 19% mercury, 17% oxygen, 15% lead, 6% sulfur, 3% calcium, 3% chlorine, 2% potassium, 1% sodium, 1% iron, 1% silicon, 1% magnesium and 1% aluminum (fig. 9).

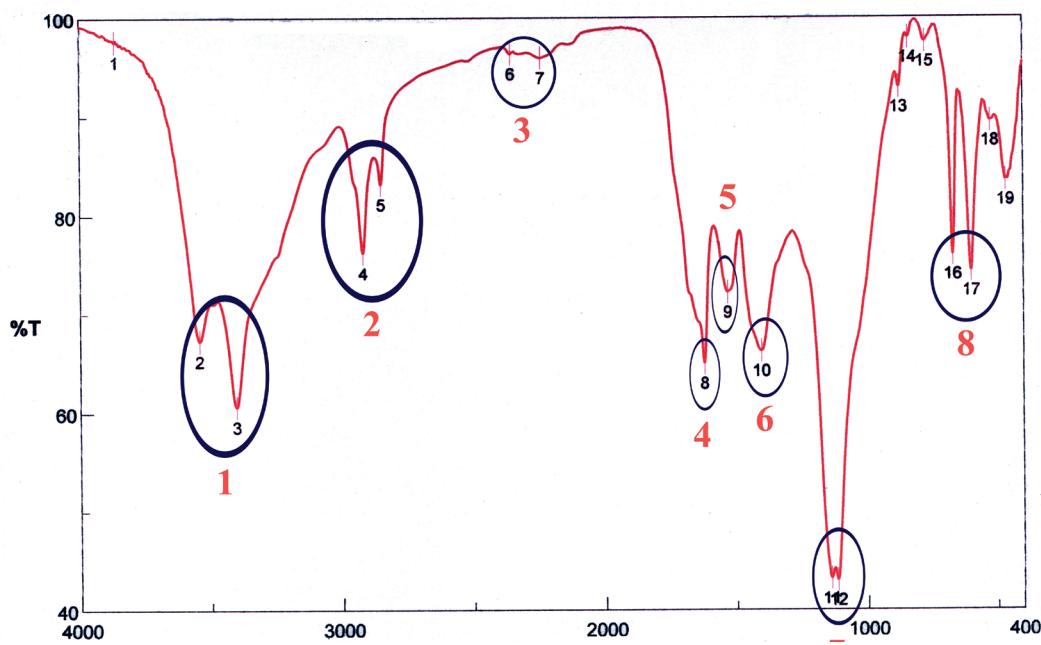
Fig. 10. FTIR spectrum of the binding medium used with the red pigment in the Sabil Alkazlar.
 [1] Asymmetric and symmetric OH stretching bands of both animal glue and gypsum (splitting of the band is due to presence of gypsum). N-H stretching band of animal glue is over lapped by OH bands.
 [2] Asymmetric and symmetric CH stretching bands of aliphatic groups of animal glue.
 [3] Combination or overtones bands.
 [4] Carbonyl stretching band of animal glue (amide I) + S=O stretching of SO_4^{2-} of gypsum.
 [5] Combination of C-N stretching band and N-H bending band (amide II) of animal glue.
 [6] C-H bending + OH bending band. [7] Asymmetric SO_4^{2-} stretching band of gypsum.
 [8] SO_4^{2-} bending band of gypsum.

Four samples were analyzed using FTIR in order to identify the medium used in both the rendering layer and pigments in Sabil Alkazlar. Functional groups and wave numbers were measured. Animal glue binding was found on the FTIR charts. Based upon the results, it has been proved that rabbit skin glue was the paint medium used to mix and fix the pigments to the plaster, and it was also used to mix the components of the plaster layer together and fix them to the wooden ceiling (fig. 10). A standard sample of rabbit skin glue was prepared for comparison (fig. 11). The result was also emphasized by the UV analysis (fig. 12) which proved that the used medium was rabbit skin glue.

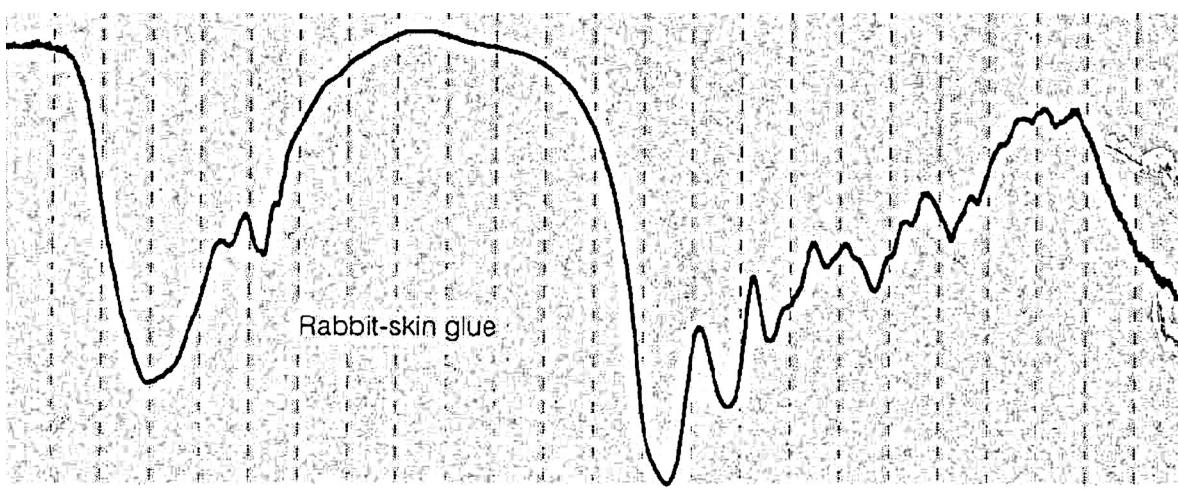
Fig. 11. FTIR standard of rabbit skin glue.

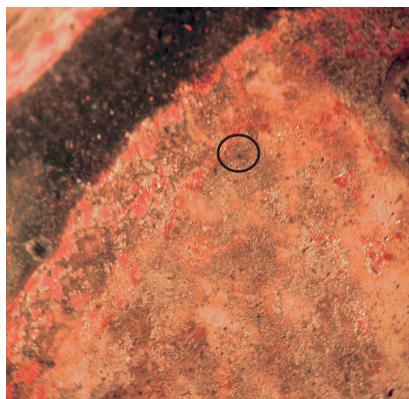
Fig. 13a. Shows the bulk sample of the ceiling's golden pigment from which the cross section was prepared (the cycles shows the exact place).

which the monument belongs.⁵ It is well-known that the decoration of ceilings is done through one of two techniques. The first and most common technique is the outlining of the design and the shape of ornamentation followed directly by the application of the pigments on the paint ground. The second technique which is rarely used involves applying different color grades and several pigments followed by coloring the upper layer with the desirable color grade. The latter technique is more advanced since it shows the experience and skill of the artist. In order to determine if the first or second technique was used, a bulk sample was taken from the ceiling's golden pigment (fig. 13a). The cross section of the golden sample (fig. 13b) revealed that the artist applied a thin sheet of gold over a thick layer of a red pigment which is composed of hematite and silica grains.

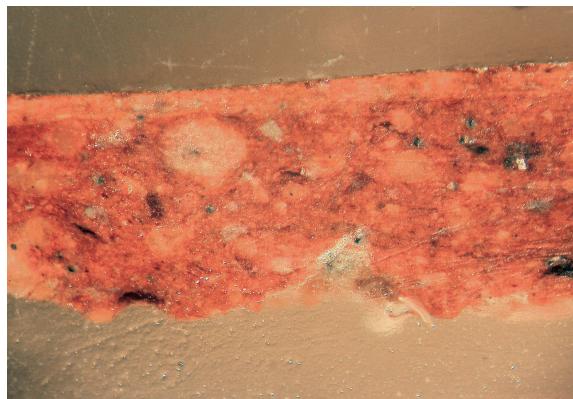
Fig. 13b. Cross section of the golden pigment in the Sabil Alkazlar (125X).

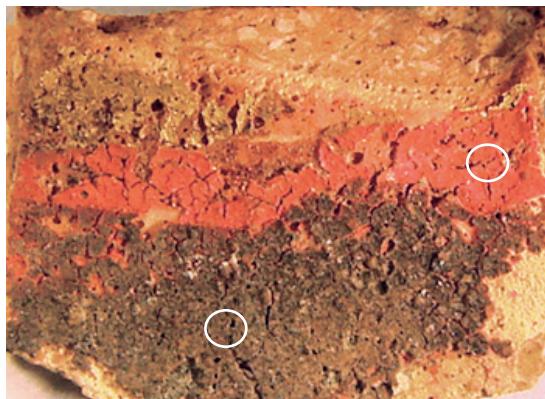
Fig. 14a. Shows the bulk sample of the ceiling's black and red pigments from which the cross section was prepared (the cycles shows the exact place).

A bulk sample of the ceiling's black and red pigments was tested (fig. 14a). The black pigment was examined under a light microscope (fig. 14b). The results showed that the layered structure consists of 5 layers: the upper layer is black; the fourth and third layers are gray; the second is creamy and the lowest layer is red. XRD analysis revealed that the black pigment is bone black and the red pigment is natural cinnabar. Both pigments appeared in all layers with variable ratios. This sample confirmed that the artist used the multi-layer technique. The sample from the red pigment (fig. 14c) revealed the presence of a thin red upper layer followed by a thicker layer; the third layer is creamy in color and is thicker than the previous two layers. The final lowest layer is the thickest layer and it is the plaster layer which precedes the paint ground. It can be concluded that the painting layers of the Sabil Alkazlar's ceiling was composed of a wooden support upon which the plaster layer was composed of two layers (*gesso grosso* and *gesso sotile*), and a pigment layer carried out using the tempera technique.

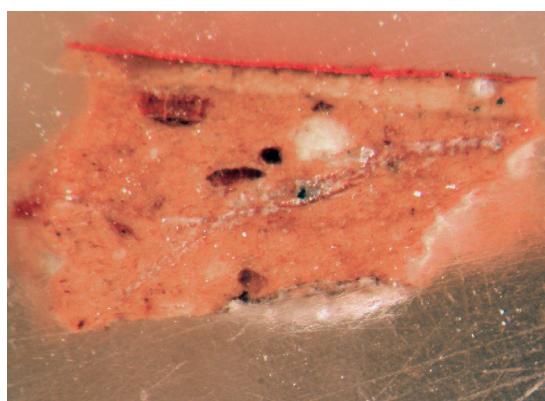
Fig. 14c. Cross section of the red pigment in the Sabil Alkazlar (125X).
