AnIsl 45 (2011), p. 321-338

M.A. Mohie, Abubakr Moussa

Diagnosis of Pigment Materials Affected by Air Pollution and Clay Minerals in Sabil Alkazlar.

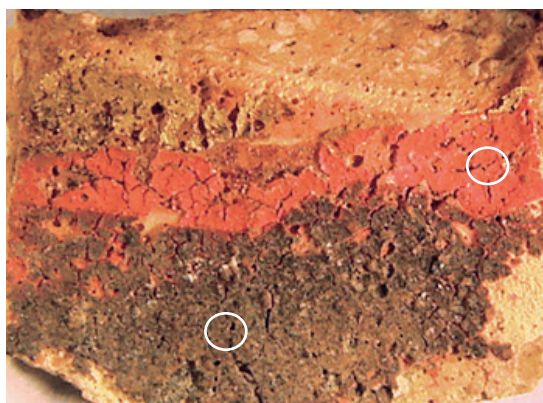
Fig. 14a. Shows the bulk sample of the ceiling's black and red pigments from which the cross section was prepared (the cycles shows the exact place).

A bulk sample of the ceiling's black and red pigments was tested (fig. 14a). The black pigment was examined under a light microscope (fig. 14b). The results showed that the layered structure consists of 5 layers: the upper layer is black; the fourth and third layers are gray; the second is creamy and the lowest layer is red. XRD analysis revealed that the black pigment is bone black and the red pigment is natural cinnabar. Both pigments appeared in all layers with variable ratios. This sample confirmed that the artist used the multi-layer technique. The sample from the red pigment (fig. 14c) revealed the presence of a thin red upper layer followed by a thicker layer; the third layer is creamy in color and is thicker than the previous two layers. The final lowest layer is the thickest layer and it is the plaster layer which precedes the paint ground. It can be concluded that the painting layers of the Sabil Alkazlar's ceiling was composed of a wooden support upon which the plaster layer was composed of two layers (*gesso grosso* and *gesso sotile*), and a pigment layer carried out using the tempera technique.
