AnIsl 46 (2013), p. 323-336

Amany Mohamed Bakr, Mona Fouad Ali, Abubakr Moussa, Amir Said

Characterization of Imitated Marble Used in Historical Buildings in Cairo - Egypt

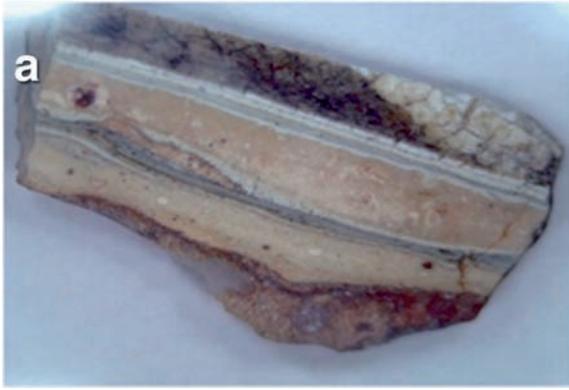
Fig. 3a. The polished cross section of the *sabīl's* sample.

The preliminary observation of the collected samples showed the stratigraphic structure of the marble-imitating stucco. The polished cross section examination revealed the presence of three main layers (fig. 3a): inner, middle and outer layer (finishing layer). Secondary layers are seen within the middle layer of some samples.
