AnIsl 50 (2017), p. 147-198

Mamluk Minarets in Modern Egypt

Tracing Restoration Decisions and Interventions

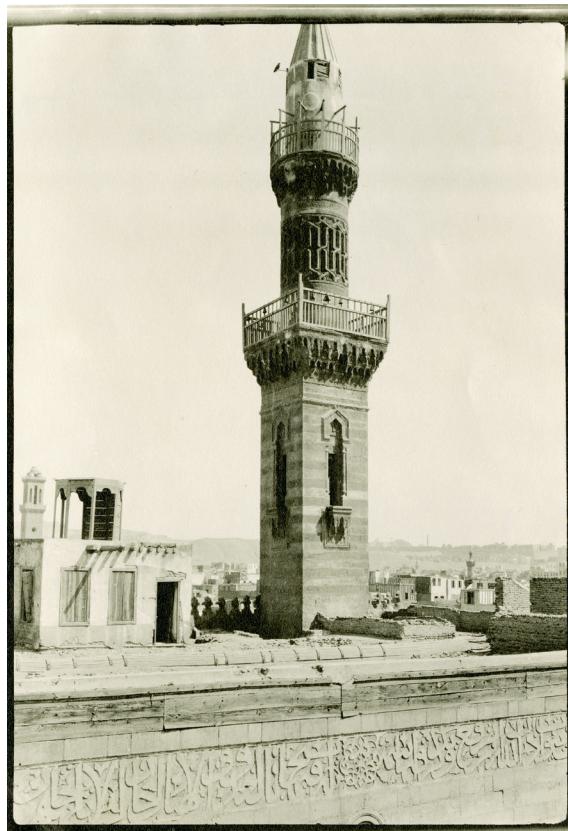
Fig. 3. K.A.C. Creswell, with manuscript mention at the back of the print: *Mosque of Barsbāī: minaret, from coping of ṣahn, before 1944*. Creswell Photographic Collection, The American University in Cairo, Album 24. Courtesy of the RBSCL.

During the Ottoman period, some damaged upper pavilions of Mamluk minarets were reconstructed in Ottoman style with the pencil-like cap (fig. 3 & fig. 4). These additions were sometimes removed by the *Comité* and restored back to Mamluk style (fig. 5). From a political perspective, Sanders, when discussing this type of restoration work by the *Comité*, argues broadly that: “One of the most urgent tasks of the *Comité* was to identify and restore these dozens of monuments to proper dynastic style”¹⁹ arguing that the “*Comité* was decidedly anti-Ottoman”.²⁰

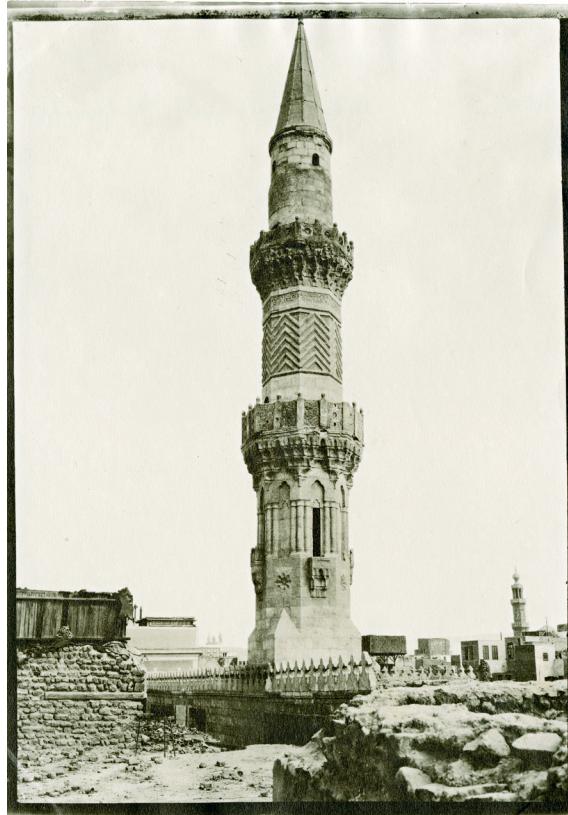
Fig. 4. K.A.C. Creswell, [Minaret of Qādī 'Abd al-Bāsiṭ mosque], with manuscript mention at the back of the print: *Mosque of 'Abd el-Basset: N. façade, prior to 1936–1940*. Creswell Photographic Collection, The American University in Cairo, Album 24. Courtesy of RBSCL.

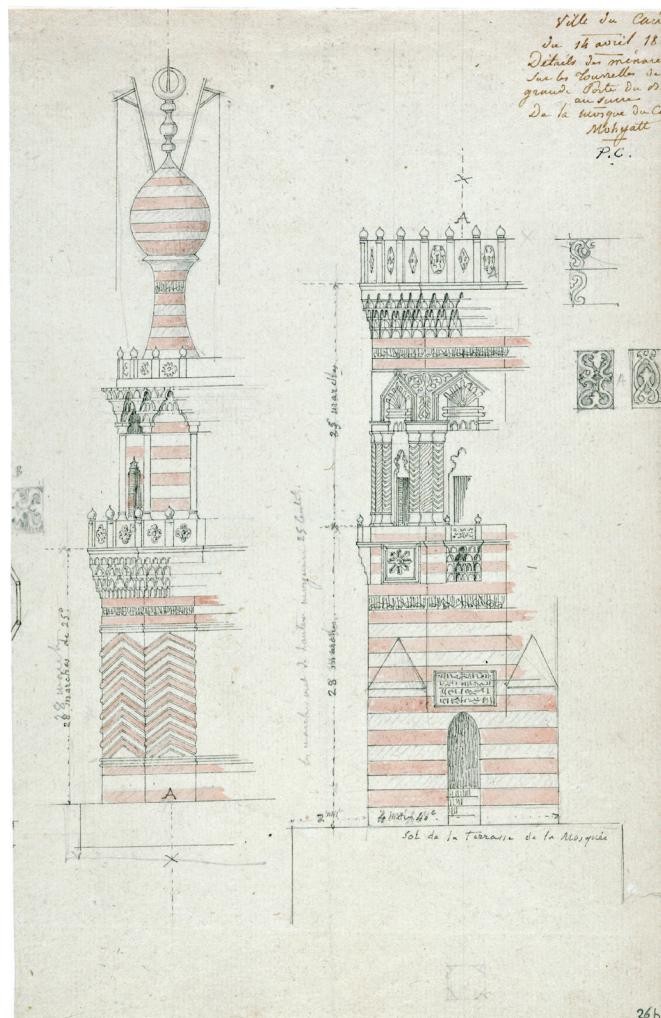
Fig. 6. Pascal Coste, Ville du Caire, [dessin ?] du 14 avril 182[2], Détails des minarets sur les tourrelles [sic] de [la] grande porte du [magasin ?] au sucre de la mosquée [sic] du Ca[life] Mohyatt. Drawing, Bibliothèque de l'Alcazar, Marseille, Album MS 1310, Folio no. 26b. Courtesy of BMVR.

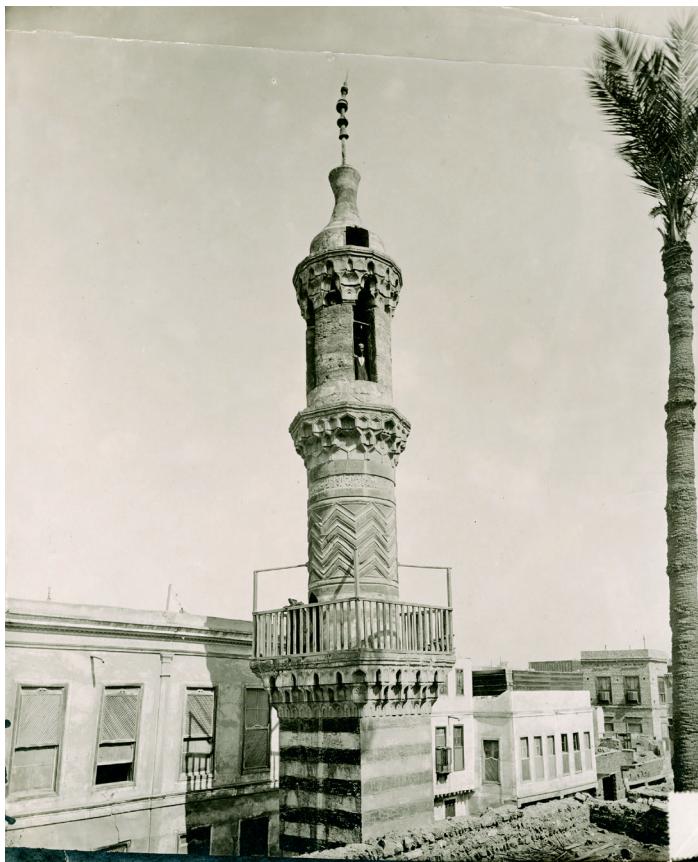
Fig. 9. Probably Giuntini, [Minaret of Qānibāy al-Šarkasī mosque], with manuscript mention at the back of the print: *Kānbāï el-Djarkassi (mosquée de): minaret, vue d'ensemble*, 1901. Silver print. Creswell Photographic Collection, The American University in Cairo, Album 24. Courtesy of RBSC.

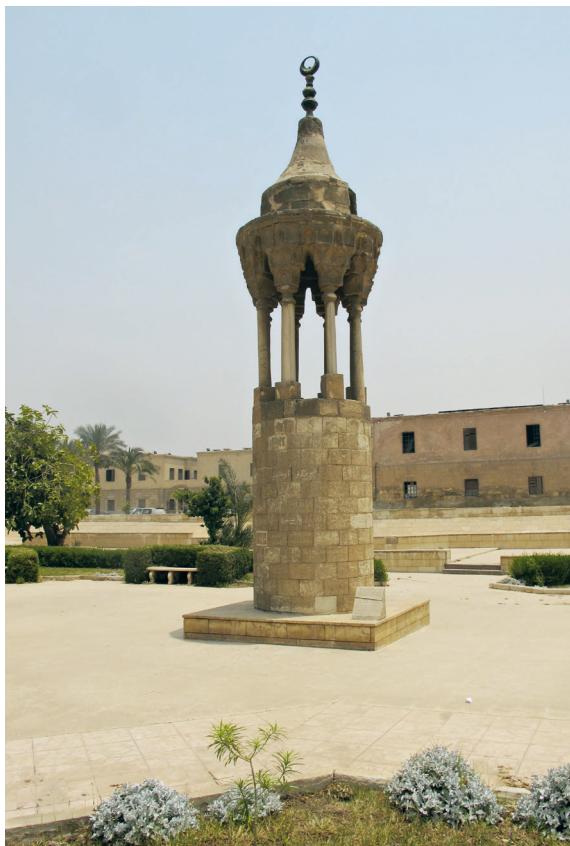
Fig. 10. [Upper part of the Minaret of Qānībāy al-Šarkasī mosque, now at the Cairo citadel], 2015. Digital photograph. © Dina Bakhoum.

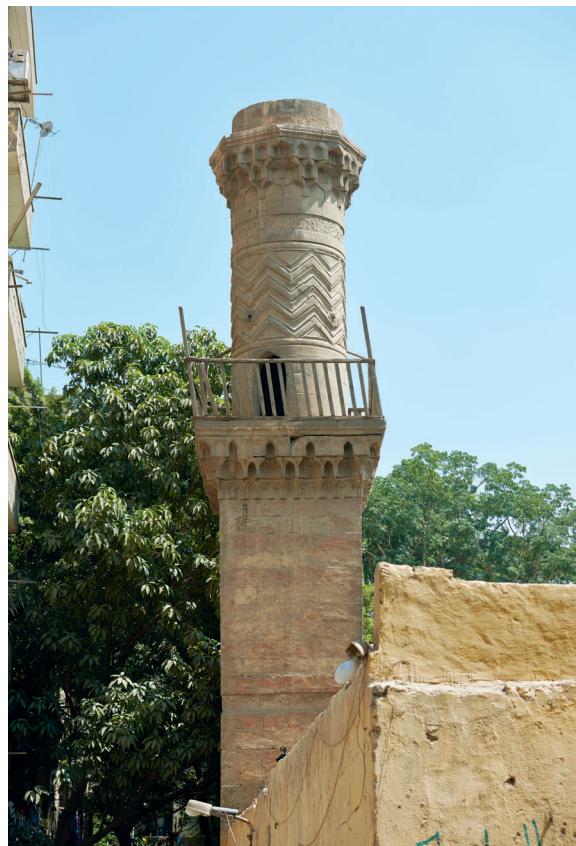
Fig. 11. [Minaret of Qānībāy al-Šarkasī mosque], 2015. Digital photograph. © Matjaž Kačičnik.

The Comité decided to delay the minaret's reconstruction while requesting that the Ministry of Awqāf take measures to connect the ablution area to the public sewer.¹⁰⁸ The upper part of the minaret of Qānībāy al-Šarkasī was eventually moved from the courtyard of al-Ḥākim mosque to its present location behind the offices containing the Comité's photographic and architectural archives at the Citadel in Cairo (fig. 10). It is labelled with its name and a 15th century date, however its story since its dismantling from the mosque of Qānībāy al-Šarkasī in 1901 remains untold. Today, the mosque still stands with an incomplete minaret (fig. 11).

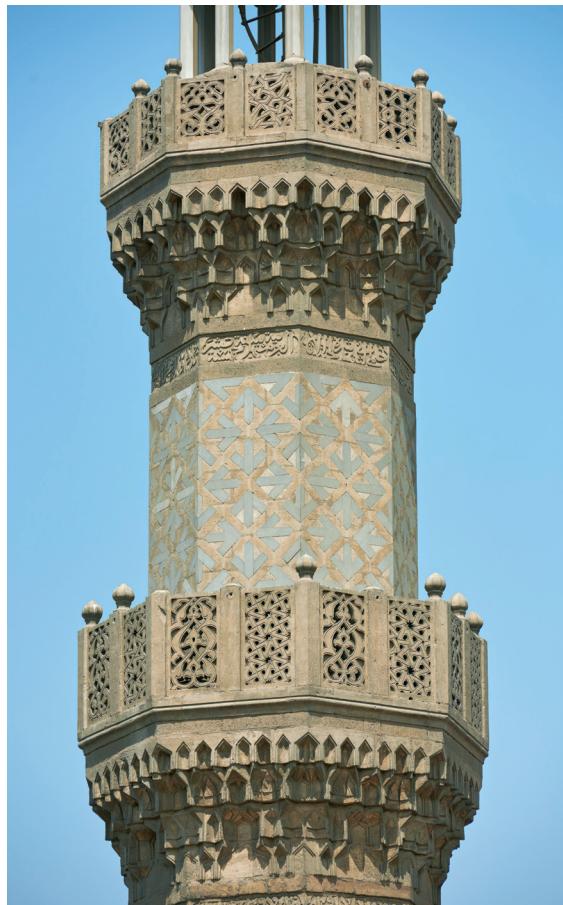
Fig. 12. [Upper part of the Minaret of Qādī Yaḥyā Zayn al-Dīn mosque, showing the *Comité*’s inscription], 2015. Digital photograph.

Today, the complete minaret might appear to the regular viewer as a 15th century Mamluk minaret; however, an inscription band running along the top of the new second storey carries valuable information. The inscription states that the restoration of the second shaft and what is above it was carried out during the reign of ‘Abbās Ḥilmī II under the supervision of the *Comité* in 1315 AH—hence—AD 1897–1898 (fig. 12).

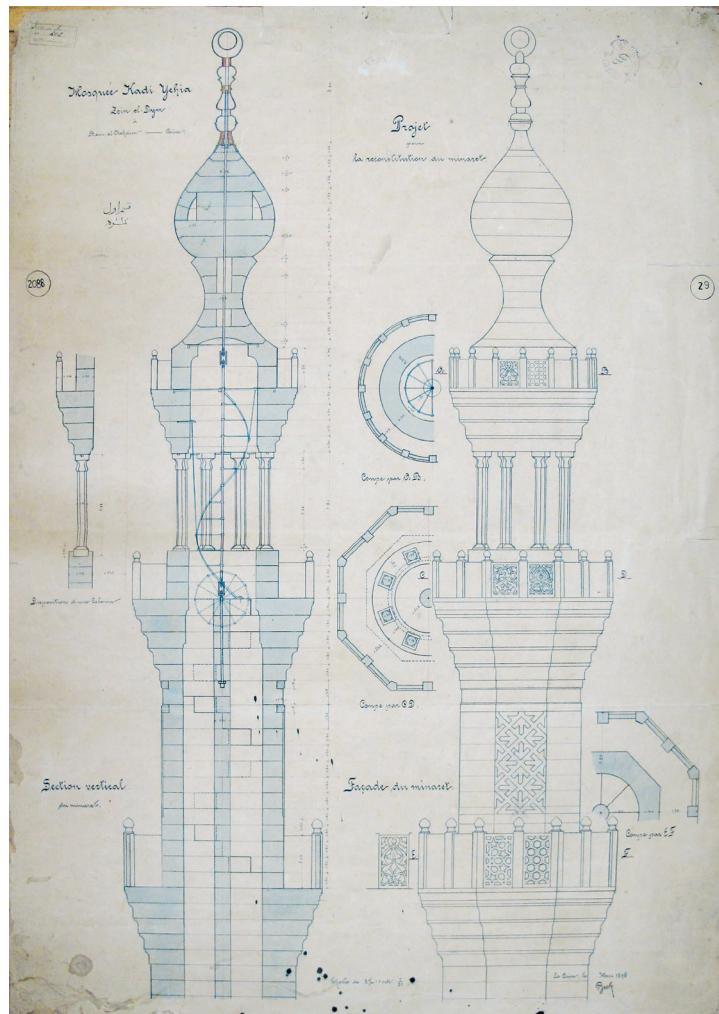
Fig. 14. Steyrer, [Reconstruction drawing of the Minaret of Gānim al-Bahlawān mosque], Cairo, 1903. Markaz tasqīl al-ātār al-islāmiyya wa-l-qibṭiyya, Archives of the Supreme Council of Antiquities. Courtesy of the Ministry of Antiquities.

Herz's monograph demonstrates that initially the Comité's plan was not to remove the Ottoman cap and that their aim was to simply consolidate the minaret. It was the discovery of original blocks that triggered the restoration of the balustrades and the replacement of the Ottoman top with a Mamluk one. Herz was keen to note that the pieces found were used to trace the shape of the bulb with accuracy, and also to make sure that the two existing shafts were structurally safe to support the new construction.

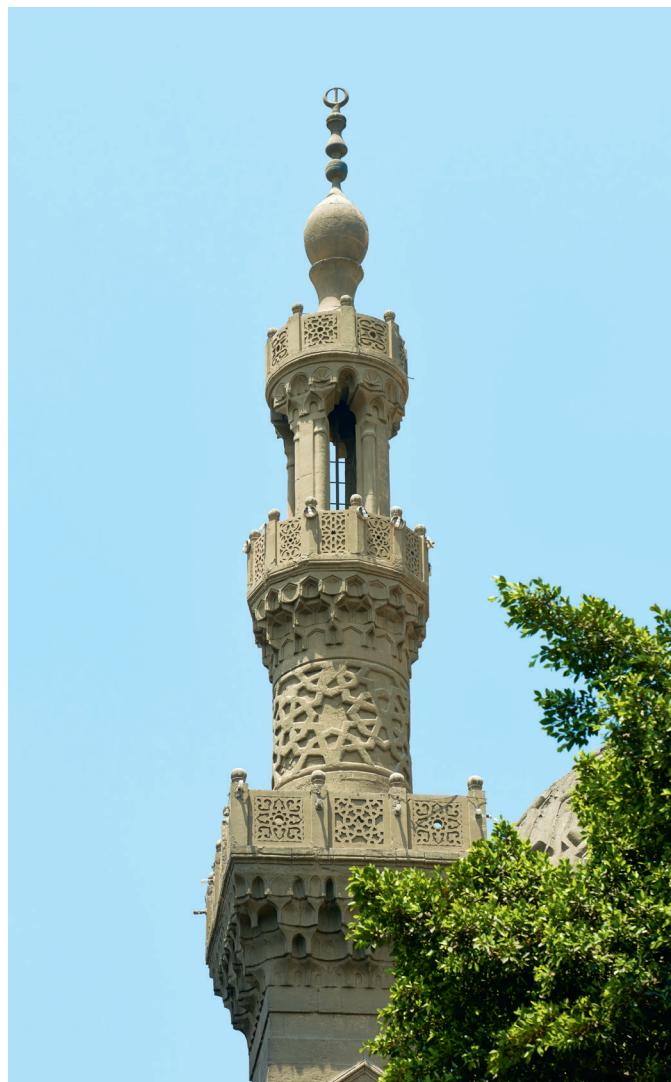
Fig. 15. Minaret of Taghī Birdī mosque, 2015. Digital photograph.
© Matjaž Kačičnik.

It must be noted, however, that the design didn't follow the eight marble columns, but instead used stone piers with attached columns (fig. 15).
