AnIsl 50 (2017), p. 147-198

Dina Ishak Bakhoum

Mamluk Minarets in Modern Egypt. Tracing Restoration Decisions and Interventions

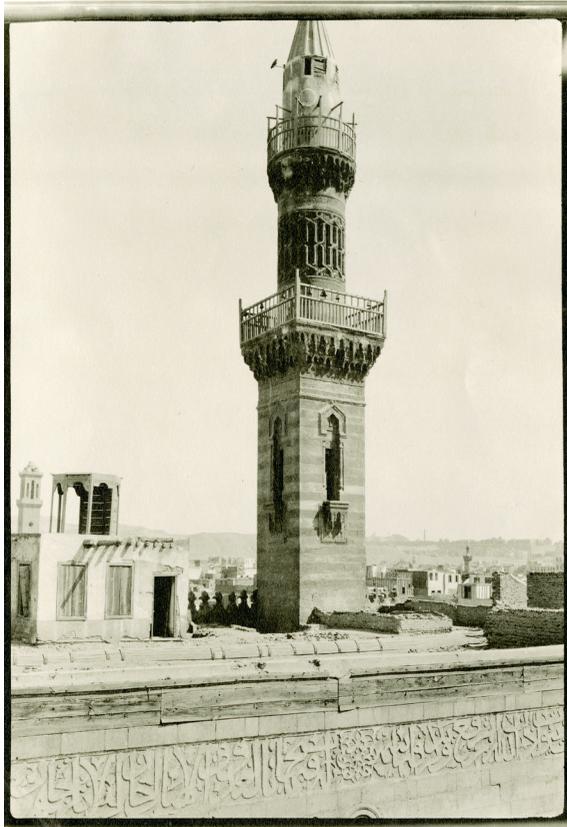
Fig. 3. K.A.C. Creswell, with manuscript mention at the back of the print: *Mosque of Barsbâi: minaret, from coping of şahn, before 1944*. Creswell Photographic Collection, The American University in Cairo, Album 24. Courtesy of the RBSCL.

During the Ottoman period, some damaged upper pavilions of Mamluk minarets were reconstructed in Ottoman style with the pencil-like cap (fig. 3 & fig. 4). These additions were sometimes removed by the *Comité* and restored back to Mamluk style (fig. 5). From a political perspective, Sanders, when discussing this type of restoration work by the *Comité*, argues broadly that: “One of the most urgent tasks of the *Comité* was to identify and restore these dozens of monuments to proper dynastic style”¹⁹ arguing that the “*Comité* was decidedly anti-Ottoman”.²⁰

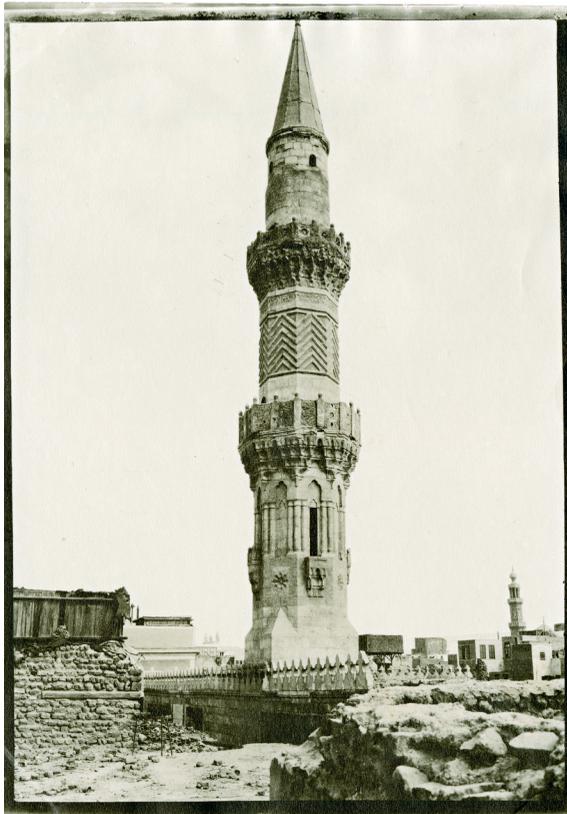
Fig. 4. K.A.C. Creswell, [Minaret of Qāḍī ‘Abd al-Bāsiṭ mosque], with manuscript mention at the back of the print: *Mosque of ‘Abd el-Basset: N. façade, prior to 1936–1940*. Creswell Photographic Collection, The American University in Cairo, Album 24. Courtesy of RBSCL.

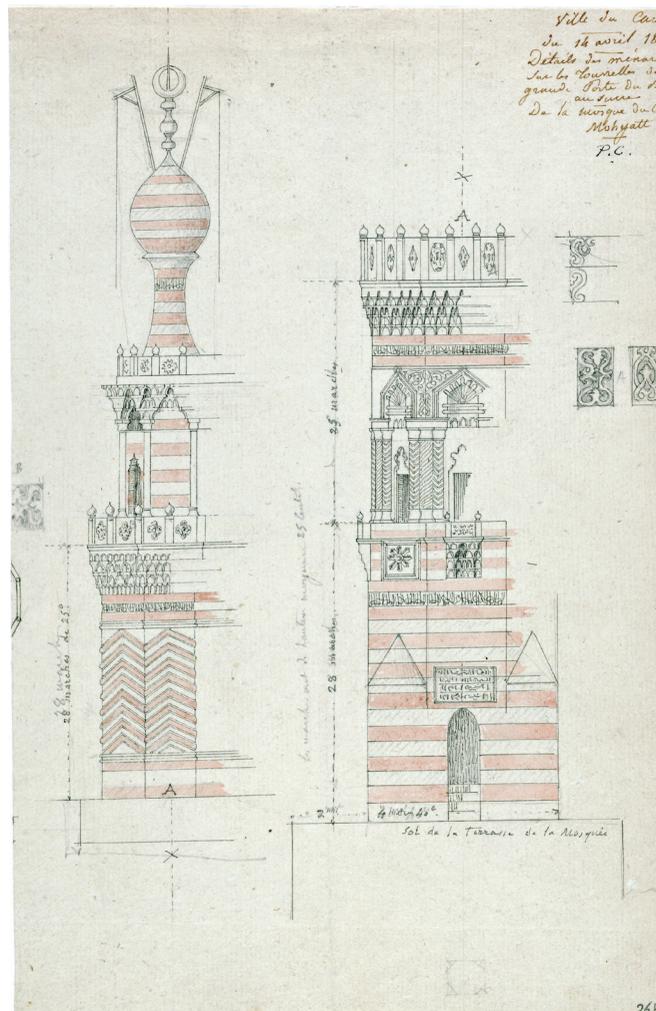
Fig. 6. Pascal Coste, *Ville du Caire*, [dessin ?] du 14 avril 182[2], *Détails des minarets sur les tourelles [sic] de [la] grande porte du [magasin ?] au sucre de la mosquée [sic] du Ca[ife] Mohyatt*. Drawing, Bibliothèque de l'Alcazar, Marseille, Album MS 1310, Folio no. 26b. Courtesy of BMVR.

The inter-column masonry mentioned above can be observed in numerous other late 19th and early 20th century photographs and drawings of Mamluk minarets, and was carried out prior to the *Comité's* establishment for structural safety reasons. Engineering studies analyzing how Mamluk-era minarets respond to earthquakes have concluded that the upper part, often with columns supporting a heavy bulb, is the structure's weakest point.⁴⁵

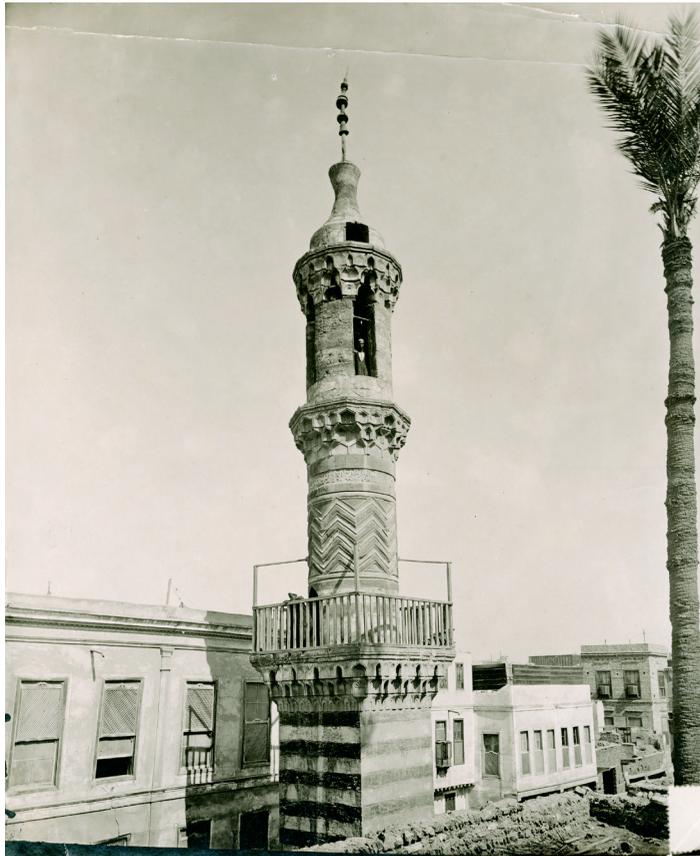
Fig. 9. Probably Giuntini, [Minaret of Qānībāy al-Šarkasī mosque], with manuscript mention at the back of the print: *Kānbāi el-Djarkassi (mosquée de): minaret, vue d'ensemble*, 1901. Silver print. Creswell Photographic Collection, The American University in Cairo, Album 24. Courtesy of RBSCL.

94. In BC 18, 1901, "8° Paiements", pp. 48–49, Giuntini's payment for his photographs of the minaret of Qānībāy al-Šarkasī is mentioned. The two photographs of the pre-demolition condition were not published by the *Comité* but were found in Creswell's archive at the American University in Cairo, although with no reference to the author of the photograph.

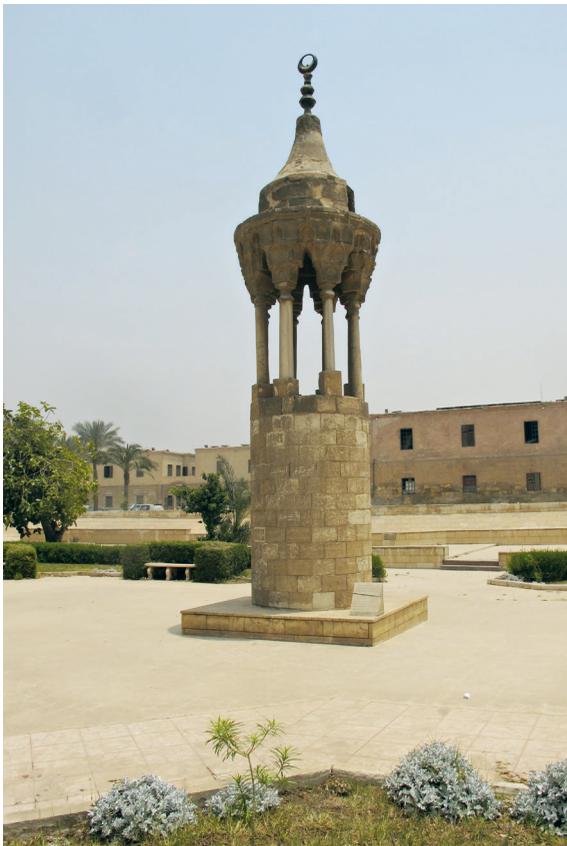
Fig. 10. [Upper part of the Minaret of Qānībāy al-Šarkasī mosque, now at the Cairo citadel], 2015. Digital photograph. © Dina Bakhom.

Neither the archives nor the *Comité's* Bulletins contain further discussion of the minaret of Qānībāy al-Šarkasī, until 1941, when *Comité* members visited the mosque of al-Ḥākīm, and noticed the pieces of its upper part in the courtyard. It must be noted here that since 1936, the *Comité* was no longer under the supervision of *Awqāf*, but of the Ministry of Public Instruction.¹⁰⁴ Muḥammad Riyāḍ Pasha, then president of the *Comité* suggested that it be transported and remounted in its original place and that the project be studied and details be submitted to the *Comité* for consideration.¹⁰⁵ The *Comité's* engineer duly prepared a report on the minaret's condition noting the following:¹⁰⁶

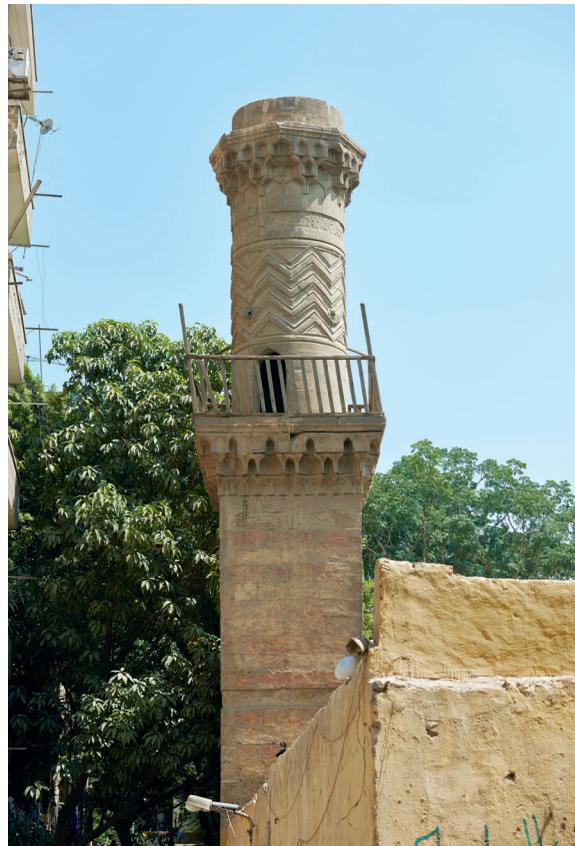
Fig. 11. [Minaret of Qānībāy al-Šarkasī mosque], 2015. Digital photograph. © Matjaž Kačičnik.

The *Comité* decided to delay the minaret's reconstruction while requesting that the Ministry of *Awqāf* take measures to connect the ablution area to the public sewer.¹⁰⁸ The upper part of the minaret of Qānībāy al-Šarkasī was eventually moved from the courtyard of al-Ḥākīm mosque to its present location behind the offices containing the *Comité's* photographic and architectural archives at the Citadel in Cairo (fig. 10). It is labelled with its name and a 15th century date, however its story since its dismantling from the mosque of Qānībāy al-Šarkasī in 1901 remains untold. Today, the mosque still stands with an incomplete minaret (fig. 11).

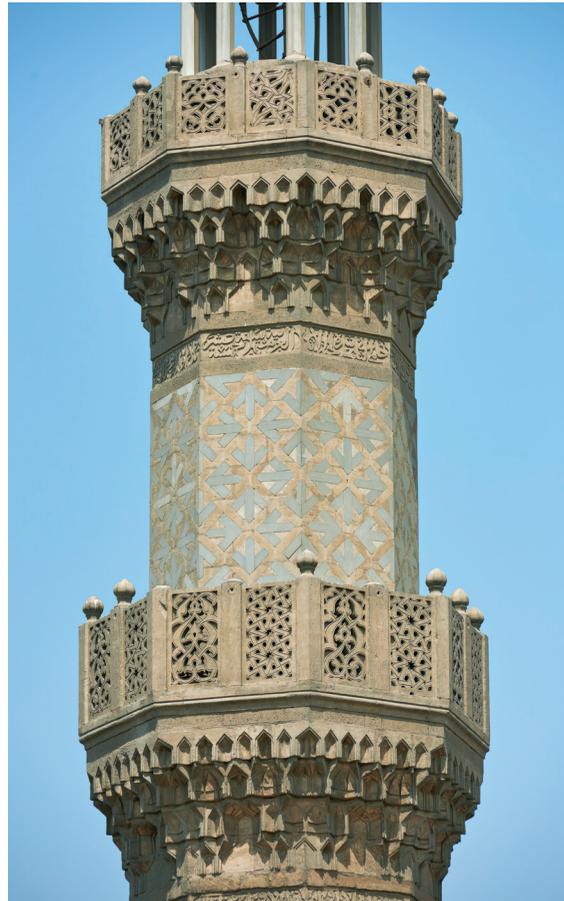
Fig. 12. [Upper part of the Minaret of Qāḍī Yaḥyā Zayn al-Dīn mosque, showing the *Comité*'s inscription], 2015. Digital photograph. © Matjaž Kačičnik.

Today, the complete minaret might appear to the regular viewer as a 15th century Mamluk minaret; however, an inscription band running along the top of the new second storey carries valuable information. The inscription states that the restoration of the second shaft and what is above it was carried out during the reign of ‘Abbās Ḥilmī II under the supervision of the *Comité* in 1315 AH—hence—AD 1897–1898 (fig. 12).

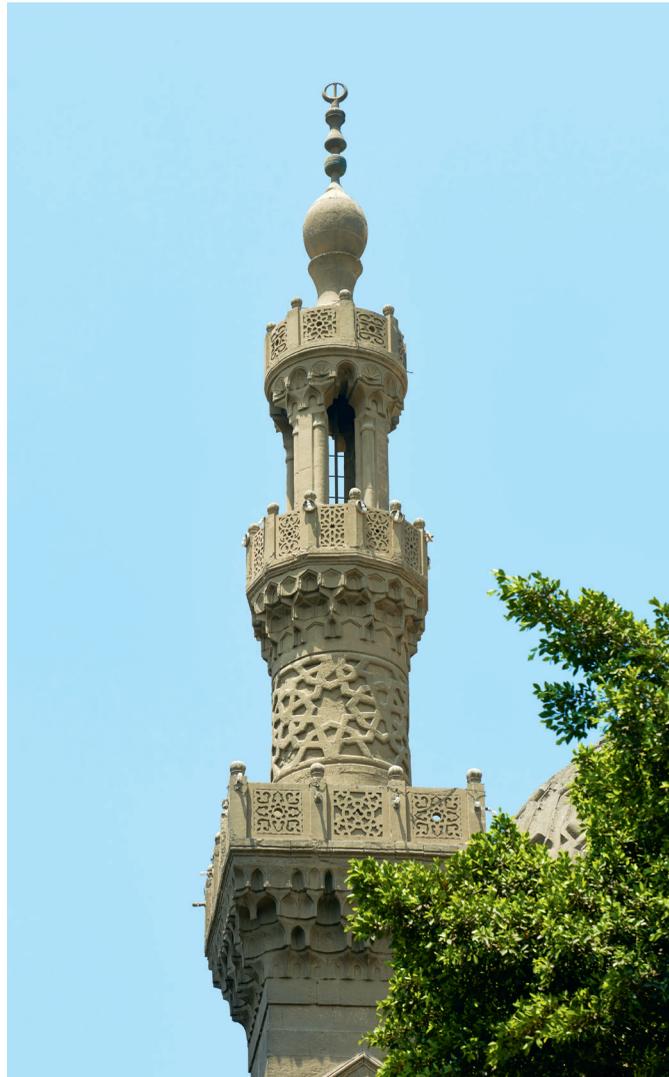
Fig. 15. Minaret of Tağrī Birdī mosque, 2015. Digital photograph.
© Matjaž Kačičnik.

It must be noted, however, that the design didn't follow the eight marble columns, but instead used stone piers with attached columns (fig. 15).
