BIFAO 90 (1991), p. 41-49

Marek Baranski

Preserving the Christian Basilica of El-Ashmunein.

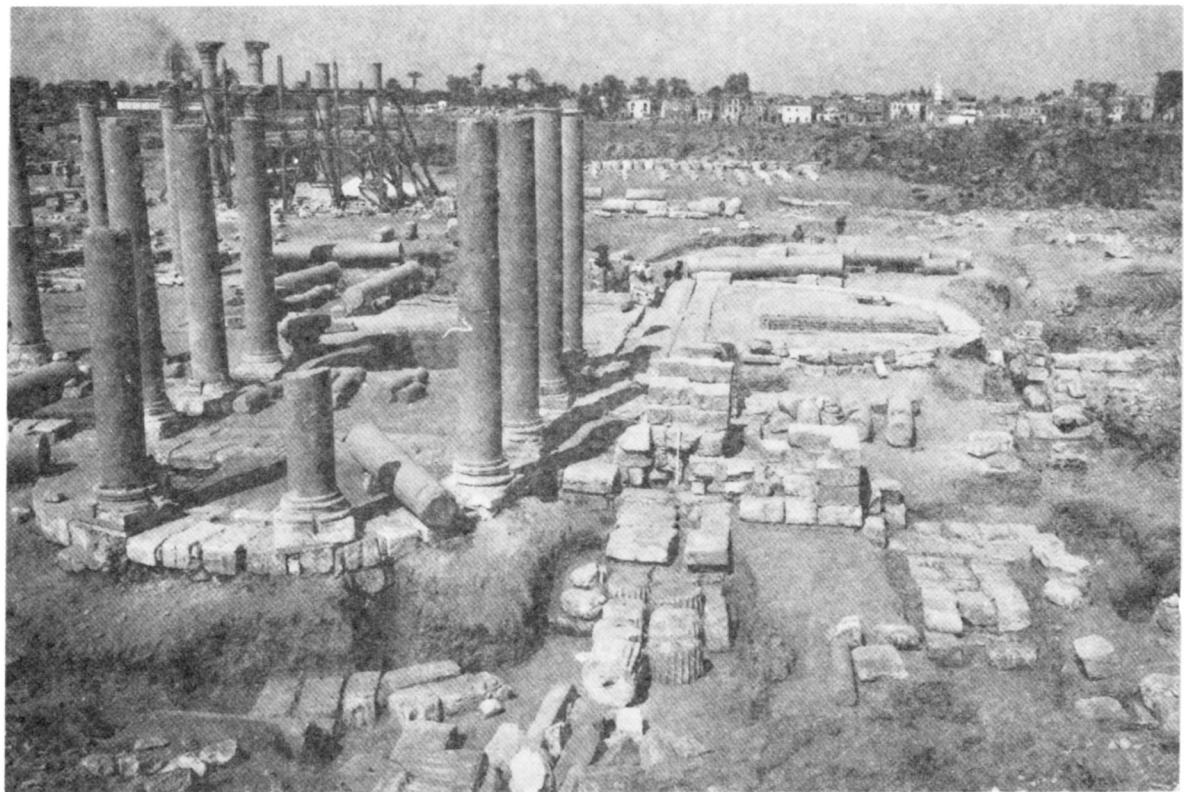
2. *The Basilica. State of preservation in year 1989.*

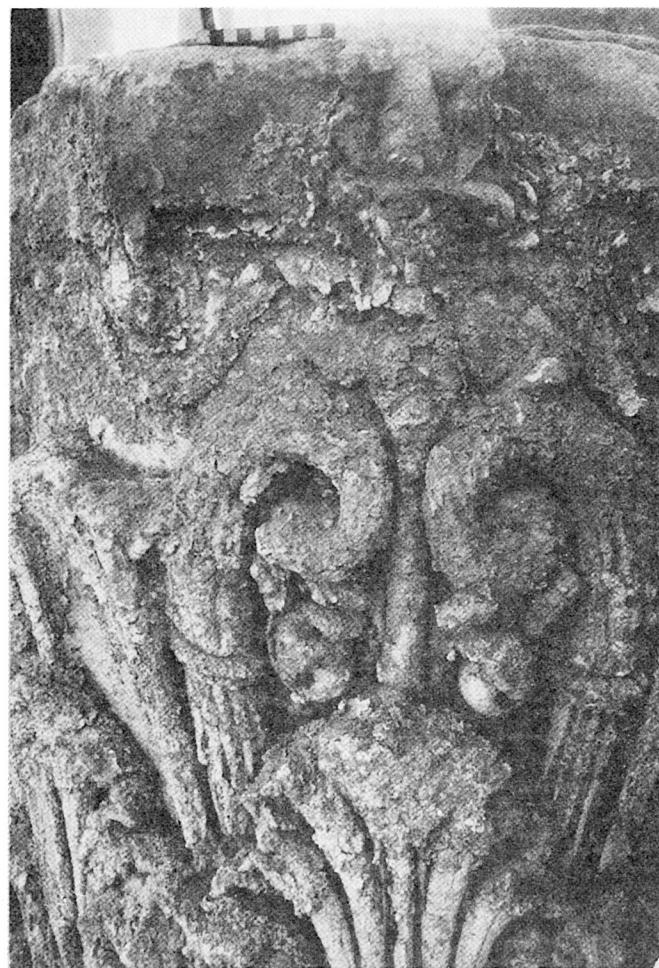
5. The salt efflorescence on the Hellenistic capitals.

As it was mentioned, the ruins of the basilica and other monuments at Ashmunein are exposed to destructive action of salts crystallization. One must realize that this phenomenon has been occurring for ages. Such deterioration could be observed in granite column-shafts which had been projecting from the soil. There are also newly exposed elements of which the rate of destruction is similar. Such acceleration of damage is caused by unfavourable conditions. Therefore the most important is to stop ground water suction by the limestone remains. Our programme proposes that foundation should remain in the conditions of humid equilibrium. Therefore the exposed elements of the basilica namely column bases and walls should be insulated against ground water¹⁷. Different protective measures will be applied according to the present state of objects. Inspection of column bases which were restored in the forties confirms that such interventions are indispensable. Lack of damp-proof course caused destruction of almost all bases. Stone shows progressing erosion. Existing mortar mouldings are completely disjointed or deeply eroded. In many bases steel bands are completely rotten. Actually almost all bases are shapeless now. Protection of bases with their desalination and conservation without lifting the columns up seems to be a difficult and expensive task and in many cases useless. Therefore we decided to leave and conserve only the best preserved ones. Other bases ought to be replaced by the new replicas. The preserved parts of walls will be treated in a similar way. The maintenance of the architectonic elements, both those from the basilica and the Hellenistic ones is a separate problem. At present, specialists both in Egypt and Poland test methods of big limestone blocks desalination in the Egyptian conditions. We do hope that after conservation these elements will be applied in the restored basilica. To prevent destruction of exposed limestone elements the most deteriorated ones were covered temporarily with sand. Tests for elaboration of protection of mudbrick remains are also one of mission tasks.
