BIFAO 90 (1991), p. 41-49

Marek Baranski

Preserving the Christian Basilica of El-Ashmunein.

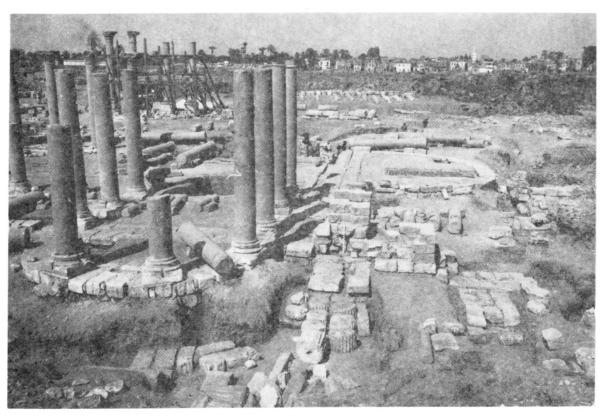
2. The Basilica. State of preservation in year 1989.

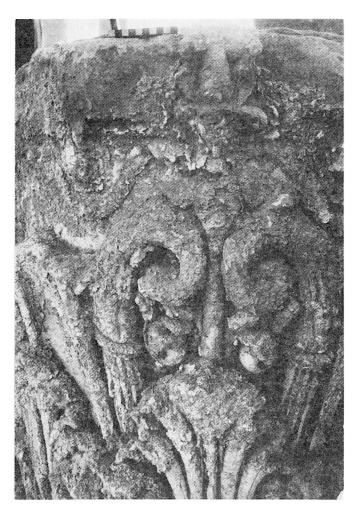
5. The salt efflorescence on the Hellenistic capitals.

As it was mentioned, the ruins of the basilica and other monuments at Ashmunein are exposed to destructive action of salts crystallization. One must realize that this phenomenon has been occurring for ages. Such deterioration could be observed in granite columnshafts which had been projecting from the soil. There are also newly exposed elements of which the rate of destruction is similar. Such acceleration of damage is caused by Therefore the most important is to stop ground water unfavourable conditions. suction by the limestone remains. Our programme proposes that foundation should remain in the conditions of humid equilibrium. Therefore the exposed elements of the basilica namely column bases and walls should be insulated against ground water 17. Different protective measures will be applied according to the present state of objects. Inspection of column bases which were restored in the forties confirms that such interventions are indispensable. Lack of damp-proof course caused destruction of almost all bases. Stone shows progressing erosion. Existing mortar mouldings are completely disjointed or deeply eroded. In many bases steel bands are completely rotten. Actually almost all bases are shapeless now. Protection of bases with their desalination and conservation without lifting the columns up seems to be a difficult and expensive task and in many cases useless. Therefore we decided to leave and conserve only the best preserved ones. Other bases ought to be replaced by the new replicas. The preserved parts of walls will be treated in a similar way. The maintenance of the architectonic elements, both those from the basilica and the Hellenistic ones is a separate problem. At present, specialists both in Egypt and Poland test methods of big limestone blocks desalination in the Egyptian conditions. We do hope that after conservation these elements will be applied in the restored basilica. To prevent destruction of exposed limestone elements the most deteriorated ones were covered temporarily with sand. Tests for elaboration of protection of mudbrick remains are also one of mission tasks.
