Marek Baranski

Preserving the Christian Basilica of El-Ashmunein.

## PRESERVING THE CHRISTIAN BASILICA OF EL-ASHMUNEIN

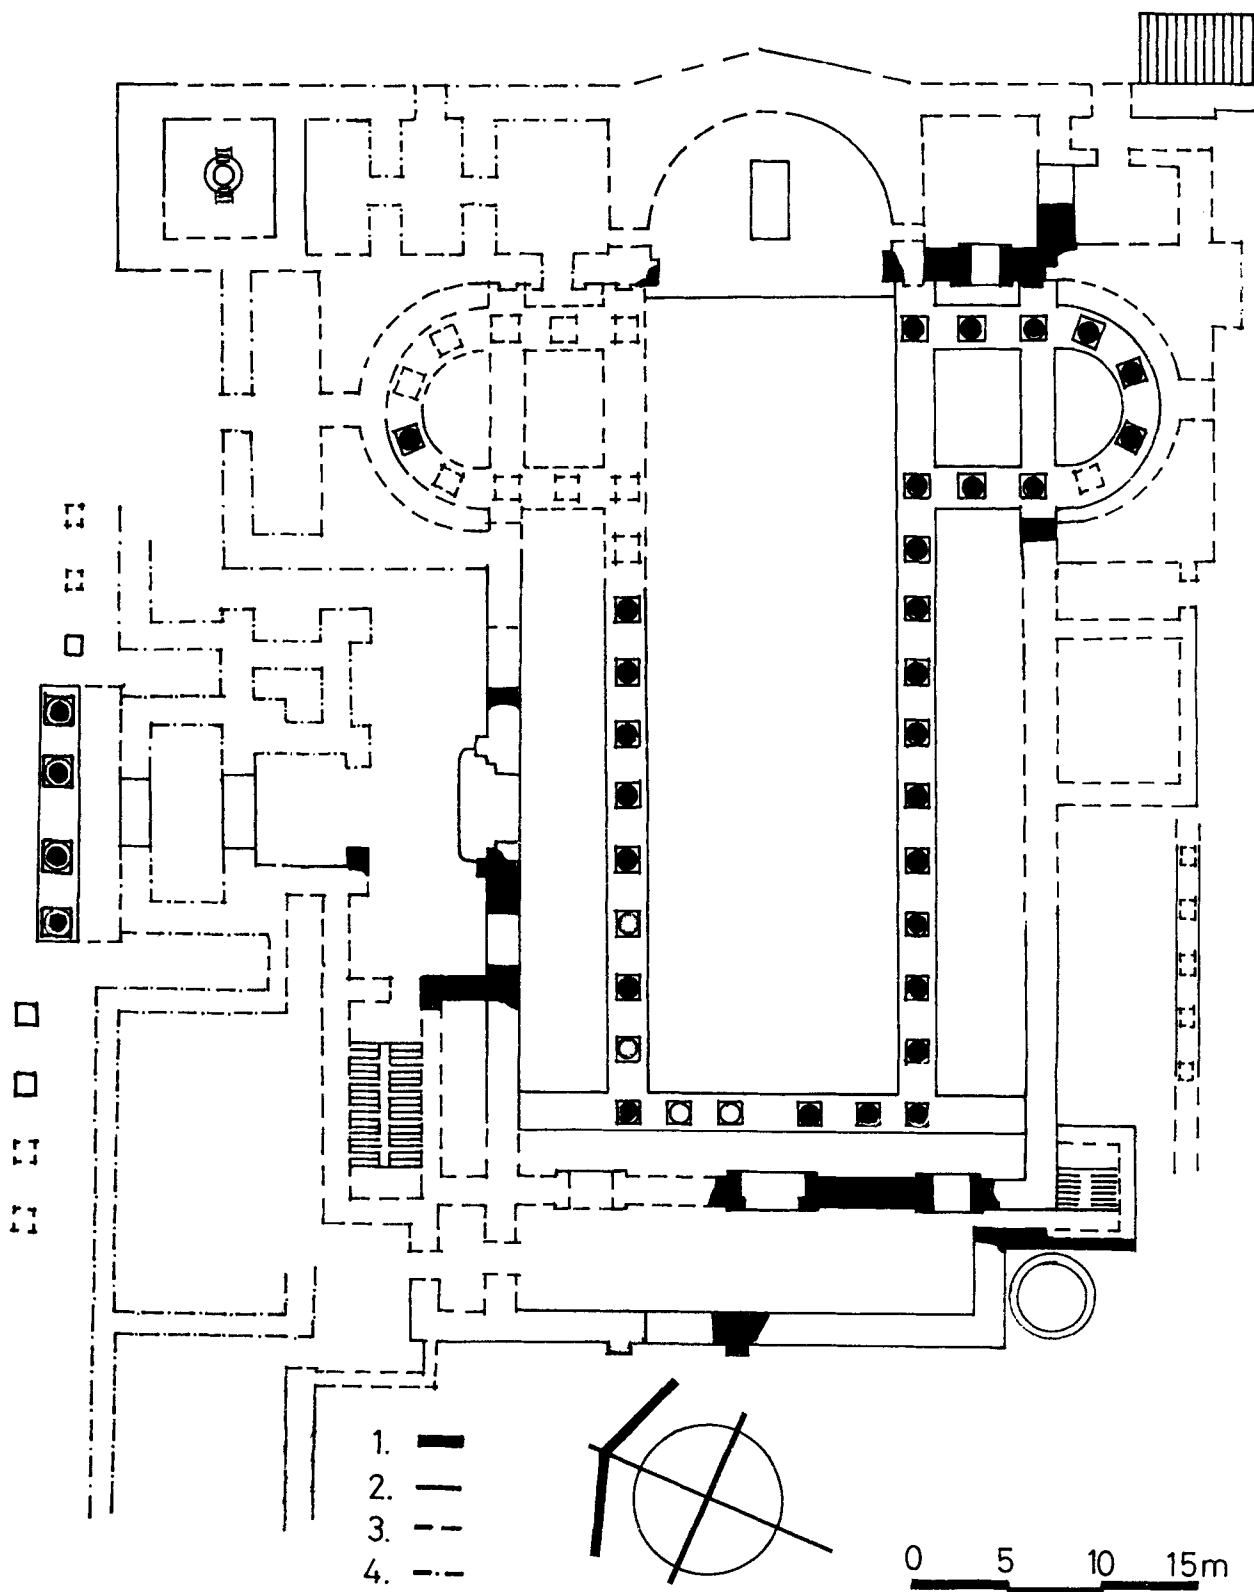
1. The Basilica in Ashmunein. Plan.

| 1. Remaining walls. | 3. Outline of non-existing foundations. |
| 2. Outline of existing foundations. | 4. Probable outline of walls (not excavated yet). |

The church in Ashmunein is a big basilica with side galleries. Its length is of 55 metres, span of the nave is of 14.7 m and depth of aisles is of 5.6 m. The columnaded transept has exaedras on both sides. This feature makes that the basilica is one of the most important examples of early Christian architecture development <sup>7</sup>. At the east end there is a great apse of width equal to the nave span. The western part of the church was ended by the esonarthex, which was later on completed by the narthex. On its north and south sides there were unsymmetrically situated staircases which led to the side galleries. It is supposed that the ceiling of the church was wooden. Presumably the basilica was 22 m high. There were two entrances leading into the basilica. The main entrance from the spacious atrium was situated on the western end of the church. The other one was the side entrance situated on the north and leading from the Antinoe street through the four column portico—the Tetrastyle. The baptistery tank was situated in the north-east corner of the church complex. The basilica was built in the centre of the town, what caused destruction of earlier buildings present on this area.

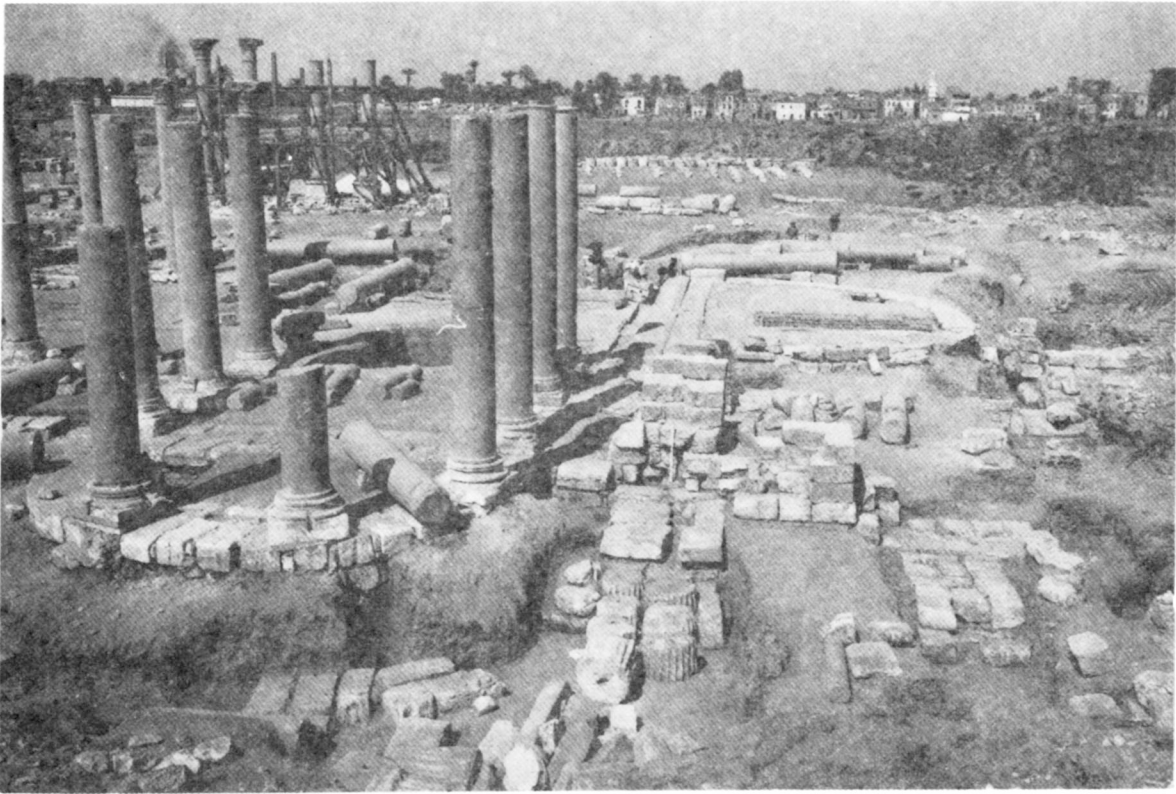
*2. The Basilica. State of preservation in year 1989.*

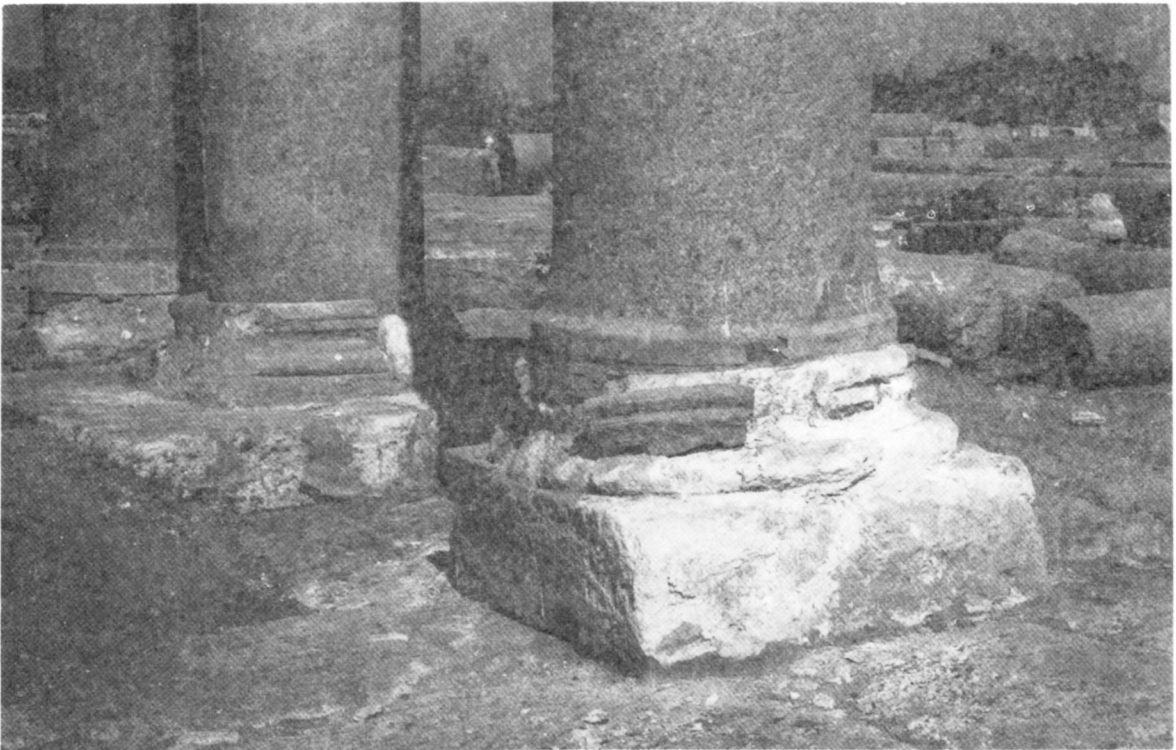
*3. Destroyed column bases in the transept.*

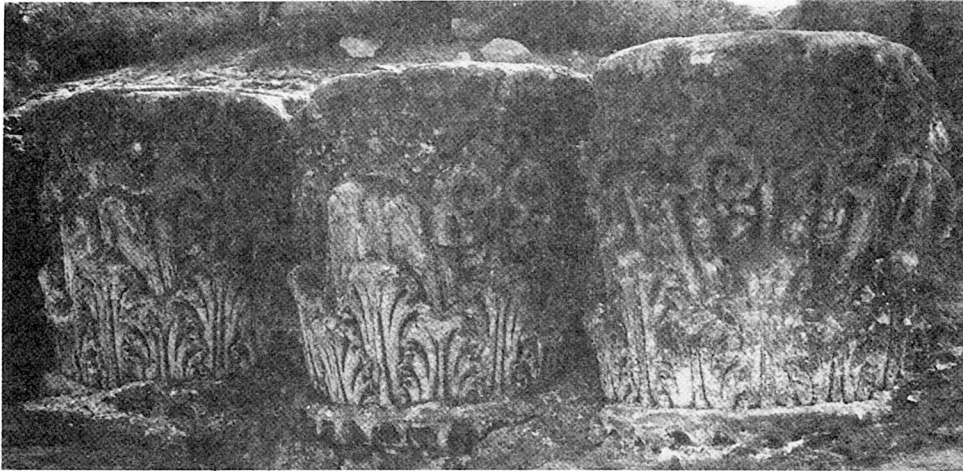
4. *Hellenistic capitals found in the basilica foundations.*

The great number of Hellenistic blocks which were taken out from the foundations form another problem. At present, elements of Doric and Corinthian buildings are stored in the lapidarium nearby the basilica. After the thorough selection, the best preserved ones should be exhibited in the groups representative for particular architectonic orders. The present storage area is not the best place for their exhibition. The fact that they are situated close to the original monuments, *i.e.* the basilica, the Komasterion, the Bastion can mislead the visitors suggesting that they are remnants of the buildings which stood on this area. Megaw, in his report proposed that the Corinthian column should be erected on the remnants of the Hellenistic foundation in order to mark on site building activity of this period<sup>18</sup>. But, until now it has not been stated to what building this foundation belonged. Moreover, the effect of setting the fluted column close to the basilica's plain granite shafts can make a disharmony in the visitors eyes. In our consideration the best place for such an exhibition would be the area nearby the museum's storehouse in Ashmunein, where the reconstructed statues of Baboons, which originally stood in front the Amenophis III temple and after its demolition were used as a rubble core of the foundation, are already standing.

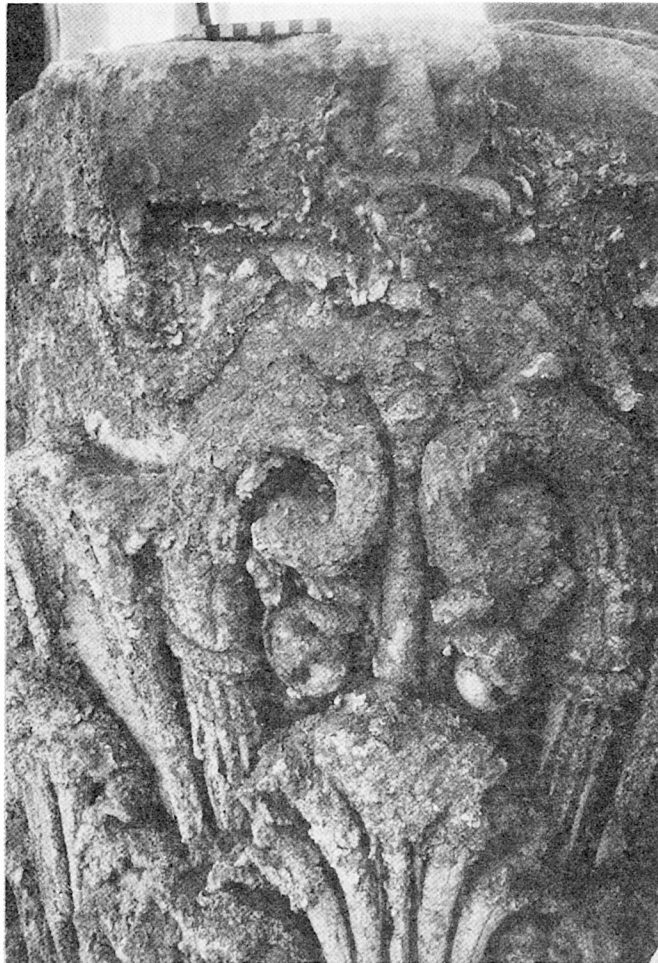
5. *The salt efflorescence on the Hellenistic capitals.*

As it was mentioned, the ruins of the basilica and other monuments at Ashmunein are exposed to destructive action of salts crystallization. One must realize that this phenomenon has been occurring for ages. Such deterioration could be observed in granite column-shafts which had been projecting from the soil. There are also newly exposed elements of which the rate of destruction is similar. Such acceleration of damage is caused by unfavourable conditions. Therefore the most important is to stop ground water suction by the limestone remains. Our programme proposes that foundation should remain in the conditions of humid equilibrium. Therefore the exposed elements of the basilica namely column bases and walls should be insulated against ground water<sup>17</sup>. Different protective measures will be applied according to the present state of objects. Inspection of column bases which were restored in the forties confirms that such interventions are indispensable. Lack of damp-proof course caused destruction of almost all bases. Stone shows progressing erosion. Existing mortar mouldings are completely disjointed or deeply eroded. In many bases steel bands are completely rotten. Actually almost all bases are shapeless now. Protection of bases with their desalination and conservation without lifting the columns up seems to be a difficult and expensive task and in many cases useless. Therefore we decided to leave and conserve only the best preserved ones. Other bases ought to be replaced by the new replicas. The preserved parts of walls will be treated in a similar way. The maintenance of the architectonic elements, both those from the basilica and the Hellenistic ones is a separate problem. At present, specialists both in Egypt and Poland test methods of big limestone blocks desalination in the Egyptian conditions. We do hope that after conservation these elements will be applied in the restored basilica. To prevent destruction of exposed limestone elements the most deteriorated ones were covered temporarily with sand. Tests for elaboration of protection of mudbrick remains are also one of mission tasks.
