AnIsl 45 (2011), p. 321-338

M.A. Mohie, Abubakr Moussa

Diagnosis of Pigment Materials Affected by Air Pollution and Clay Minerals in Sabil Alkazlar.

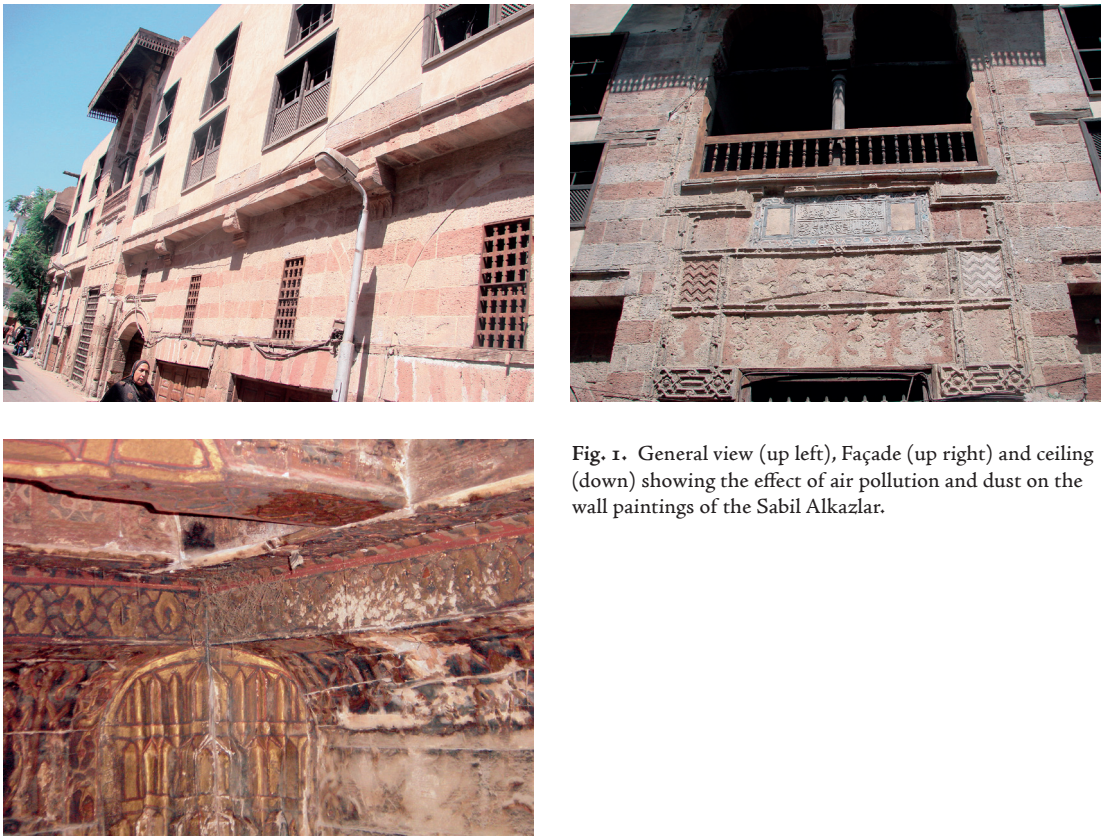
in those samples that have no black pigment material. The complex physical and chemical interactions of these agents with the mineral material have dramatically accelerated the decay of the building materials.[19] Particulate pollutants vary enormously in size and are especially dangerous to objects because they attract moisture and gaseous pollutants. Dust can be an abrasive agent. Removing dust involves washing, wiping, or shaking, all of which accelerates deterioration and increases the risk of physical damage to wall paintings.[20] Dust precipitated on the wall paintings of the Sabil (fig. 1) and in the micro cracks (fig. 9).

b. The porosity of the building materials.[24] Chemically, salts in reaction with the pigment components play a role as a catalyst in the discoloring phenomenon (fig. 1).

Fig. 1. General view (up left), Façade (up right) and ceiling (down) showing the effect of air pollution and dust on the wall paintings of the Sabil Alkazlar.

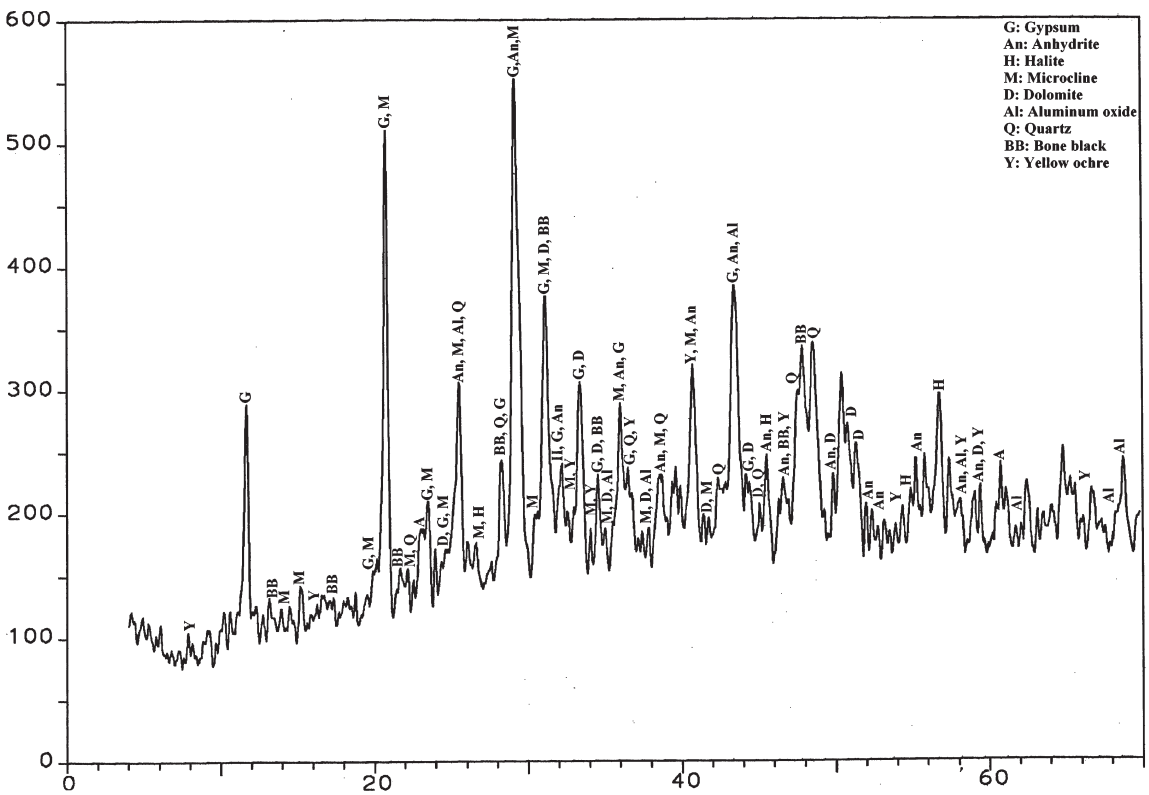
The XRD analysis of the rendering layer applied to the wooden ceiling of Sabil Alkazlar; revealed the presence of gypsum, anhydrite, dolomite, quartz, aluminum oxide, microcline, halite, bone black, yellow ochre and hematite (fig. 2). SEM-EDAX of the same sample showed the presence of: 43% oxygen, 18% calcium, 13% silicon, 11% carbon, 3% iron, 5% aluminum, 2% sulfur, 2% magnesium, 1% chlorine, 1% potassium and 1% sodium (fig. 3).

1. The XRD and SEM-EDAX analyses indicate that gypsum and anhydrite are the dominant compounds in the plaster layer. Two destructive expansive reactions are usually taking place in the presence of gypsum leading to the formation of ettringite and thaumasite. The latter forms in historic mortars and plasters by the reaction of gypsum and calcium aluminum hydrates in a moist condition.[6] Sabil Alkazlar is not immune of that effect because of its location in historical Cairo which suffers from the continuous increase of water table. The formation of ettringite or thaumasite leads to the complete destruction of the material.[7] Fissuring and cracking phenomena are widely observed in the plastered ceiling and walls of Sabil Alkazlar (fig. 9). The possibility of ettringite formation in historic mortars or plasters due to air pollution effect was previously discussed by Sabbioni[8] as showed in reaction (1) & (2).

Fig. 2. XRD pattern of the studied plaster sample from the Sabil Alkazlar.

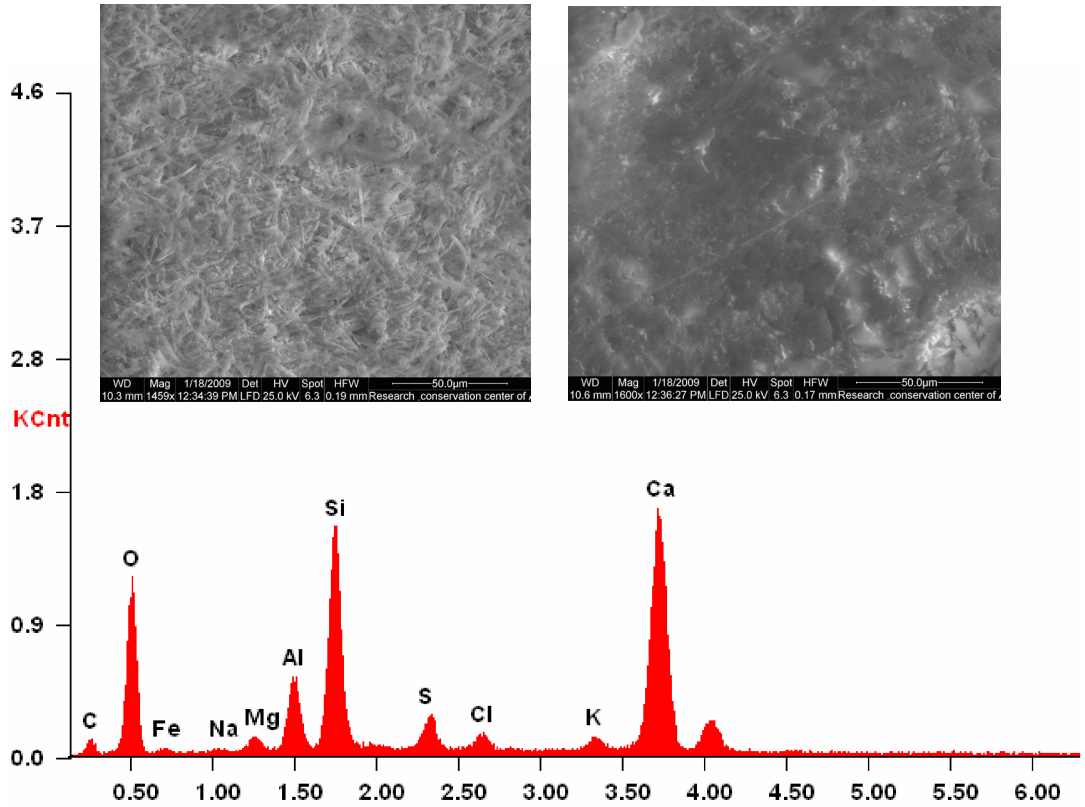
Fig. 3. SEM-EDAX spectra and micrographs of the studied plaster sample from the Sabil Alkazlar.
The micrograph (left) shows the gypsum crystals which are the main components of the plaster, while the micrograph (right) shows the growth of anhydrite and halite crystals inside gypsum.

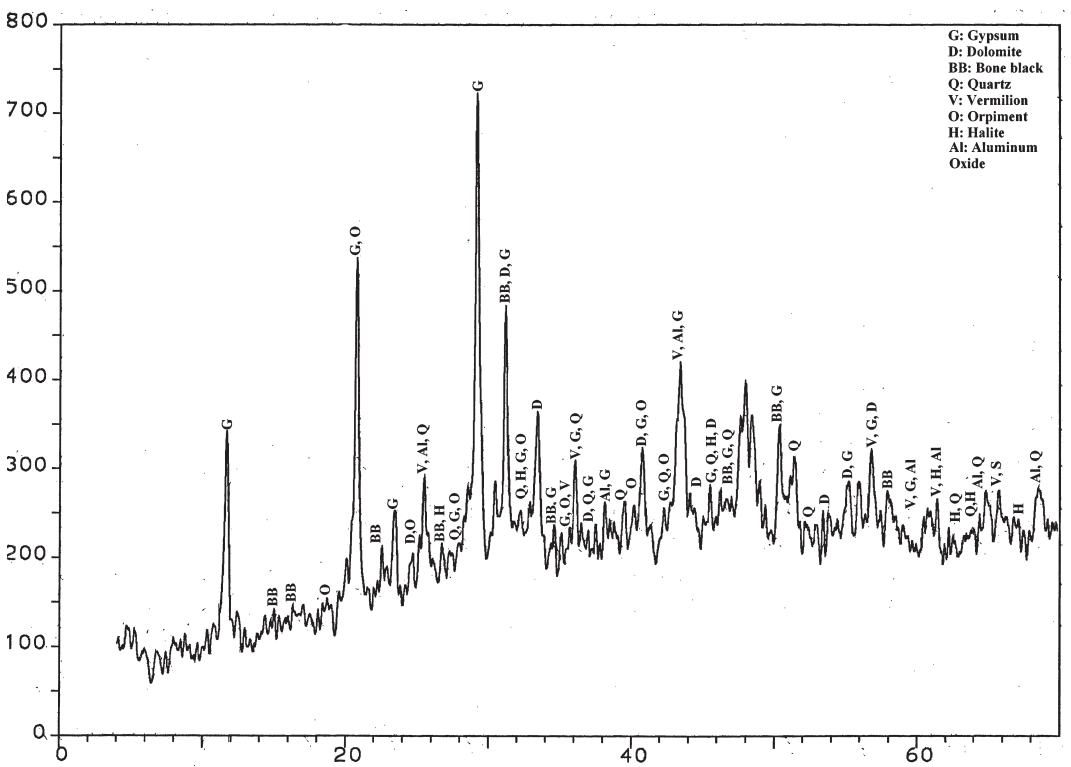
XRD analysis of a black pigmented plaster sample from the ceiling proved that the used pigment material is bone black [$C.Ca_3(PO_4)_2$]. The sample contains also gypsum, dolomite, quartz, halite, orpiment, cinnabar and aluminum oxide (fig. 4). The SEM-EDAX of the sample revealed the presence of about 65% carbon, 28% oxygen, 1% chlorine, 1% sodium, 1% calcium, 1% phosphate, 1% sulfur and traces of aluminum, silicon and magnesium (fig. 5).

Fig. 4. XRD pattern of the studied black pigment sample from the Sabil Alkazlar.

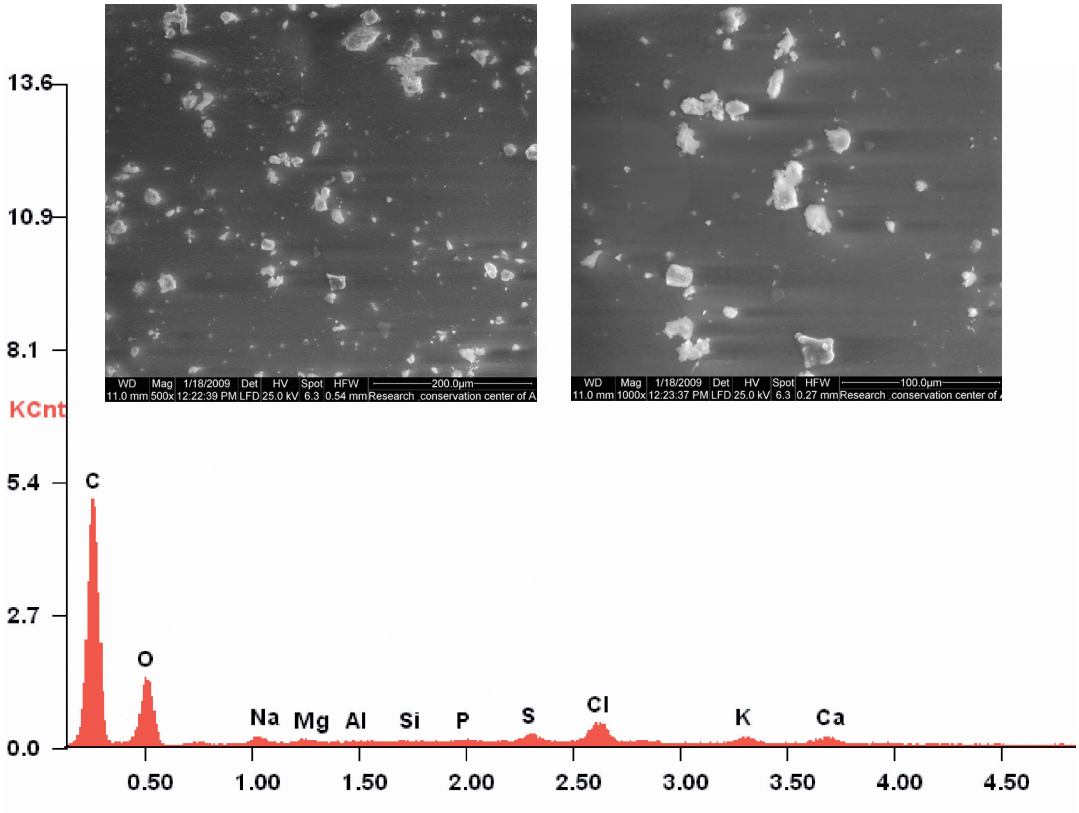
Fig. 5. SEM-EDAX spectra and micrographs of the studied black pigment from the Sabil Alkazlar. The micrographs show the growth of halite crystals upon pigment surface (efflorescence).

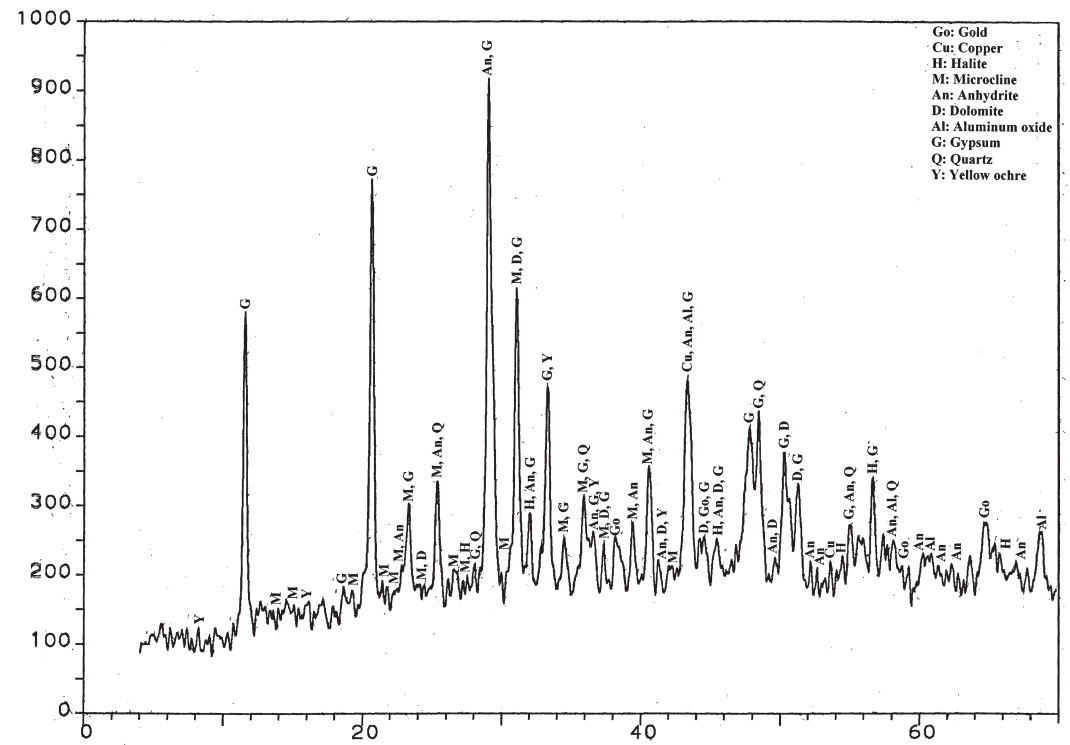
Based on the XRD analysis, the golden pigment material used in Sabil Alkazlar's ceiling is gold (Au) mixed with traces of cupper. The analyzed sample contains gypsum as a major constituent, in addition to anhydrite, dolomite, quartz, aluminum oxide, microcline, halite, yellow ochre and hematite (fig. 6). The SEM-EDAX of the same sample detected the presence of about 47% gold, 23% carbon, 18% oxygen, 7% calcium, 1% potassium, 1% quartz, 1% sodium, 1% iron and traces of copper, aluminum and magnesium (fig. 7).

Fig. 6. XRD pattern of the studied golden pigment sample from the Sabil Alkazlar.

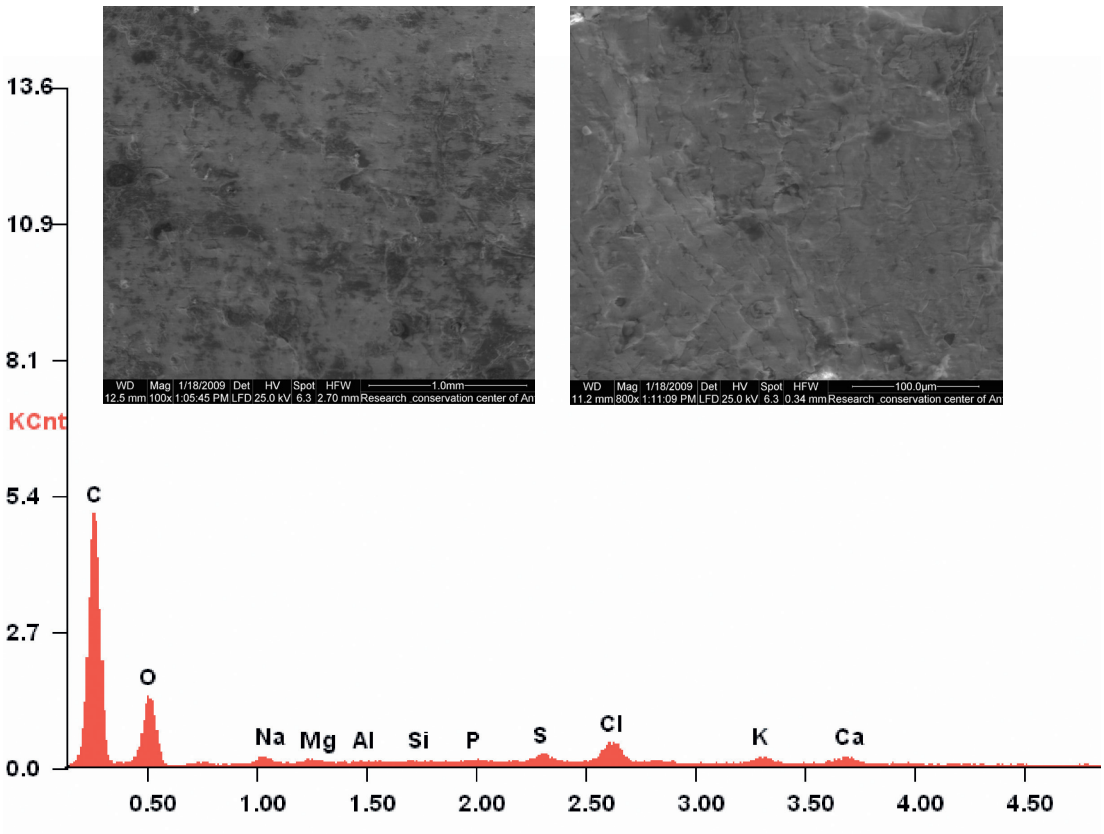
Fig. 7. SEM-EDAX spectra and micrographs of the studied golden pigment from the Sabil Alkazlar. The micrographs show the presence of blisters which can be explained due to hammering of gold leafs.

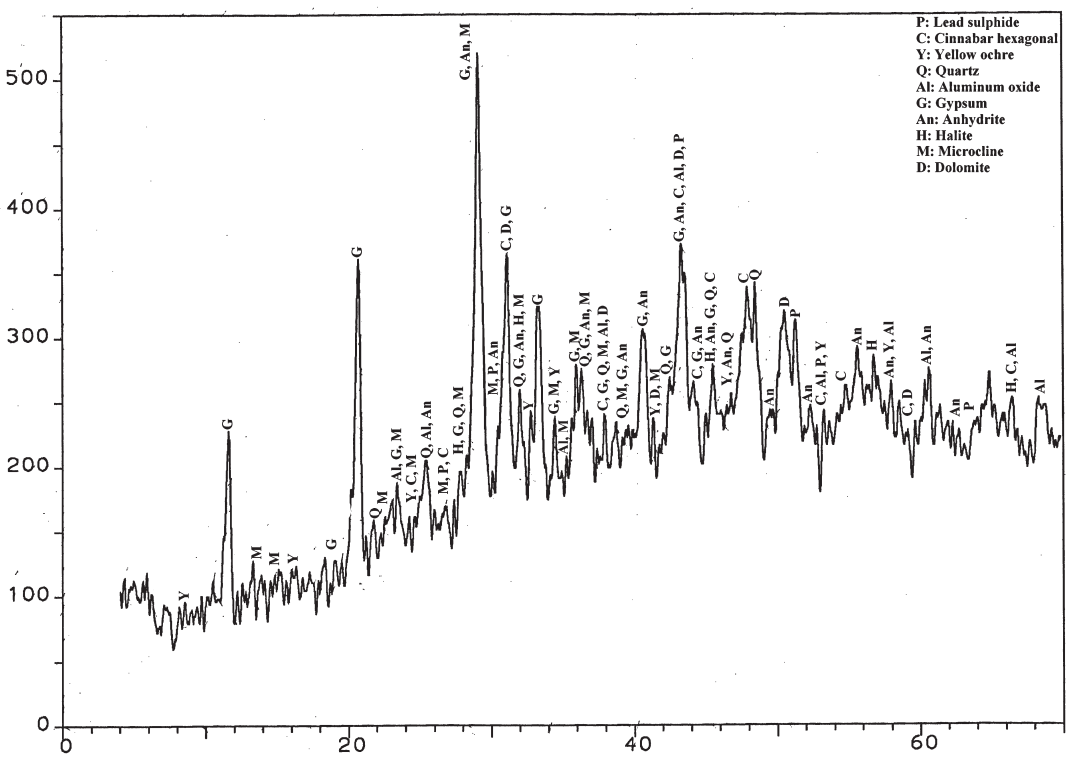
XRD analysis of the red pigment material in Sabil Alkazlar's ceiling revealed the presence of natural cinnabar (HgS). The sample also contains gypsum, anhydrite, dolomite, quartz, aluminum oxide, microcline, halite, lead sulfide, yellow ochre and hematite (fig. 8). The SEM-EDAX for the same sample detected the presence of about 30% carbon, 19% mercury, 17% oxygen, 15% lead, 6% sulfur, 3% calcium, 3% chlorine, 2% potassium, 1% sodium, 1% iron, 1% silicon, 1% magnesium and 1% aluminum (fig. 9).

Fig. 8. XRD pattern of the studied red pigment sample from the Sabil Alkazlar.

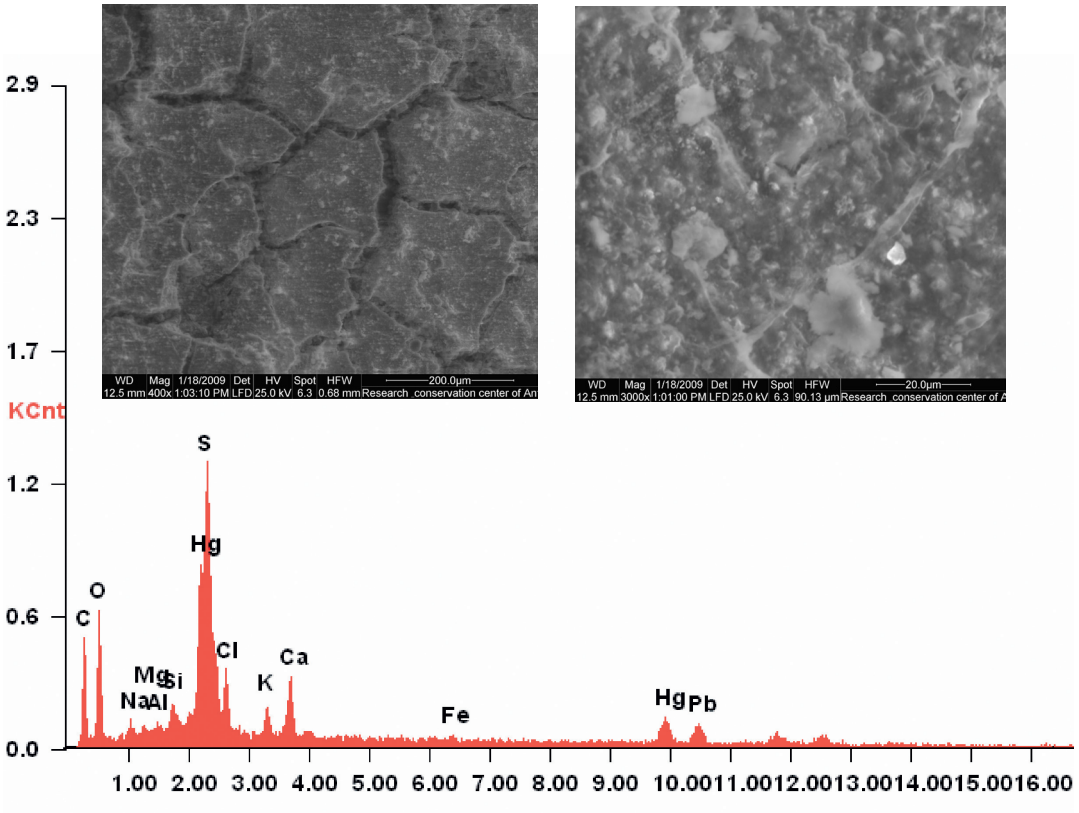
16. Smectite-illite mixed layers are able to swell more than kaolinite according to the 2:1 composition. When water is absorbed, swelling starts to appear on the wall paintings surfaces in microscopic cracks and fractures. This is shown in the SEM micrographs of the red pigment (fig. 9).

Fig. 9. SEM-EDAX spectra and micrographs of the studied red pigment from the Sabil Alkazlar.
The micrographs show a net of micro cracks in the pigment surface due to clay minerals effect; these cracks are filled with salt crystals and dust.

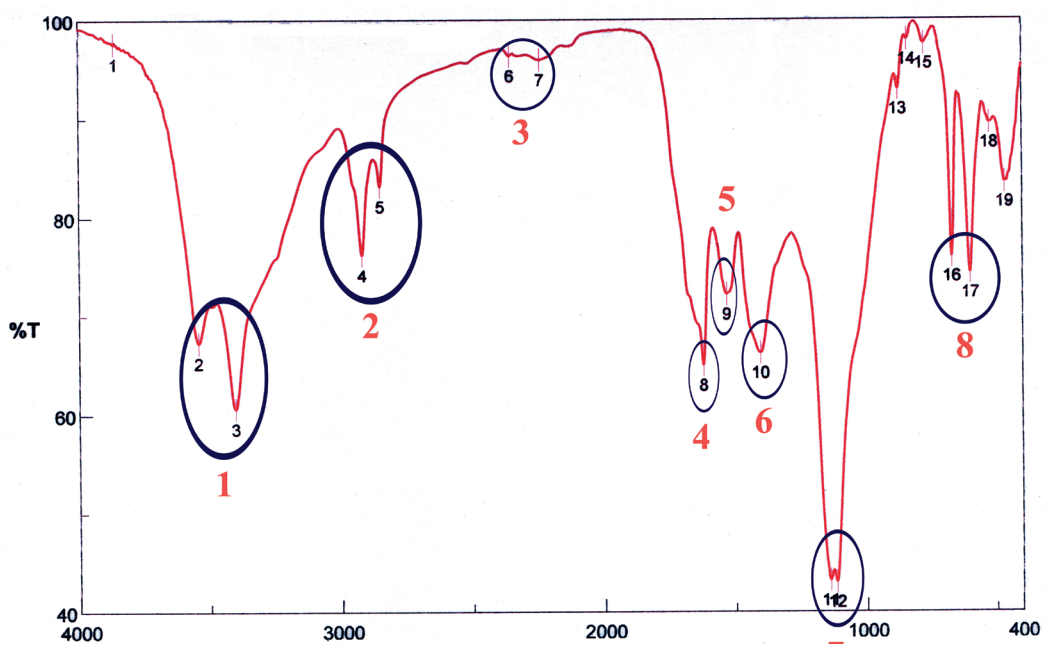
Four samples were analyzed using FTIR in order to identify the medium used in both the rendering layer and pigments in Sabil Alkazlar. Functional groups and wave numbers were measured. Animal glue binding was found on the FTIR charts. Based upon the results, it has been proved that rabbit skin glue was the paint medium used to mix and fix the pigments to the plaster, and it was also used to mix the components of the plaster layer together and fix them to the wooden ceiling (fig. 10). A standard sample of rabbit skin glue was prepared for comparison (fig. 11). The result was also emphasized by the UV analysis (fig. 12) which proved that the used medium was rabbit skin glue.

Fig. 10. FTIR spectrum of the binding medium used with the red pigment in the Sabil Alkazlar.
[1] Asymmetric and symmetric OH stretching bands of both animal glue and gypsum (splitting of the band is due to presence of gypsum). N-H stretching band of animal glue is over lapped by OH bands.
[2] Asymmetric and symmetric CH stretching bands of aliphatic groups of animal glue.
[3] Combination or overtones bands.
[4] Carbonyl stretching band of animal glue (amide I) + S=O stretching of SO_4^{-2} of gypsum.
[5] Combination of C-N stretching band and N-H bending band (amide II) of animal glue.
[6] C-H bending + OH bending band. [7] Asymmetric SO_4^{-2} stretching band of gypsum.
[8] SO_4^{-2} bending band of gypsum.

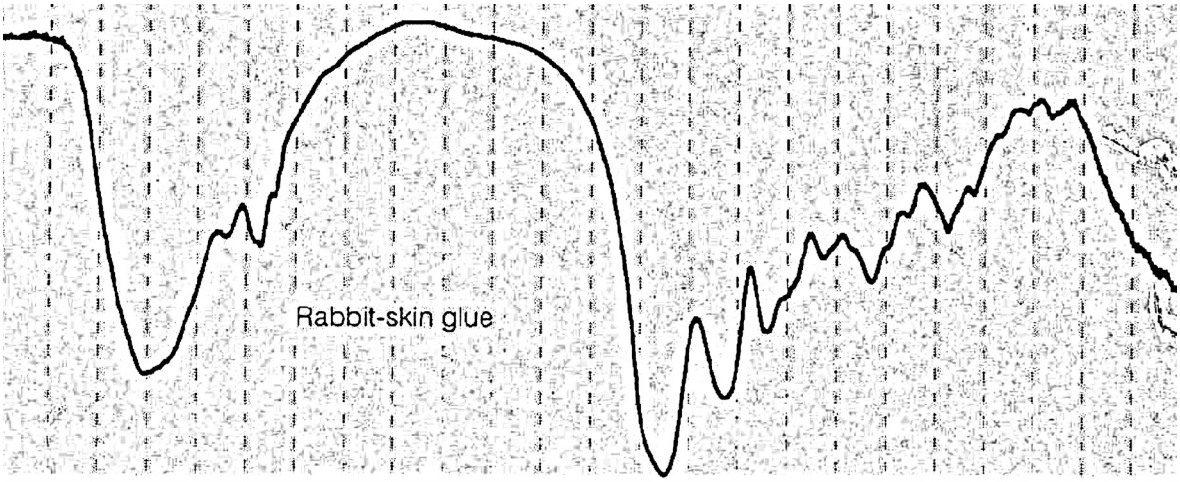
Fig. 11. FTIR standard of rabbit skin glue.

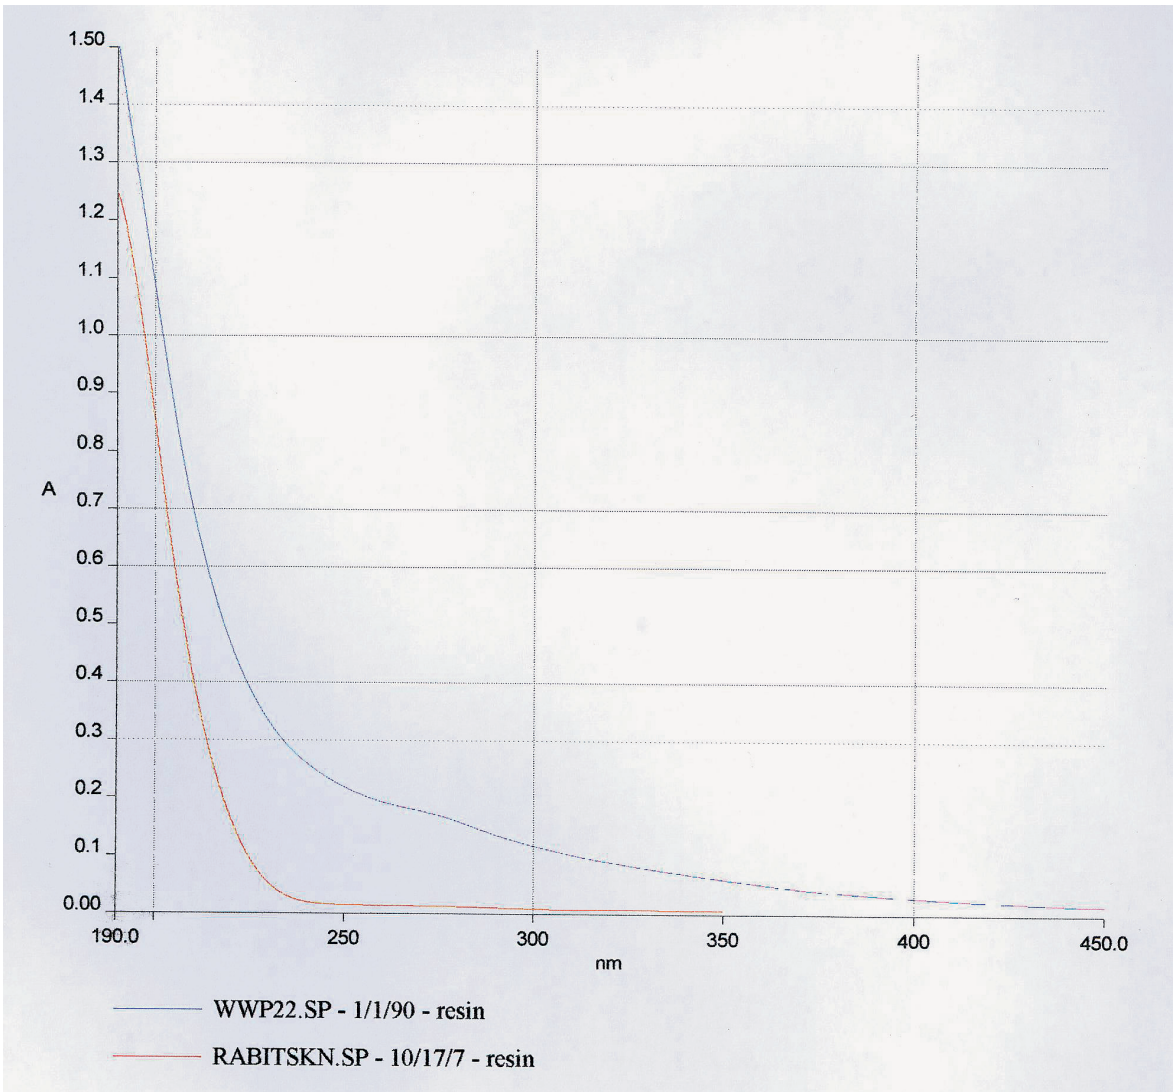
Fig. 12. UV spectrum of the binding medium used with the red pigment in the Sabil Alkazlar, proves that it is rabbit skin glue.
[1] Analyzed sample.
[2] Standard of rabbit skin glue.

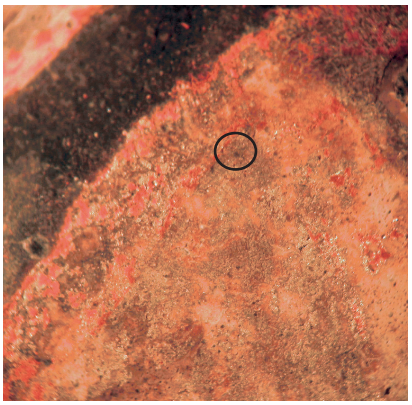
Fig. 13a. Shows the bulk sample of the ceiling's golden pigment from which the cross section was prepared (the cycles shows the exact place).

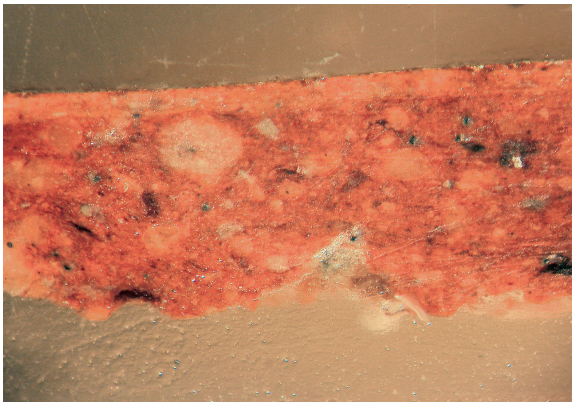
Fig. 13b. Cross section of the golden pigment in the Sabil Alkazlar (125X).

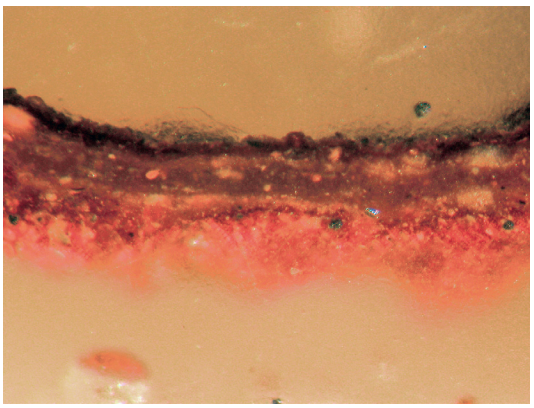
A bulk sample of the ceiling's black and red pigments was tested (fig. 14a). The black pigment was examined under a light microscope (fig. 14b). The results showed that the layered structure consists of 5 layers: the upper layer is black; the fourth and third layers are gray; the second is creamy and the lowest layer is red. XRD analysis revealed that the black pigment is bone black and the red pigment is natural cinnabar. Both pigments appeared in all layers with variable ratios. This sample confirmed that the artist used the multi-layer technique. The sample from the red pigment (fig. 14c) revealed the presence of a thin red upper layer followed by a thicker layer; the third layer is creamy in color and is thicker than the previous two layers. The final lowest layer is the thickest layer and it is the plaster layer which precedes the paint ground. It can be concluded that the painting layers of the Sabil Alkazlar's ceiling was composed of a wooden support upon which the plaster layer was composed of two layers (*gesso grosso* and *gesso sotile*), and a pigment layer carried out using the tempera technique.

Fig. 14b. Cross section of the black pigment in the Sabil Alkazlar (125X).

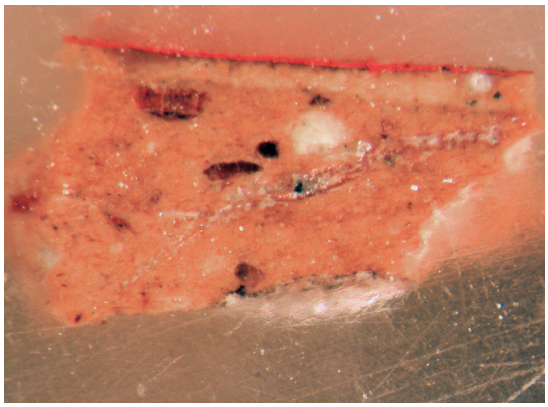
Fig. 14c. Cross section of the red pigment in the Sabil Alkazlar (125X).
