AnIsl 45 (2011), p. 321-338

M.A. Mohie, Abubakr Moussa

# Diagnosis of Pigment Materials Affected by Air Pollution and Clay Minerals in Sabil Alkazlar.

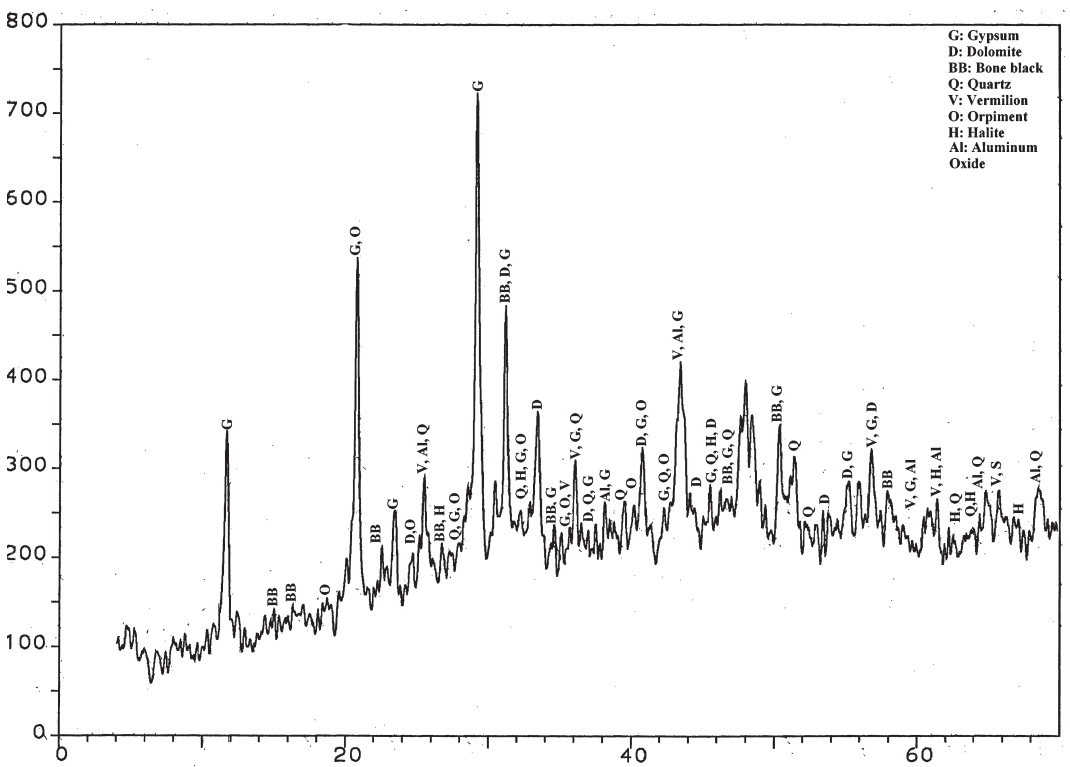
XRD analysis of a black pigmented plaster sample from the ceiling proved that the used pigment material is bone black [$C.Ca_3(PO_4)_2$]. The sample contains also gypsum, dolomite, quartz, halite, orpiment, cinnabar and aluminum oxide (fig. 4). The SEM-EDAX of the sample revealed the presence of about 65% carbon, 28% oxygen, 1% chlorine, 1% sodium, 1% calcium, 1% phosphate, 1% sulfur and traces of aluminum, silicon and magnesium (fig. 5).

Fig. 4. XRD pattern of the studied black pigment sample from the Sabil Alkazlar.

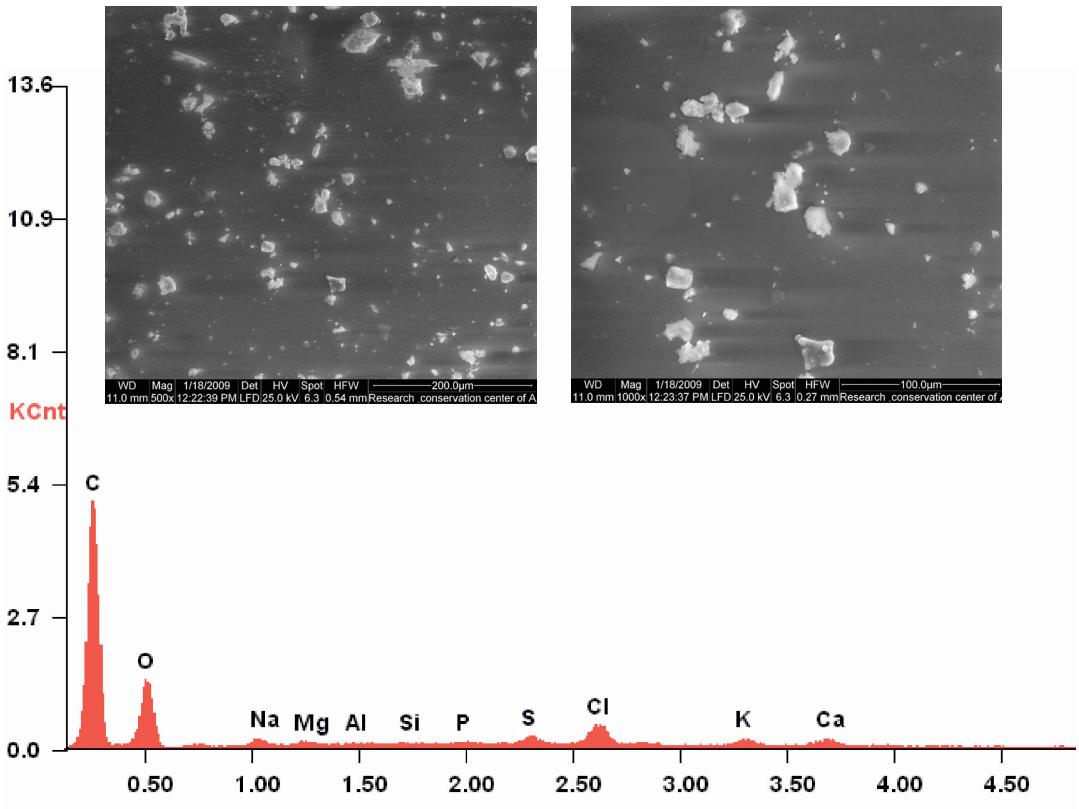
Fig. 5. SEM-EDAX spectra and micrographs of the studied black pigment from the Sabil Alkazlar. The micrographs show the growth of halite crystals upon pigment surface (efflorescence).

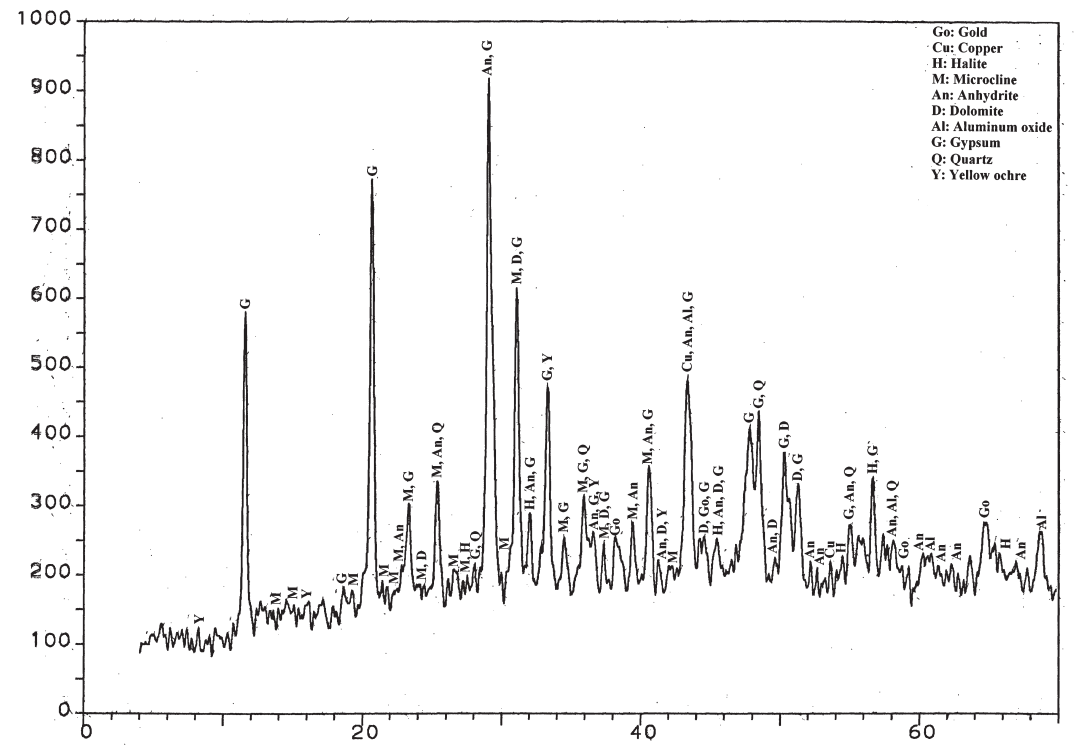
Based on the XRD analysis, the golden pigment material used in Sabil Alkazlar's ceiling is gold (Au) mixed with traces of cupper. The analyzed sample contains gypsum as a major constituent, in addition to anhydrite, dolomite, quartz, aluminum oxide, microcline, halite, yellow ochre and hematite (fig. 6). The SEM-EDAX of the same sample detected the presence of about 47% gold, 23% carbon, 18% oxygen, 7% calcium, 1% potassium, 1% quartz, 1% sodium, 1% iron and traces of copper, aluminum and magnesium (fig. 7).

Fig. 6. XRD pattern of the studied golden pigment sample from the Sabil Alkazlar.

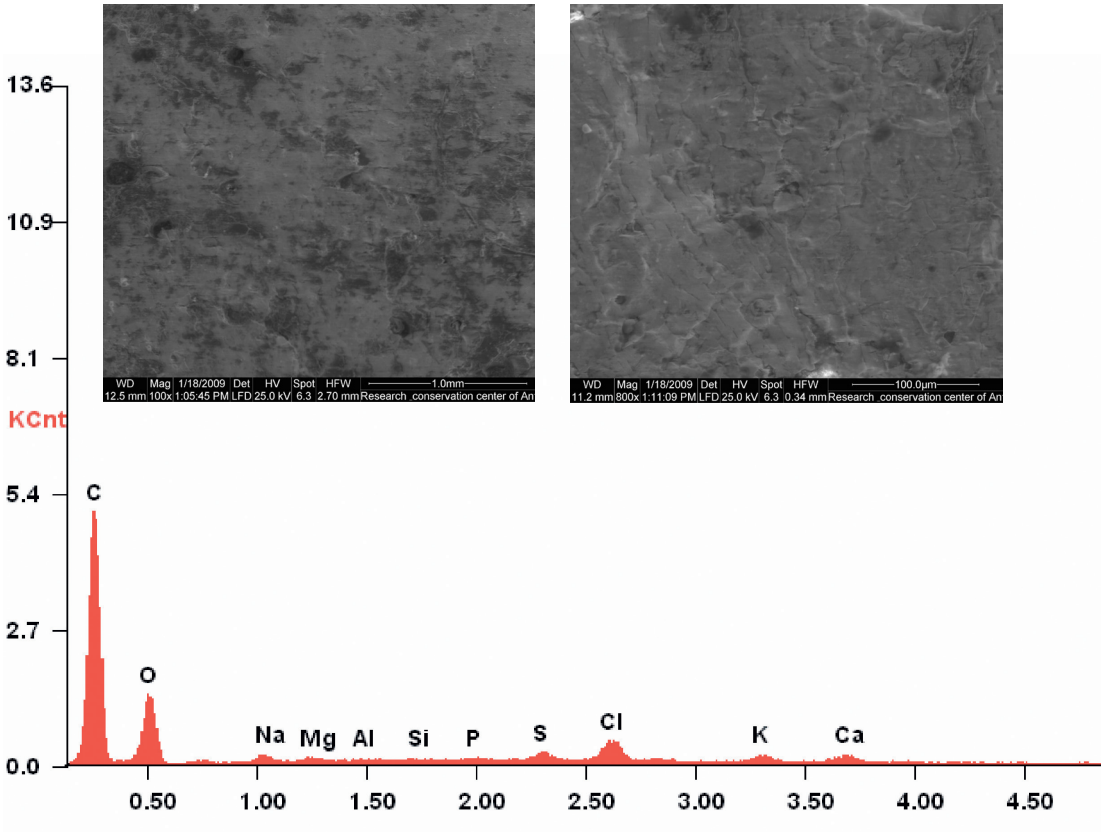
Fig. 7. SEM-EDAX spectra and micrographs of the studied golden pigment from the Sabil Alkazlar. The micrographs show the presence of blisters which can be explained due to hammering of gold leafs.

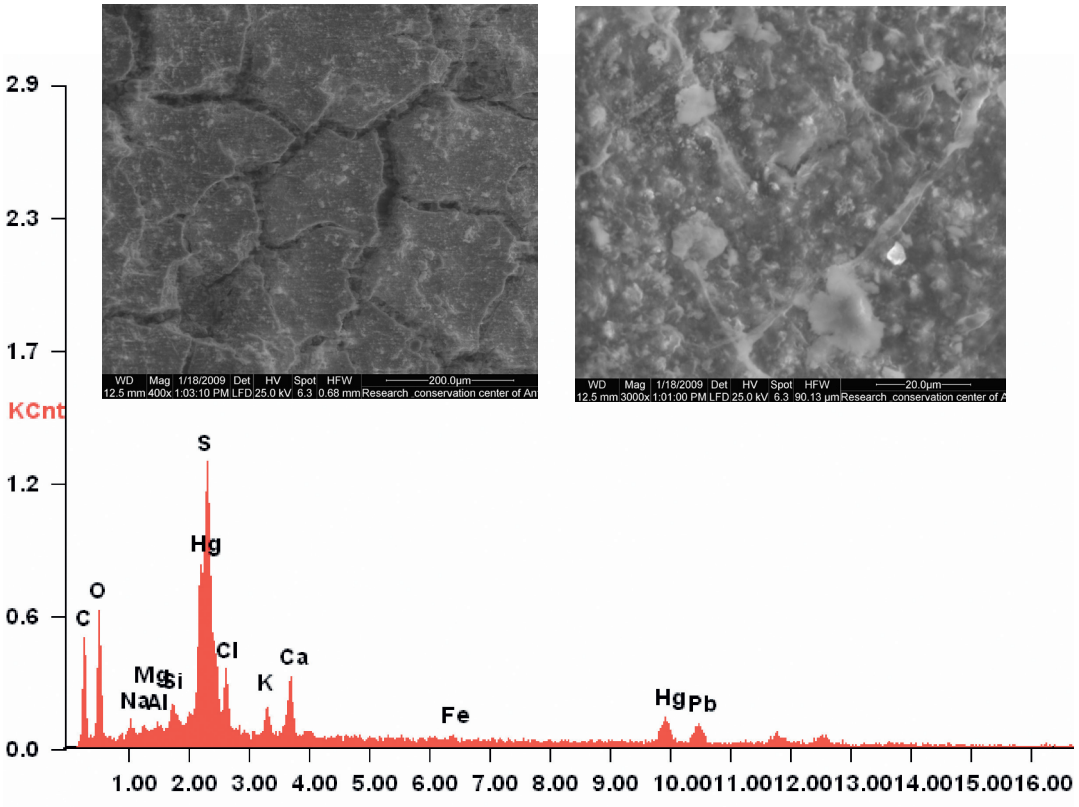
XRD analysis of the red pigment material in Sabil Alkazlar's ceiling revealed the presence of natural cinnabar (HgS). The sample also contains gypsum, anhydrite, dolomite, quartz, aluminum oxide, microcline, halite, lead sulfide, yellow ochre and hematite (fig. 8). The SEM-EDAX for the same sample detected the presence of about 30% carbon, 19% mercury, 17% oxygen, 15% lead, 6% sulfur, 3% calcium, 3% chlorine, 2% potassium, 1% sodium, 1% iron, 1% silicon, 1% magnesium and 1% aluminum (fig. 9).

16. Smectite-illite mixed layers are able to swell more than kaolinite according to the 2:1 composition. When water is absorbed, swelling starts to appear on the wall paintings surfaces in microscopic cracks and fractures. This is shown in the SEM micrographs of the red pigment (fig. 9).

Fig. 9. SEM-EDAX spectra and micrographs of the studied red pigment from the Sabil Alkazlar.
The micrographs show a net of micro cracks in the pigment surface due to clay minerals effect; these cracks are filled with salt crystals and dust.

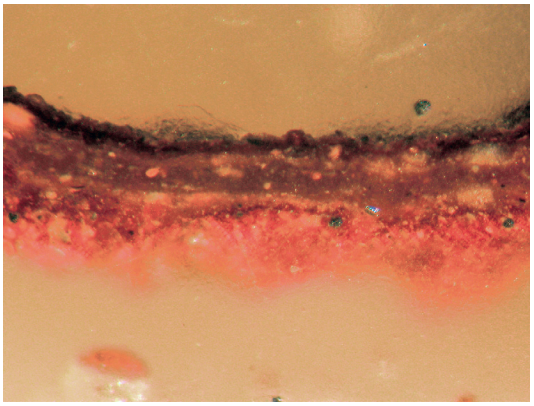
A bulk sample of the ceiling's black and red pigments was tested (fig. 14a). The black pigment was examined under a light microscope (fig. 14b). The results showed that the layered structure consists of 5 layers: the upper layer is black; the fourth and third layers are gray; the second is creamy and the lowest layer is red. XRD analysis revealed that the black pigment is bone black and the red pigment is natural cinnabar. Both pigments appeared in all layers with variable ratios. This sample confirmed that the artist used the multi-layer technique. The sample from the red pigment (fig. 14c) revealed the presence of a thin red upper layer followed by a thicker layer; the third layer is creamy in color and is thicker than the previous two layers. The final lowest layer is the thickest layer and it is the plaster layer which precedes the paint ground. It can be concluded that the painting layers of the Sabil Alkazlar's ceiling was composed of a wooden support upon which the plaster layer was composed of two layers (*gesso grosso* and *gesso sotile*), and a pigment layer carried out using the tempera technique.

**Fig. 14b.** Cross section of the black pigment in the Sabil Alkazlar (125X).
