AnIsl 46 (2013), p. 323-336

Amany Mohamed Bakr, Mona Fouad Ali, Abubakr Moussa, Amir Said

Characterization of Imitated Marble Used in Historical Buildings in Cairo – Egypt

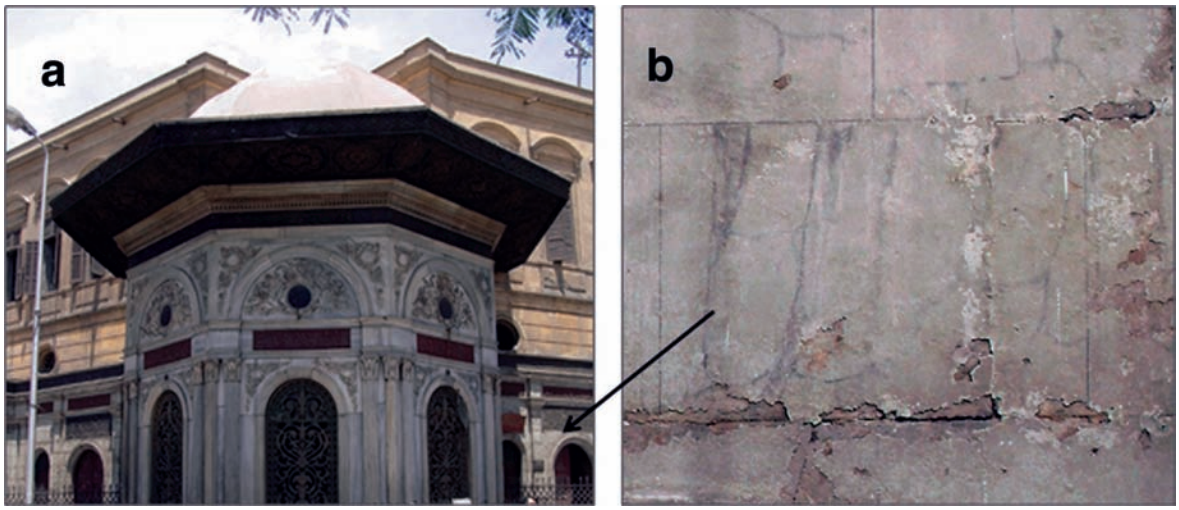
The Arabic word *sabīl* stands for public drinking fountain. This sabil was built in 1867 by Khedive ʿAbbās's mother. The left and right sides of the main octagonal façade are decorated with marble-imitating wall casing that simulate the white veined marble (fig. 1a and 1b). The imitated marble casing shows various deterioration phenomena such as exfoliation, blackening and cracks in different sizes and shapes (fig. 1b). Separation of the facing layer from the stone background is dispersed all over the wall casing. Three representative samples were collected.

Fig. 1a. The façade of *sabīl* Umm ʿAbbās.
Fig. 1b. The white veined imitated marble and its deterioration phenomena.

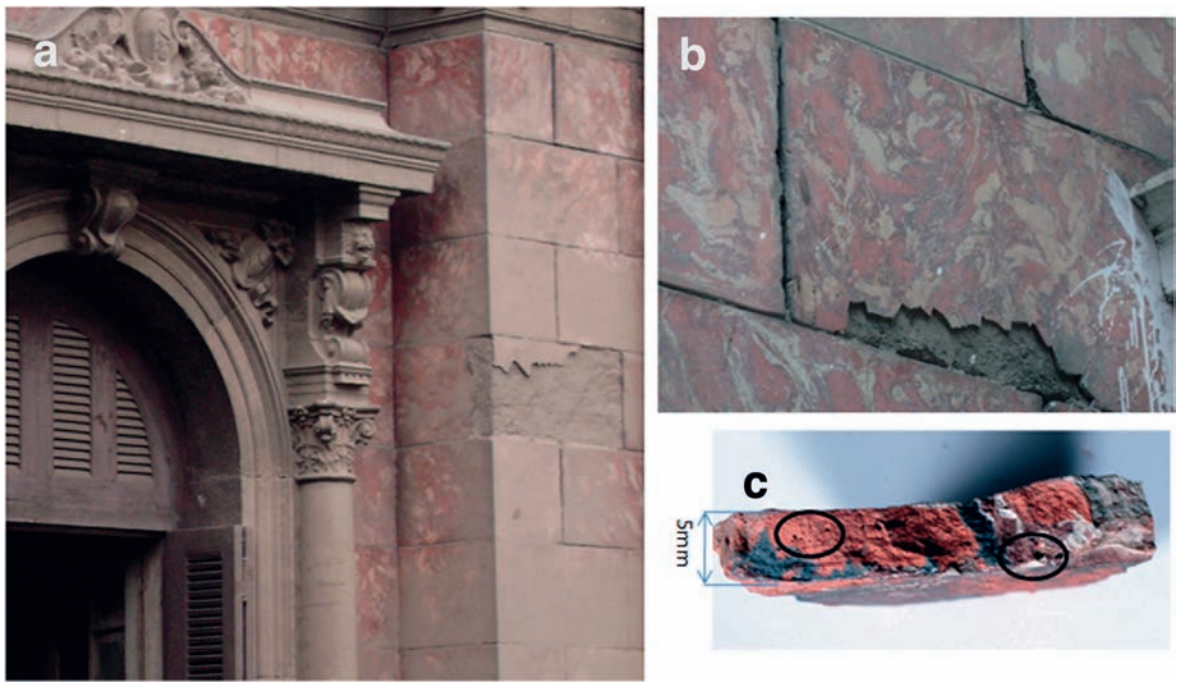
The collected samples are characterized by the strength and light weight. The surface of the imitated marble-textured layer is very dense and smooth while the back side is rough. The interference of red, black and white colors that form the veins of the tiles is seen on the surface and within the cross section of marble-textured layer. Significant amounts of spherical and irregular air voids in different sizes can be seen with naked eye within the cross section (fig. 2c).

On the bases of the mineral composition and the microscopic examination, it is suggested that a mixture of very fine powder of limestone (unstained and stained with red iron oxides), very fine sand and white cement colored with red and black iron oxides pigments was used to execute the red veined imitated marble layer of the tiles. The gypsum detected in the sample is most probably related to the white cement used. It is known that gypsum is added to the cement clinker before grinding during production in order to control the setting of the cement mortars.[16] The air voids in different shapes (spherical and irregular) and sizes usually indicate to the high content of water used in the preparation of the mixture.[17] The gel formation (colloform) texture noticed in the petrographic examination confirms the use of colloid solution (high content of water) in the execution of the red veined layer. Depending on the petrographic features and the mineral composition it can be suggested that the red veined imitated marble tiles are manufactured by the wet cast process or molding process and it most probably belongs to the decorative cement tiles elements. The cement tiles were invented during the second half of the 19th century in Europe. During this period of time the diffusion of the new hydraulic binders, such as white cement, made it possible to manufacture elements of particular hardness and durability with the aim to imitate the stone.[18] The manufacture of the veined red layer was based on the pouring of hydraulic colored mixture into a main mold that it was in the same size of the tile. The mixture composed of fine powder of limestone, very fine sand and white cement was mixed with hematite to get the red color or was mixed with magnetite to get the black color. Random patterns of swirls with black and white mixtures were poured within the red mixture to create the black and white veins. Each tile has its own pattern of white and black veins. The visual examination of the tile showed that under the veined red layer there is a base layer composed of normal gray Portland cement mortar. The shiny surface seen in some studies samples indicate that the surface of tiles were perfectly polished without using organic matter since no organic substances were identified with the FTIR analysis. The mineralogical-geochemical study of the sample reveals the presence of some mineral composition related to the degradation process. The presence of secondary gypsum veinlets is most probably the result of remobilization of the primary gypsum used in the white cement or weathering alteration of calcite that is represented the main component of the tiles. The volume changes between the mineral phases could lead to disintegration and formation of cracks, degrading the tiles.

Fig. 2a. Part of the façade of Saʿīd Ḥalīm Palace.
Fig. 2b. The disfiguration and separation of the facing layer of the veined red tiles.
Fig. 2c. The collected sample, the circles are marked the spherical and irregular air voids seen within the cross section.

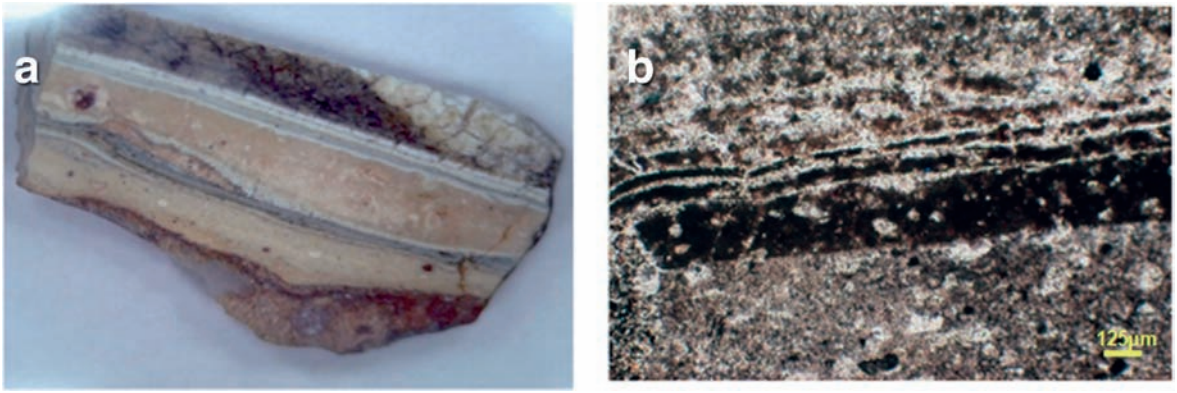
The preliminary observation of the collected samples showed the stratigraphic structure of the marble-imitating stucco. The polished cross section examination revealed the presence of three main layers (fig. 3a): inner, middle and outer layer (finishing layer). Secondary layers are seen within the middle layer of some samples.

Fig. 3a. The polished cross section of the *sabīl*'s sample.
Fig. 3b. Thin cross section image under plane polarised light × 20.

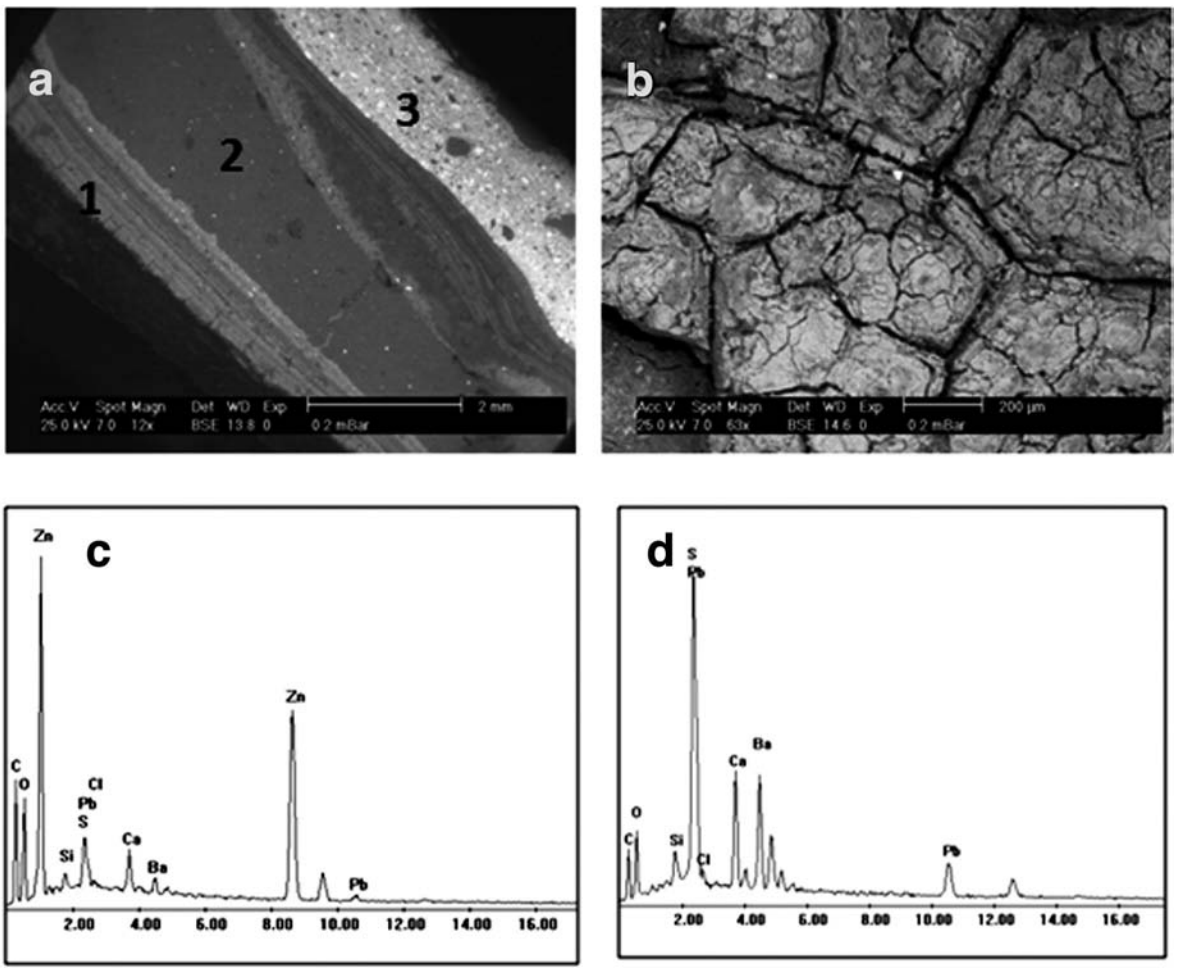
The polished cross section of the studied sample was examined by SEM-EDX. The backscattered electrons (BSE) image (fig. 4a) displayed the stratigraphic structure and the inhomogeneous elemental composition of the sample. The SEM examination of the sample representing the outer white surface layer veined with black color–showed the disintegrated cracked surface of sample (fig. 4b). The thickness of this layer ranges between 75 to 183 μm. The total EDX analysis of the samples showed that zinc (Zn), carbon (C) and lead (Pb) are the dominant elements in the white area of the surface layer (fig. 4c); their values are ranging between 15% to 20%, 14% to 16% and 5% to 15% respectively. Small amount of sulfur (S), calcium (Ca) and silicon (Si) (their values are ranging between 4% to 5%, 2% to 5% and 1% to 2% respectively) were recorded. Carbon (C) is the dominant element in the white area veined with black color sample, its value is 53%. Iron (Fe) is recorded in some area of black veins. The EDX analysis of the subsurface layer (the middle layer) (fig. 4d) showed a wide variety of the elements amounts from area to another within this layer, due to the interference between the outer, middle and inner layer. Carbon (C), lead (Pb), calcium (Ca), zinc (Zn), sulfur (S) and

barium (Ba) are the dominant elements (their highest values are 50%, 31%, 24%, 22%, 19% and 18% respectively). The inner layer which contacts directly with the limestone background wall, seen in the polished cross section (fig. 4a3), is composed mainly of calcium (Ca), sulfur (S) and carbon (C), (their values are 24%, 19% and 16%, respectively). Small amounts of Na, and Cl, were recorded all over the samples.

Fig. 4a. BSE image of the polished cross section of the *sabīl*'s sample, nos. 1, 2 and 3 point to the outer, middle and inner layers respectively of the imitated marble.
Fig. 4b. BSE image of the outer white surface layer veined with black colour.
Fig. 4c. The elemental analysis (EDX) of the outer white surface layer.
Fig. 4d. The elemental analysis (EDX) of the subsurface layer (the middle layer).

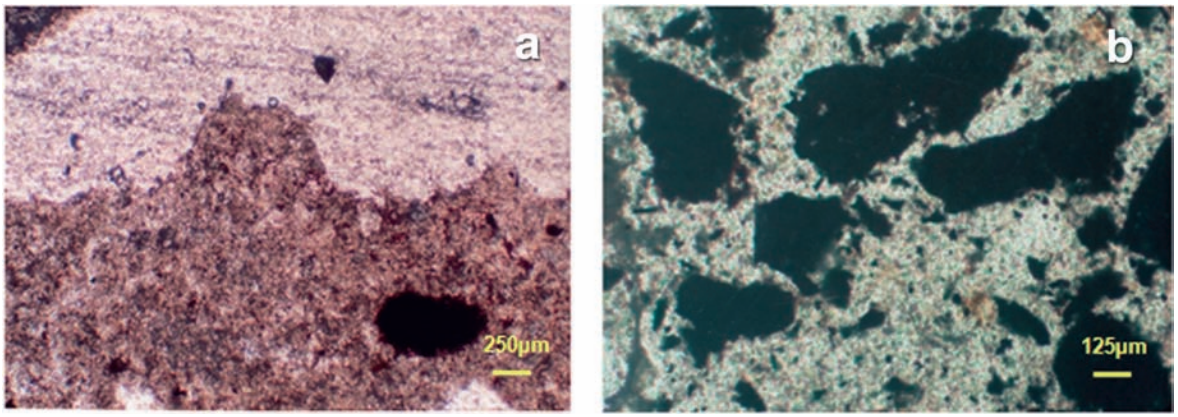
The examination of the veined red with black and white colors thin section under the polarizing light microscope displayed the gel formation (colloform) texture of very finely microcrystalline matrix composed mainly of carbonate (calcite) and silicates (fig. 5a). The matrix that represents the red area is stained with red iron oxides (hematite). Coarser crystals (100μm to 200 μm) of unstained calcite are seen in the matrix indicating that hematite was mixed with unstained powder of limestone to prepare the red mixture. Thin veinlets built of secondary gypsum are dispersed within the matrix. Spherical air voids (ranging from 50μm to 200μm) are also seen in the matrix. The contact area between the red, white and black color are characterized by wide zigzag form. The presence of these textures indicates that colloid solution was used in the execution of the veined red imitated marble-texture layer. The gradational texture of the dark red and light red observed in the veined red thin section is most probably the effect of the gradually addition of the various hues of red colloid solution. Dark opaque angular grains of magnetite (ranging from 50μm to 300μm) are dispersed within gray matrix that represents the black veins in the veined red tile (fig. 5b).

Fig. 5a. The thin cross section image of the veined red sample of Saʿīd Ḥalīm Palace under plane polarised light × 10.
Fig. 5b. The thin cross section image of the black veins in the veined red tile under plane polarised light × 20.

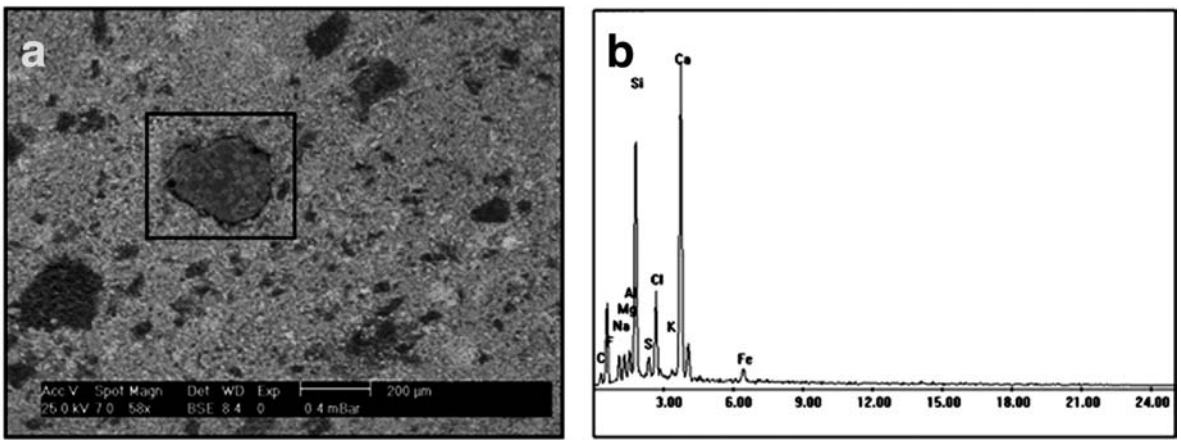
The polished cross-section of the veined red samples was examined by SEM-EDX to distinguish between the elemental compositions of different hues of colors. The back-scattered electrons (BSE) images shows fine-grain matrix with numerous coarse grains of iron oxides. Rounded dark-grey grains, composed mainly of Ca, Si, C and O, represent probably calcium silicate hydrate phase, are seen within the lighter area composed mainly of Ca, C and O that represents carbonate phase (fig. 6a, b). The results of microanalysis in different areas of the studied sample indicated that carbon (C), calcium (Ca), iron (Fe) and silicon (Si) are the dominant elements in the samples. Their values are ranging between 10% to 80%, 2% to 54%, 2% to 59% and 2% to 9% respectively. Their ratios varied significantly between different areas of the samples depending on the interference of various hues of colors (red, black and white). Small amounts of, sulphur (S), aluminum (Al) and magnesium (Mg) were recorded throughout the samples (their values are ranging between 0.5% to 4%, 1% to 5% and 0.5% to 2% respectively. Small amount of chlorine (Cl) and sodium (Na) were also recorded.

Fig. 6a. BSE image of veined red sample, the square illustrates the grain represented calcium silicate hydrate phase.
Fig. 6b. Elemental analysis (EDX) of the marked area in the (a) photo.

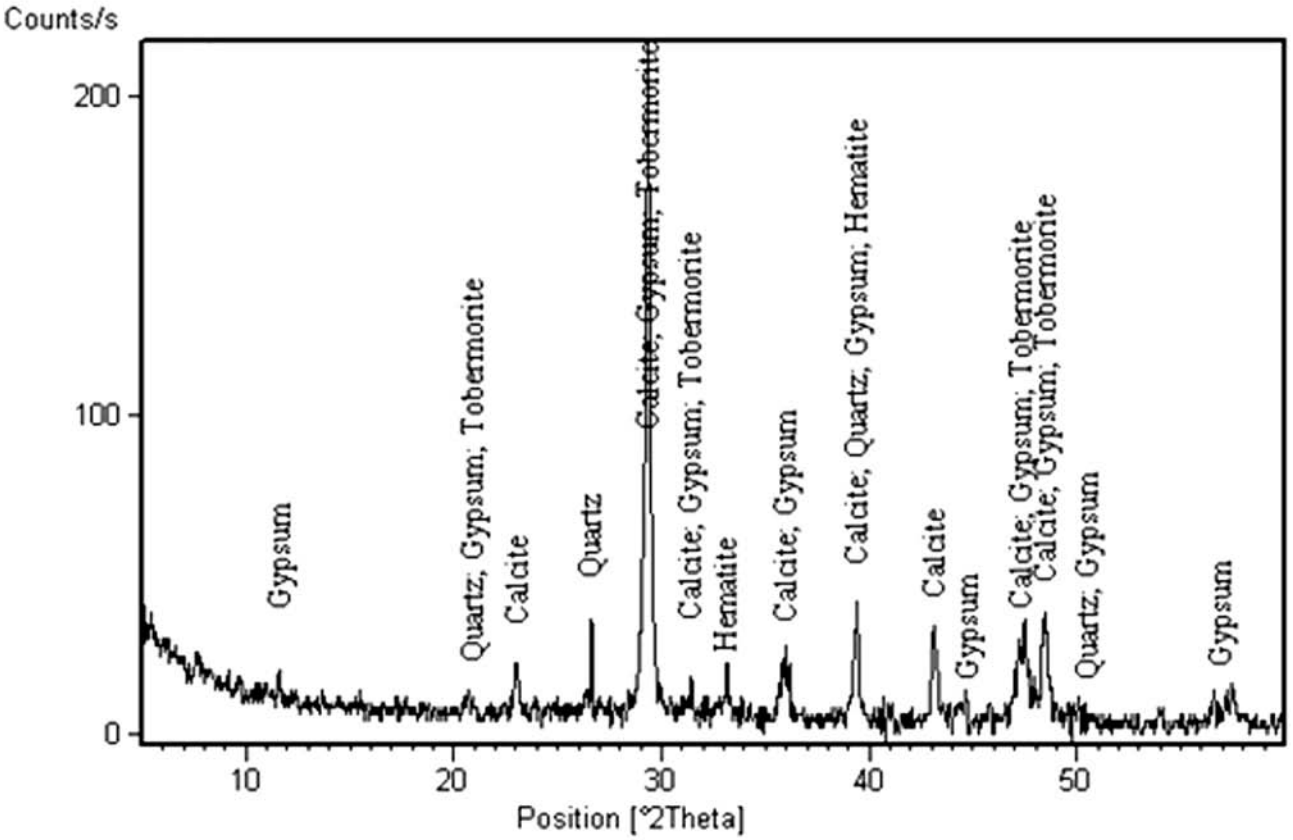
The X-ray powder diffraction pattern (fig. 7) of the studied sample shows the presence of the following mineral phases: calcite ($CaCO_3$), as a prevalent mineral, quartz (SiO_2),

Hematite (Fe_2O_3), gypsum ($CaSO_4.2H_2O$) and Tobermorite [Calcium Silicate Hydrate ($4CaO.5SiO_2.5H_2O$)]. Tobermorite is one of the hydraulic mineral phases that are usually identified in Portland cement.[14, 15] The FTIR analysis of the studied samples showed the absence of any organic matter. Only the functional groups of carbonates, related to calcite, and silicate, most probably related to Tobermorite, were detected.

Fig. 7. The XRD pattern of the veined red sample of Saʿīd Ḥalīm palace.
