Mamluk Minarets in Modern Egypt. Tracing Restoration Decisions and Interventions

# Mamluk Minarets in Modern Egypt

## Tracing Restoration Decisions and Interventions

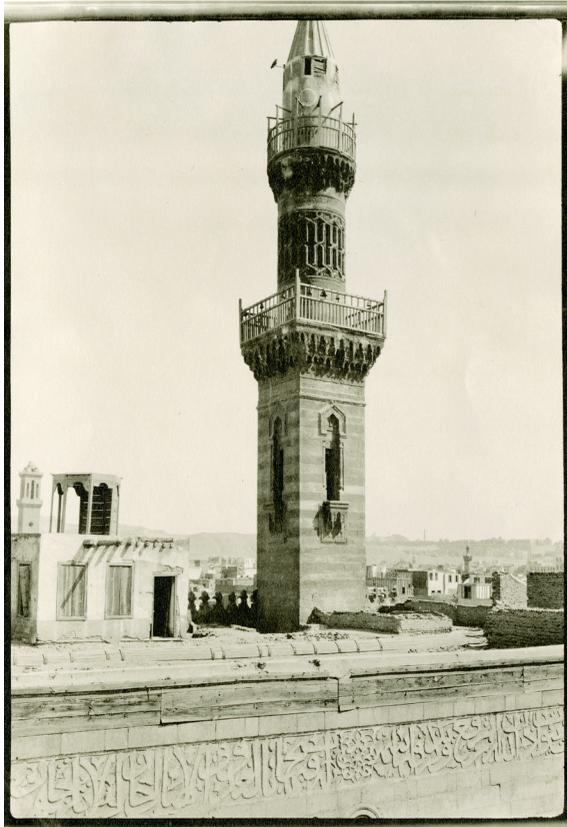
Fig. 3. K.A.C. Creswell, with manuscript mention at the back of the print: *Mosque of Barsbâi: minaret, from coping of ṣahn*, before 1944. Creswell Photographic Collection, The American University in Cairo, Album 24. Courtesy of the RBSCL.

During the Ottoman period, some damaged upper pavilions of Mamluk minarets were reconstructed in Ottoman style with the pencil-like cap (fig. 3 & fig. 4). These additions were sometimes removed by the *Comité* and restored back to Mamluk style (fig. 5). From a political perspective, Sanders, when discussing this type of restoration work by the *Comité*, argues broadly that: “One of the most urgent tasks of the *Comité* was to identify and restore these dozens of monuments to proper dynastic style”<sup>19</sup> arguing that the “*Comité* was decidedly anti-Ottoman”.<sup>20</sup>

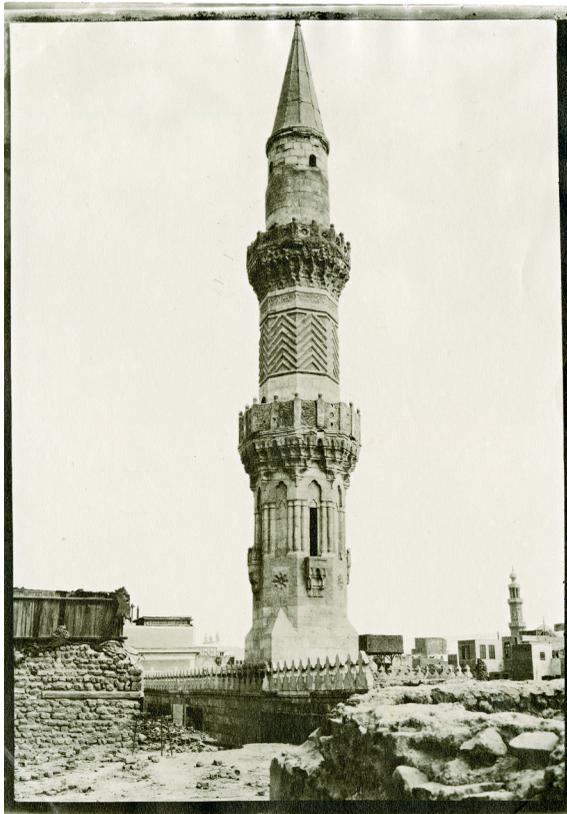
Fig. 4. K.A.C. Creswell, [Minaret of Qāḍi ‘Abd al-Bāsiṭ mosque], with manuscript mention at the back of the print: *Mosque of ‘Abd el-Basset: N. façade*, prior to 1936–1940. Creswell Photographic Collection, The American University in Cairo, Album 24. Courtesy of RBSCL.

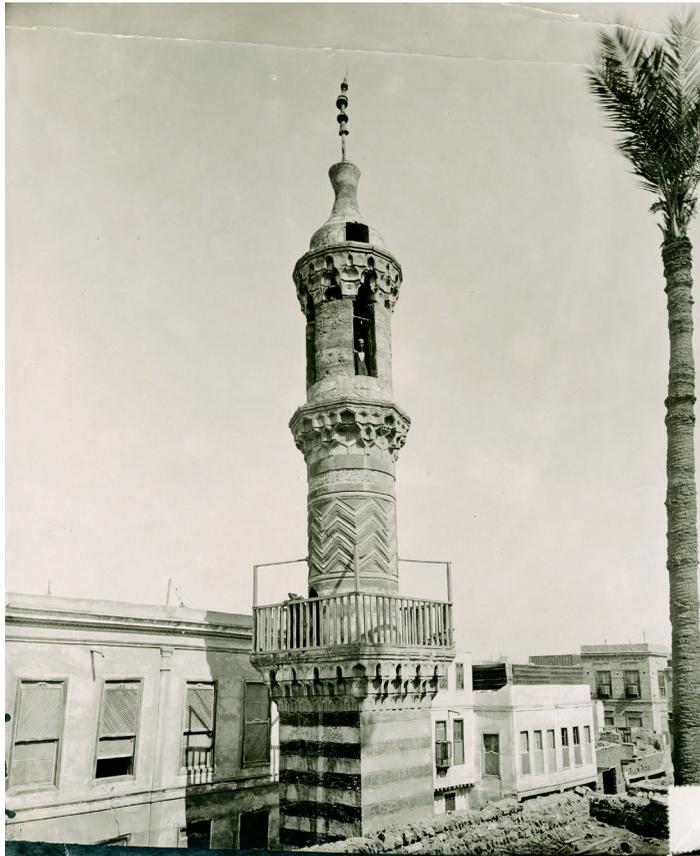
Fig. 9. Probably Giuntini, [Minaret of Qānībāy al-Šarkasī mosque], with manuscript mention at the back of the print: *Kānbāi el-Djarkassi (mosquée de): minaret, vue d'ensemble*, 1901. Silver print. Creswell Photographic Collection, The American University in Cairo, Album 24. Courtesy of RBSCL.

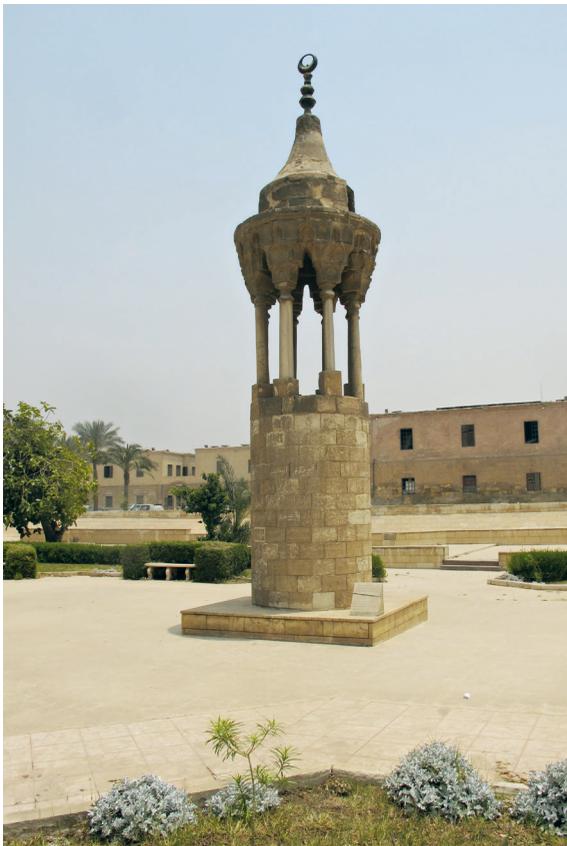
Fig. 10. [Upper part of the Minaret of Qānībāy al-Šarkasī mosque, now at the Cairo citadel], 2015. Digital photograph. © Dina Bakhoun.

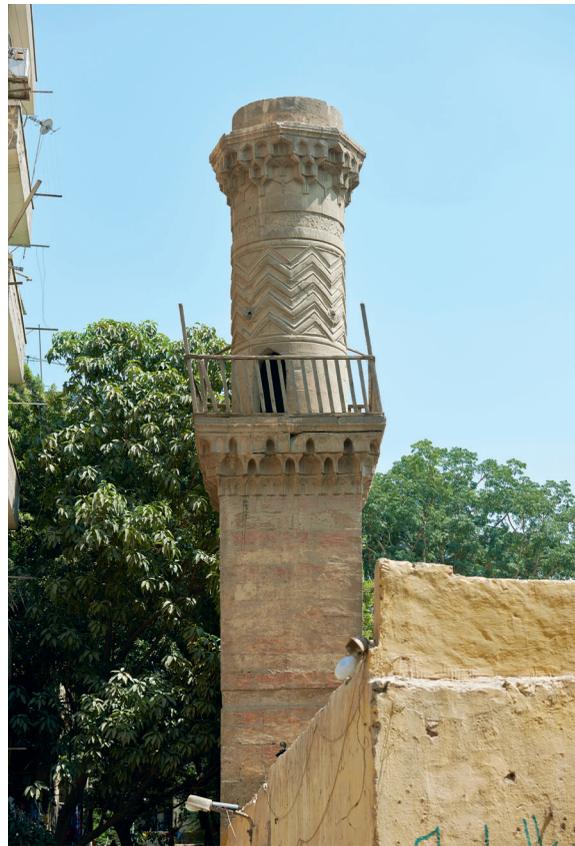
Fig. 11. [Minaret of Qānībāy al-Šarkasī mosque], 2015. Digital photograph. © Matjaž Kačičnik.

The *Comité* decided to delay the minaret's reconstruction while requesting that the Ministry of *Awqāf* take measures to connect the ablution area to the public sewer.<sup>108</sup> The upper part of the minaret of Qānībāy al-Šarkasī was eventually moved from the courtyard of al-Ḥākīm mosque to its present location behind the offices containing the *Comité's* photographic and architectural archives at the Citadel in Cairo (fig. 10). It is labelled with its name and a 15th century date, however its story since its dismantling from the mosque of Qānībāy al-Šarkasī in 1901 remains untold. Today, the mosque still stands with an incomplete minaret (fig. 11).

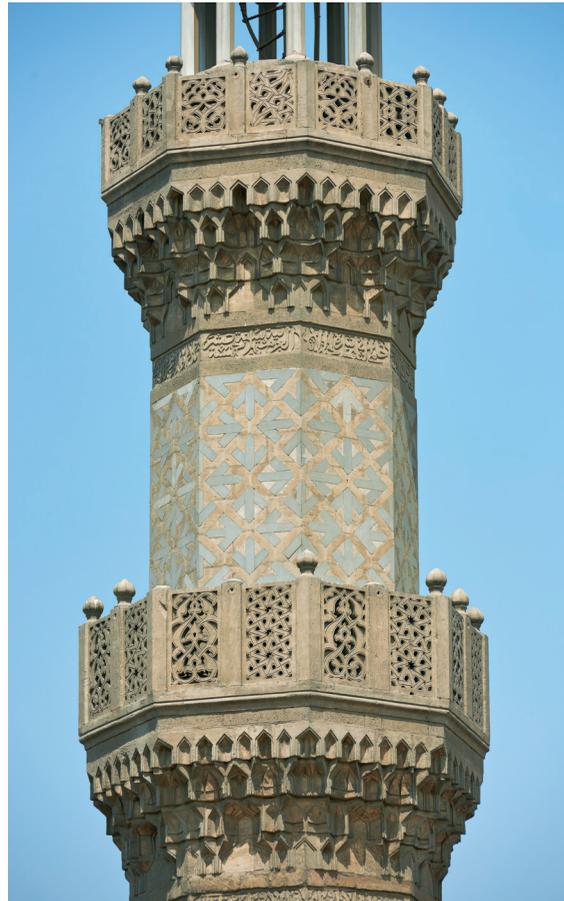
Fig. 12. [Upper part of the Minaret of Qāḍī Yaḥyā Zayn al-Dīn mosque, showing the *Comité*'s inscription], 2015. Digital photograph. © Matjaž Kačičnik.

Today, the complete minaret might appear to the regular viewer as a 15th century Mamluk minaret; however, an inscription band running along the top of the new second storey carries valuable information. The inscription states that the restoration of the second shaft and what is above it was carried out during the reign of ‘Abbās Ḥilmī II under the supervision of the *Comité* in 1315 AH—hence—AD 1897–1898 (fig. 12).

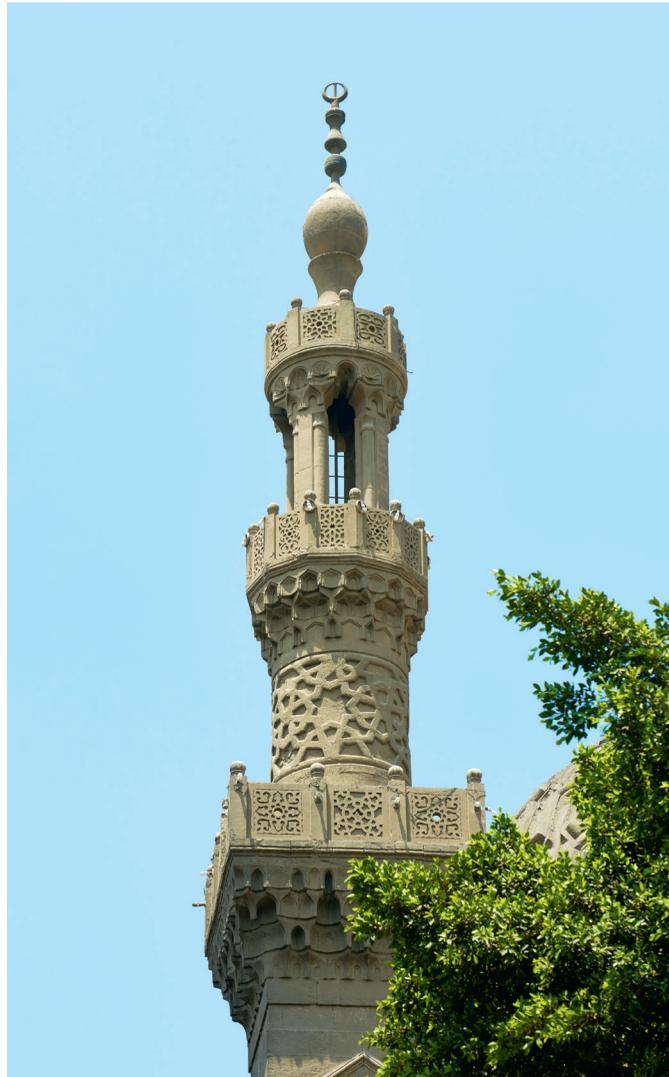
Fig. 15. Minaret of Tağrī Birdī mosque, 2015. Digital photograph.  
© Matjaž Kačičnik.

It must be noted, however, that the design didn't follow the eight marble columns, but instead used stone piers with attached columns (fig. 15).
