Dina Ishak Bakhoum

Mamluk Minarets in Modern Egypt. Tracing Restoration Decisions and Interventions

Mamluk Minarets in Modern Egypt

Tracing Restoration Decisions and Interventions

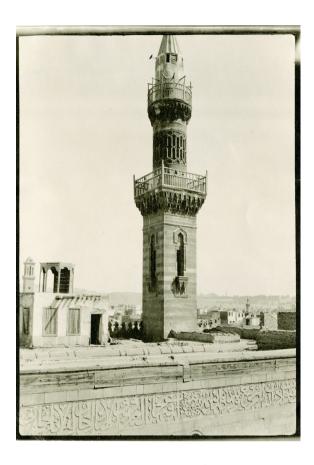
Fig. 3. K.A.C. Creswell, with manuscript mention at the back of the print: Mosque of Barsbäï: minaret, from coping of şahn, before 1944. Creswell Photographic Collection, The American University in Cairo, Album 24. Courtesy of the RBSCL.

During the Ottoman period, some damaged upper pavilions of Mamluk minarets were reconstructed in Ottoman style with the pencil-like cap (fig. 3 & fig. 4). These additions were sometimes removed by the *Comité* and restored back to Mamluk style (fig. 5). From a political perspective, Sanders, when discussing this type of restoration work by the *Comité*, argues broadly that: "One of the most urgent tasks of the *Comité* was to identify and restore these dozens of monuments to proper dynastic style" arguing that the "Comité was decidedly anti-Ottoman". ²⁰

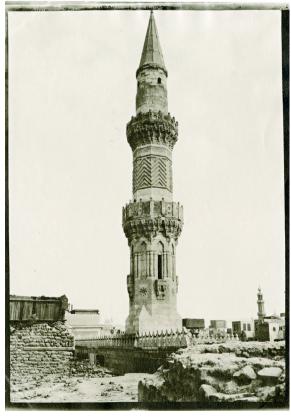
Fig. 4. K.A.C. Creswell, [Minaret of Qāḍī 'Abd al-Bāsiṭ mosque], with manuscript mention at the back of the print: Mosque of 'Abd el-Basset: N. façade, prior to 1936—1940. Creswell Photographic Collection, The American University in Cairo, Album 24. Courtesy of RBSCL.

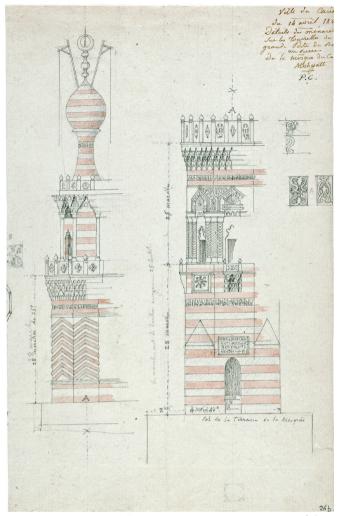
Fig. 6. Pascal Coste, Ville du Caire, [dessin?] du 14 avril 182[2], Détails des minarets sur les tourrelles [sic] de [la] grande porte du [magasin?] au sucre de la mosquée [sic] du Ca[life] Mohyatt. Drawing, Bibliothèque de l'Alcazar, Marseille, Album MS 1310, Folio no. 26b. Courtesy of BMVR.

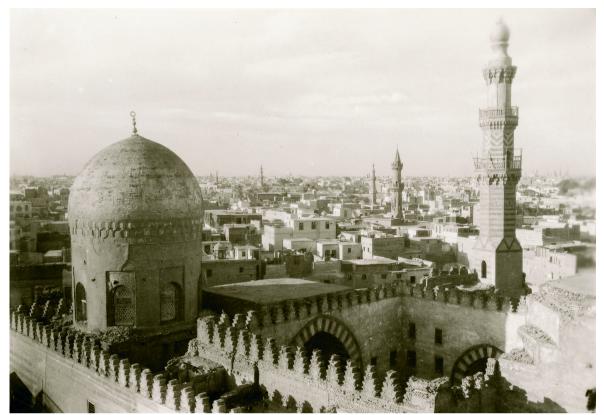
Fig. 8. Unknown photographer, [Mosque and minaret of the mosque of Ṣarġatmiš], post 1894 and before 1935. Silver print, Creswell Photographic Collection, The American University in Cairo. Album 22. Courtesy of RBSCL.

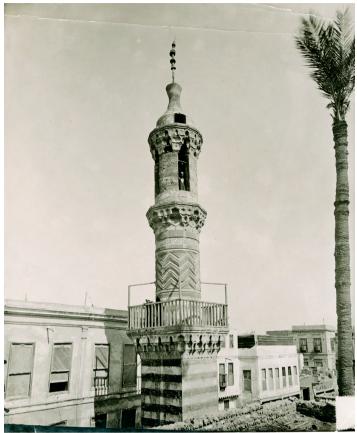
Fig. 9. Probably Giuntini, [Minaret of Qānībāy al-Šarkasī mosque], with manuscript mention at the back of the print: Kânbâï el-Djarkassi (mosquée de): minaret, vue d'ensemble, 1901. Silver print. Creswell Photographic Collection, The American University in Cairo, Album 24. Courtesy of RBSCL.

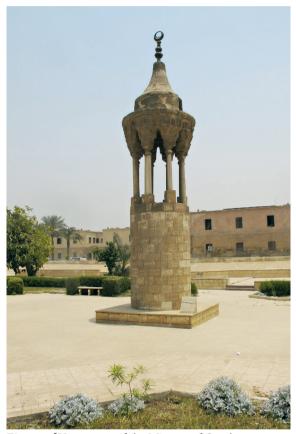
Fig. 10. [Upper part of the Minaret of Qānībāy al-Šarkasī mosque, now at the Cairo citadel], 2015. Digital photograph.
© Dina Bakhoum.

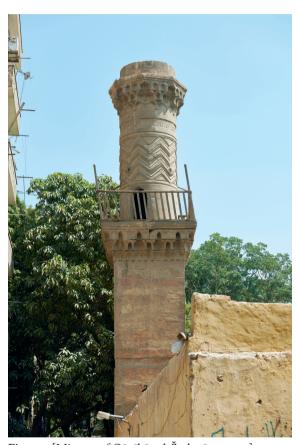
Fig. 11. [Minaret of Qānībāy al-Šarkasī mosque], 2015. Digital photograph. © Matjaž Kačičnik.

The Comité decided to delay the minaret's reconstruction while requesting that the Ministry of Awqāf take measures to connect the ablution area to the public sewer. ¹⁰⁸ The upper part of the minaret of Qānībāy al-Šarkasī was eventually moved from the courtyard of al-Ḥākim mosque to its present location behind the offices containing the Comité's photographic and architectural archives at the Citadel in Cairo (fig. 10). It is labelled with its name and a 15th century date, however its story since its dismantling from the mosque of Qānībāy al-Šarkasī in 1901 remains untold. Today, the mosque still stands with an incomplete minaret (fig. 11).

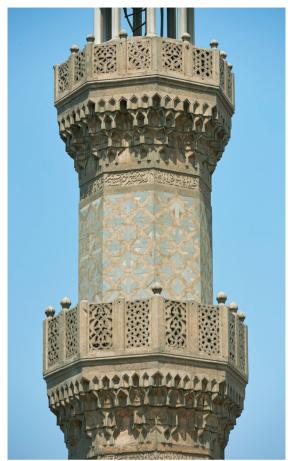
Fig. 12. [Upper part of the Minaret of Qāḍī Yaḥyā Zayn al-Dīn mosque, showing the *Comité*'s inscription], 2015. Digital photograph.

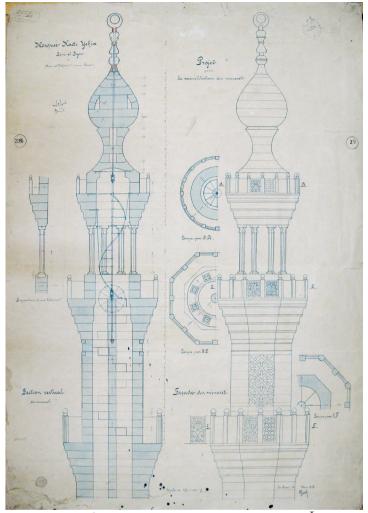
Fig. 14. Steyrer, [Reconstruction drawing of the Minaret of Ğānim al-Bahlawān mosque], Cairo, 1903. Markaz tasǧīl al-āṭār al-islāmiyya wa-l-qibṭiyya, Archives of the Supreme Council of Antiquities. Courtesy of the Ministry of Antiquities.

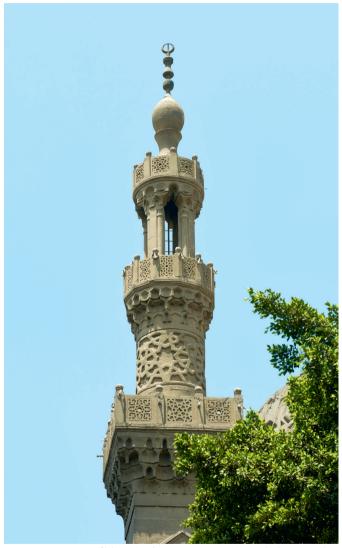
Fig. 15. Minaret of Taġrī Birdī mosque, 2015. Digital photograph. © Matjaž Kačičnik.

It must be noted, however, that the design didn't follow the eight marble columns, but instead used stone piers with attached columns (fig. 15).
