Mamluk Minarets in Modern Egypt. Tracing Restoration Decisions and Interventions

# Mamluk Minarets in Modern Egypt

## Tracing Restoration Decisions and Interventions

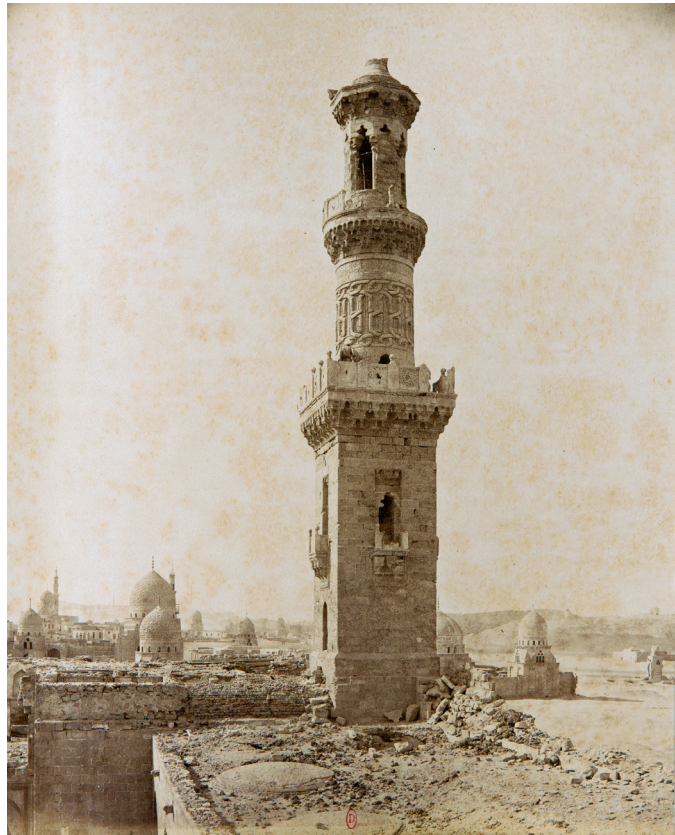
Fig. 1. Facchinelli, *Panorama preso dalle Torri di Sultan Barquq (Cairo)*, 1887, Silver print. From *Raccolta Artistica Di Fotografie Sull'Architettura Araba, Ornati Ecc. Dal XII° al XVIII° Secolo Fotografia Italiana Del Cav. B. Facchinelli*, 1887, Library of INHA, Fol Phot 065, f° 40. Courtesy of BINHA.

From a structural perspective, minarets are not only a challenge to construct, but their restoration must have been a costly and difficult task for the *Comité*, especially as many of them suffered after a number of earthquakes that will be discussed below (fig. 1 & fig. 2).

Minarets that appear in images of the late 19th century in quite a ruined state (fig. 1 & fig. 2) were endangered not only as a result of neglect and lack of maintenance, but also due to a number of recorded earthquakes.

northern one. The photographs show the ruined minaret with its bulb missing, as observed in other photographs, but here we can observe in more detail the condition of the minaret and what parts of the stone balustrades of the balconies are damaged, and in other parts what is completely missing (fig. 1). The last shaft composed of marble columns is intact and clearly supported with masonry between the columns, as represented earlier by Prisse d'Avennes.

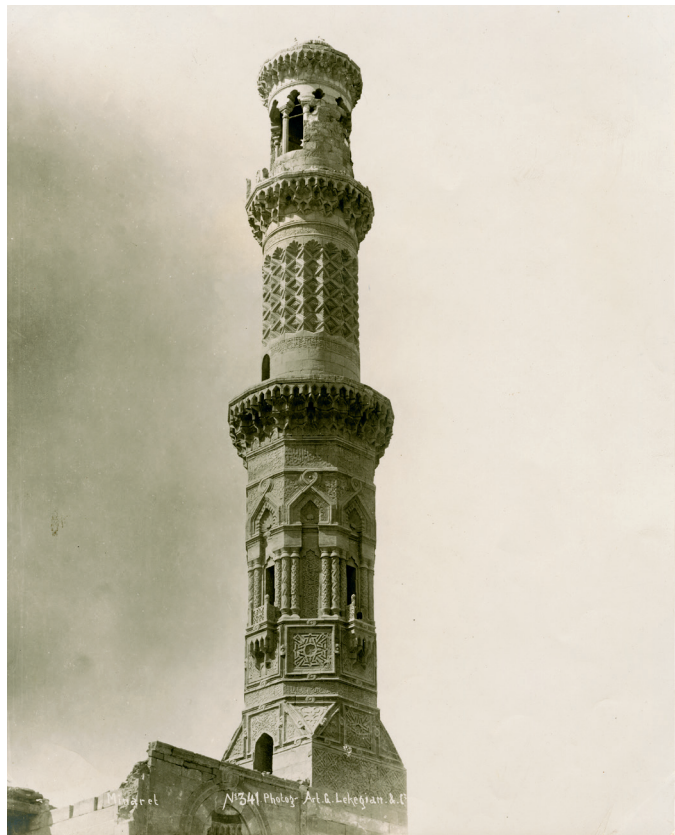
Fig. 2. G. Lekegian & C°, *Minaret [of the mosque of Qurqumās]*, ca.1880. Silver print, Creswell Photographic Collection, The American University in Cairo, Album 27. Courtesy of the RBSCL.

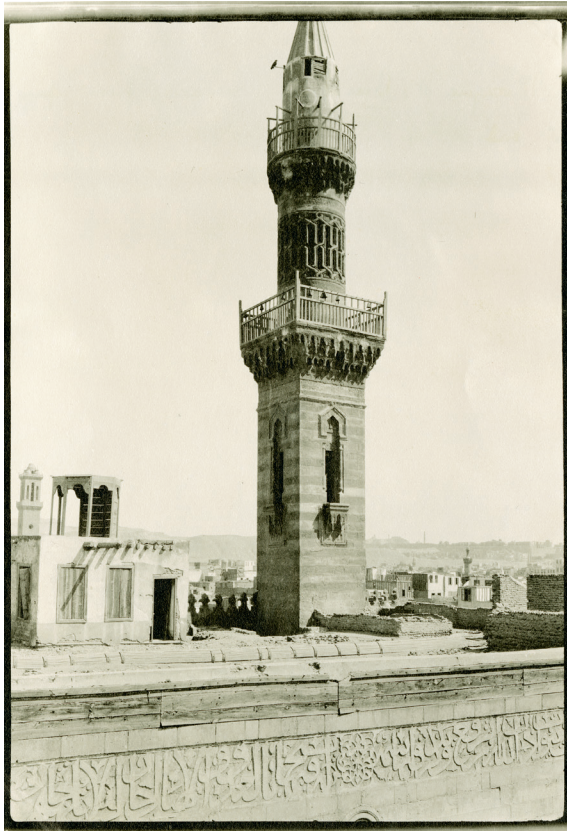
Fig. 3. K.A.C. Creswell, with manuscript mention at the back of the print: *Mosque of Barsbâi: minaret, from coping of şahn*, before 1944. Creswell Photographic Collection, The American University in Cairo, Album 24. Courtesy of the RBSCL.

During the Ottoman period, some damaged upper pavilions of Mamluk minarets were reconstructed in Ottoman style with the pencil-like cap (fig. 3 & fig. 4). These additions were sometimes removed by the *Comité* and restored back to Mamluk style (fig. 5). From a political perspective, Sanders, when discussing this type of restoration work by the *Comité*, argues broadly that: “One of the most urgent tasks of the *Comité* was to identify and restore these dozens of monuments to proper dynastic style”<sup>19</sup> arguing that the “*Comité* was decidedly anti-Ottoman”.<sup>20</sup>

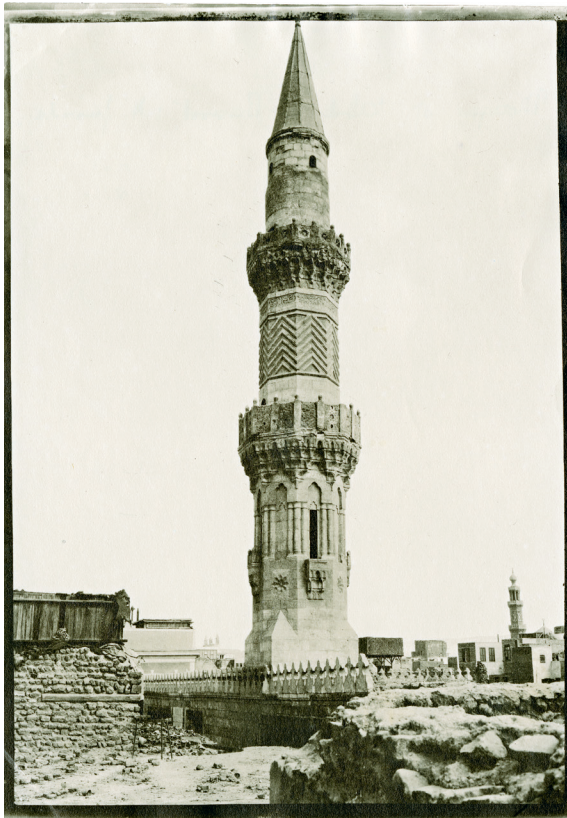
Fig. 4. K.A.C. Creswell, [Minaret of Qāḍī ‘Abd al-Bāsiṭ mosque], with manuscript mention at the back of the print: *Mosque of ‘Abd el-Basset: N. façade*, prior to 1936–1940. Creswell Photographic Collection, The American University in Cairo, Album 24. Courtesy of RBSCL.

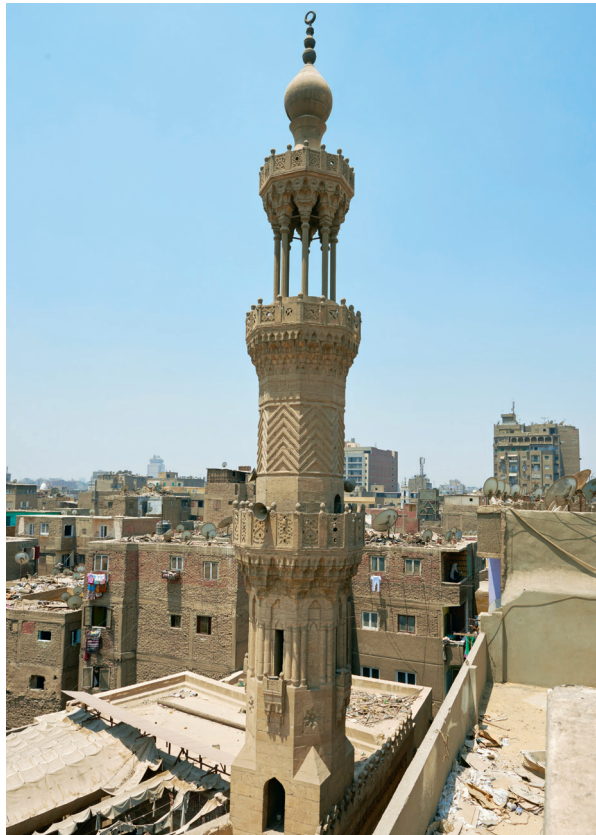
Fig. 5. [Minaret of Qāḍī 'Abd al-Bāsiṭ mosque], 2015.  
Digital photograph. © Matjaž Kačičnik.

Two photographs of the minaret belonging to the mosque of Qāḍī ‘Abd al-Bāsiṭ (823/1420) were published in the *Comité* Bulletin of 1936–1940 showing its state before and after restoration.<sup>137</sup> Before restoration, the minaret had three shafts: the first and the second are octagonal and Mamluk, while the third is cylindrical and covered with the Ottoman conical pencil-like cap in wood (fig. 4). After restoration the minaret’s third shaft appears in Mamluk style with marble columns, *muqarnaş* decoration and the onion-shaped bulb (fig. 5).

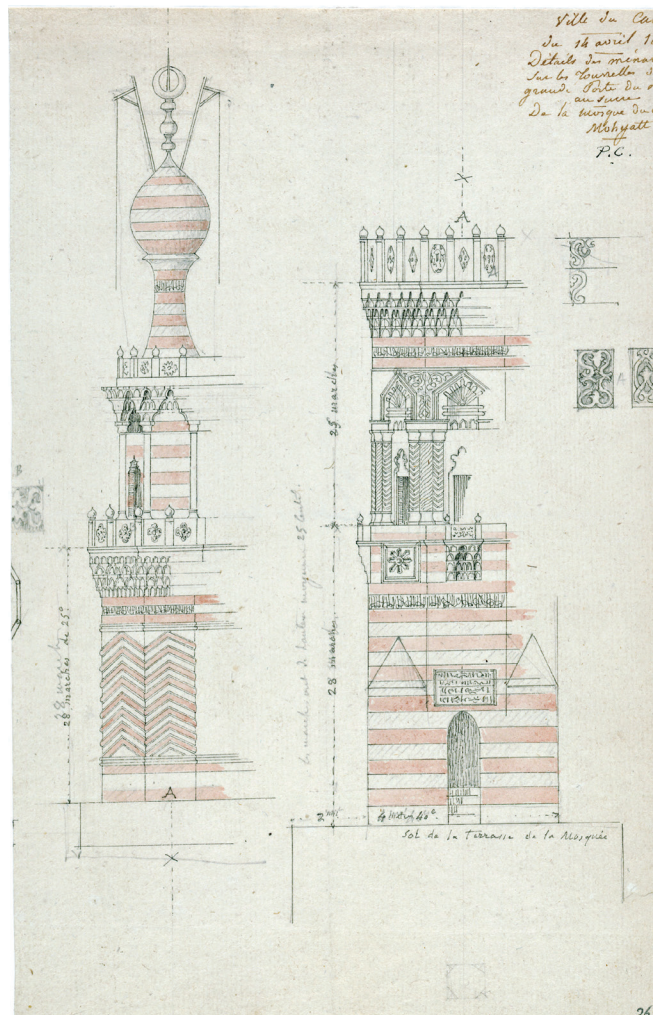
Fig. 6. Pascal Coste, *Ville du Caire*, [dessin ?] du 14 avril 182[2], *Détails des minarets sur les tourelles [sic] de [la] grande porte du [magasin ?] au sucre de la mosquée [sic] du Ca[ife] Mohyatt*. Drawing, Bibliothèque de l'Alcazar, Marseille, Album MS 1310, Folio no. 26b. Courtesy of BMVR.

In some cases, the marble columns and masonry in-between could be clearly seen, such as in representations and photographs of the minarets of al-Mu'ayyad mosque (fig. 6).

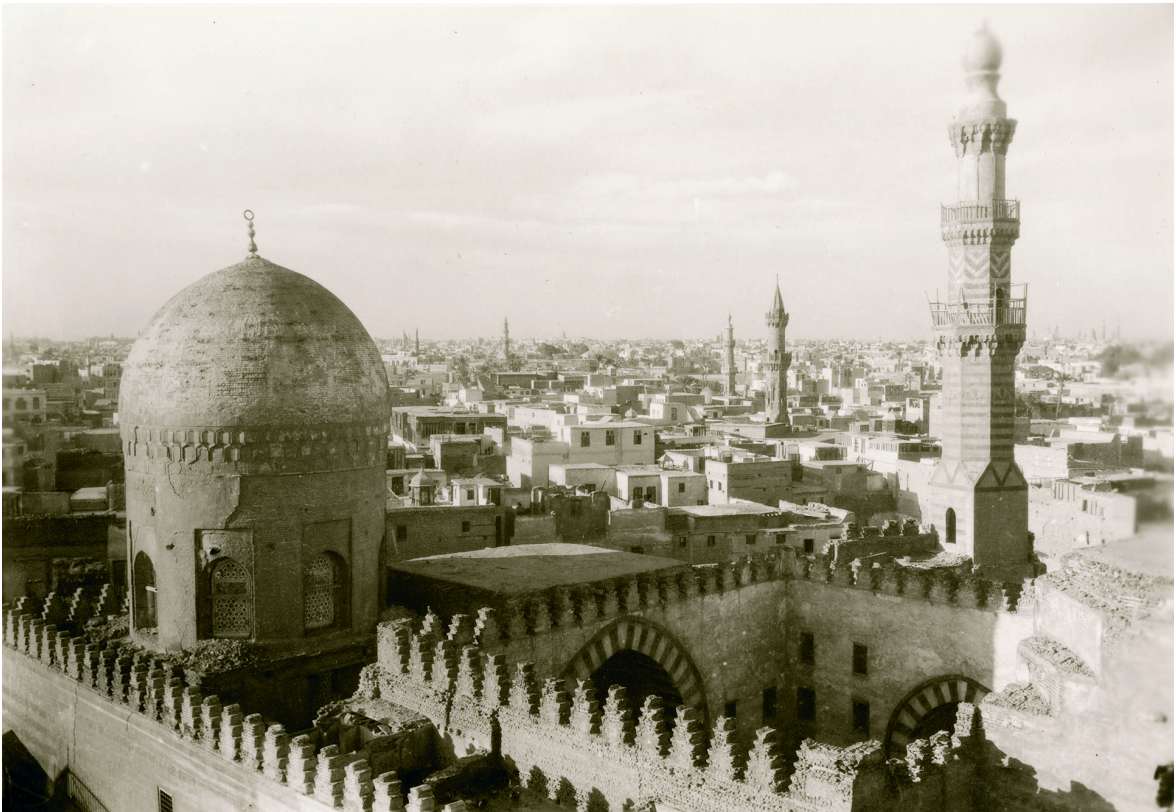
Fig. 8. Unknown photographer, [Mosque and minaret of the mosque of Şarġatmiş], post 1894 and before 1935. Silver print, Creswell Photographic Collection, The American University in Cairo. Album 22. Courtesy of RBSCCL.

What is clear from the careful investigation of photographic evidence is that a variety of interventions on minarets were carried out prior to the establishment of the *Comité*, but cannot always be accurately dated. The *Comité* acknowledged that some of these interventions were structurally useful, even if the work was not aesthetically and artistically pleasing. In one instance dating to 1894, when the *Comité* couldn't find a contractor to carry out the dismantling and reconstruction work on the minaret of Şarġatmiş (757/1356), a masonry wrapping for the upper pavilion was proposed as a consolidation measure and was executed (fig. 8).<sup>54</sup>

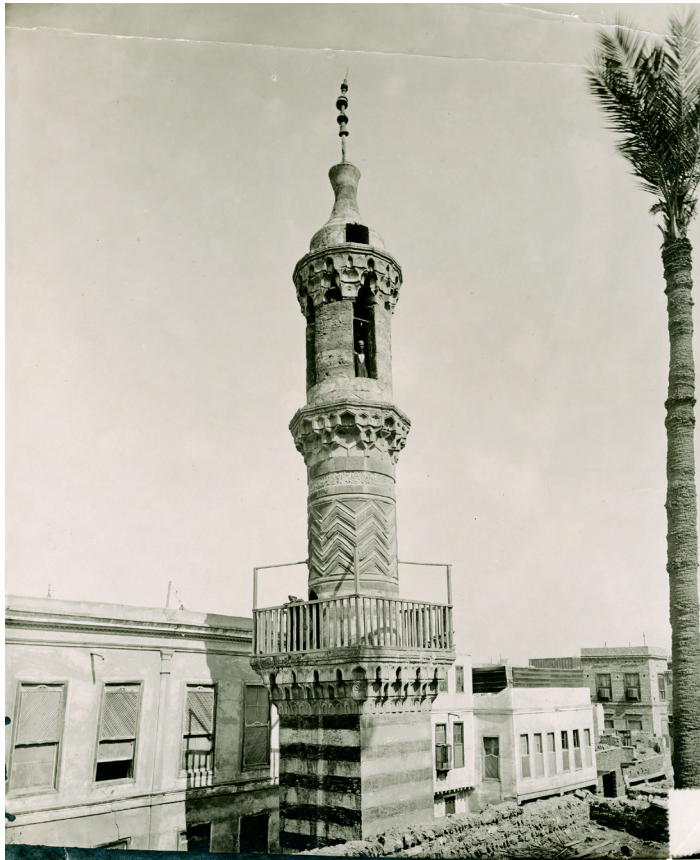
Fig. 9. Probably Giuntini, [Minaret of Qānībāy al-Šarkasī mosque], with manuscript mention at the back of the print: *Kānbāi el-Djarkassi (mosquée de): minaret, vue d'ensemble*, 1901. Silver print. Creswell Photographic Collection, The American University in Cairo, Album 24. Courtesy of RBSCL.

94. In BC 18, 1901, "8° Paiements", pp. 48–49, Giuntini's payment for his photographs of the minaret of Qānībāy al-Šarkasī is mentioned. The two photographs of the pre-demolition condition were not published by the *Comité* but were found in Creswell's archive at the American University in Cairo, although with no reference to the author of the photograph.

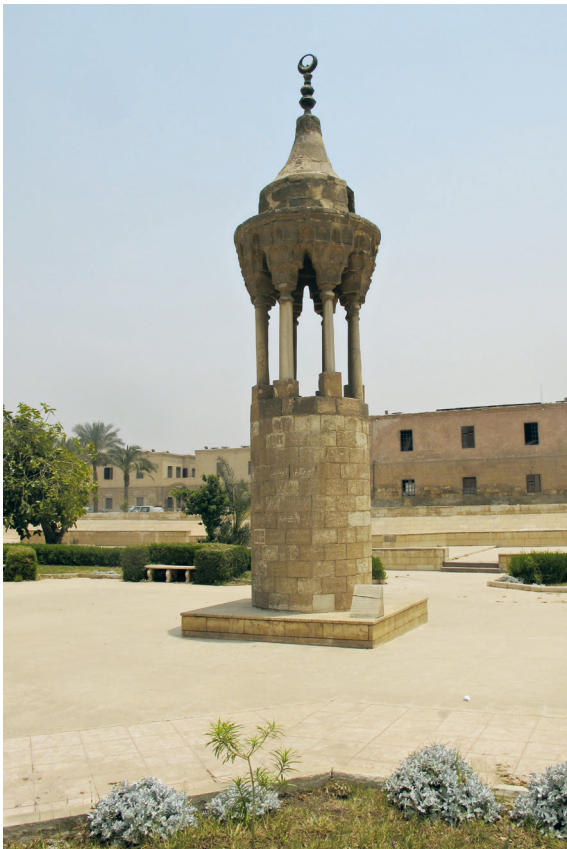
Fig. 10. [Upper part of the Minaret of Qānībāy al-Šarkasī mosque, now at the Cairo citadel], 2015. Digital photograph. © Dina Bakhoum.

Neither the archives nor the *Comité's* Bulletins contain further discussion of the minaret of Qānībāy al-Šarkasī, until 1941, when *Comité* members visited the mosque of al-Ḥākīm, and noticed the pieces of its upper part in the courtyard. It must be noted here that since 1936, the *Comité* was no longer under the supervision of *Awqāf*, but of the Ministry of Public Instruction.<sup>104</sup> Muḥammad Riyāḍ Pasha, then president of the *Comité* suggested that it be transported and remounted in its original place and that the project be studied and details be submitted to the *Comité* for consideration.<sup>105</sup> The *Comité's* engineer duly prepared a report on the minaret's condition noting the following:<sup>106</sup>

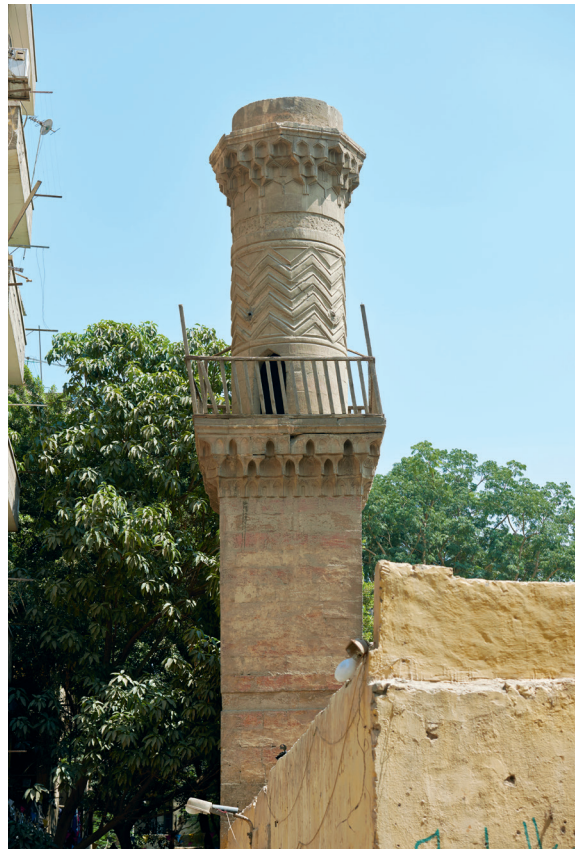
Fig. 11. [Minaret of Qānībāy al-Šarkasī mosque], 2015. Digital photograph. © Matjaž Kačičnik.

The *Comité* decided to delay the minaret's reconstruction while requesting that the Ministry of *Awqāf* take measures to connect the ablution area to the public sewer.<sup>108</sup> The upper part of the minaret of Qānībāy al-Šarkasī was eventually moved from the courtyard of al-Ḥākīm mosque to its present location behind the offices containing the *Comité's* photographic and architectural archives at the Citadel in Cairo (fig. 10). It is labelled with its name and a 15th century date, however its story since its dismantling from the mosque of Qānībāy al-Šarkasī in 1901 remains untold. Today, the mosque still stands with an incomplete minaret (fig. 11).

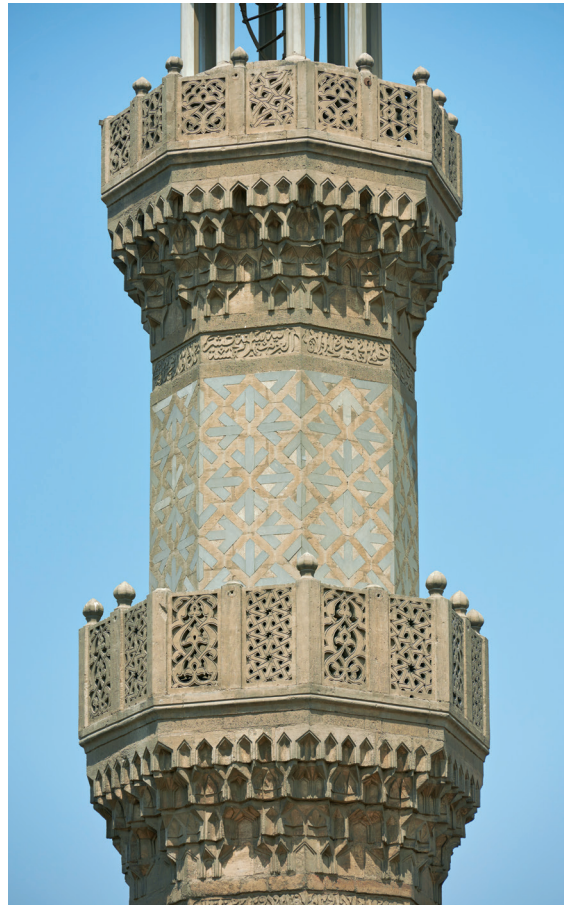
Fig. 12. [Upper part of the Minaret of Qāḍī Yaḥyā Zayn al-Dīn mosque, showing the *Comité*'s inscription], 2015. Digital photograph. © Matjaž Kačičnik.

Today, the complete minaret might appear to the regular viewer as a 15th century Mamluk minaret; however, an inscription band running along the top of the new second storey carries valuable information. The inscription states that the restoration of the second shaft and what is above it was carried out during the reign of ‘Abbās Ḥilmī II under the supervision of the *Comité* in 1315 AH—hence—AD 1897–1898 (fig. 12).

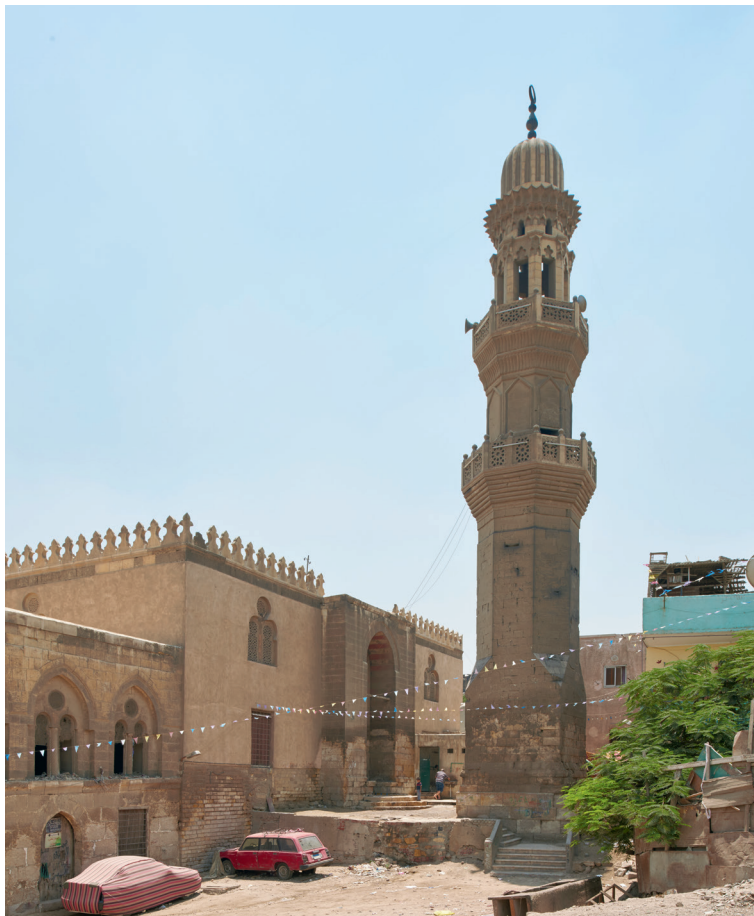
Fig. 13. [Minaret of Maṅḡak al-Yūsufi mosque], 2015. Digital photograph.  
© Matjaž Kačičnik.

Decades later, during the *Comité's* meeting of January 17, 1939, the engineer Maḥmūd Aḥmad noted the discovery of original stone blocks of the minaret, buried in the land west of the mosque and suggested that the *Comité* undertake the completion of the minaret. The project was approved unanimously by the members<sup>120</sup> and the pavilion was reconstructed by January 1941 (fig. 13).

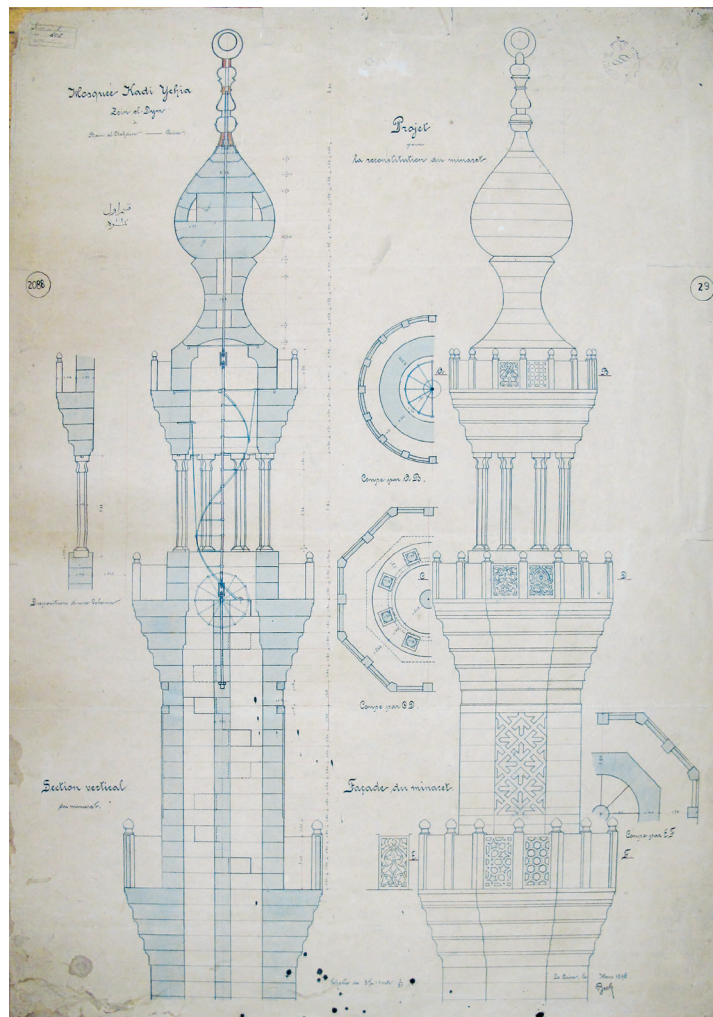
Fig. 14. Steyrer, [Reconstruction drawing of the Minaret of Ġānim al-Bahlawān mosque], Cairo, 1903. *Markaz taṣṣīl al-āṭār al-islāmiyya wa-l-qibṭiyya*, Archives of the Supreme Council of Antiquities. Courtesy of the Ministry of Antiquities.

Herz's monograph demonstrates that initially the *Comité's* plan was not to remove the Ottoman cap and that their aim was to simply consolidate the minaret. It was the discovery of original blocks that triggered the restoration of the balustrades and the replacement of the Ottoman top with a Mamluk one. Herz was keen to note that the pieces found were used to trace the shape of the bulb with accuracy, and also to make sure that the two existing shafts were structurally safe to support the new construction.

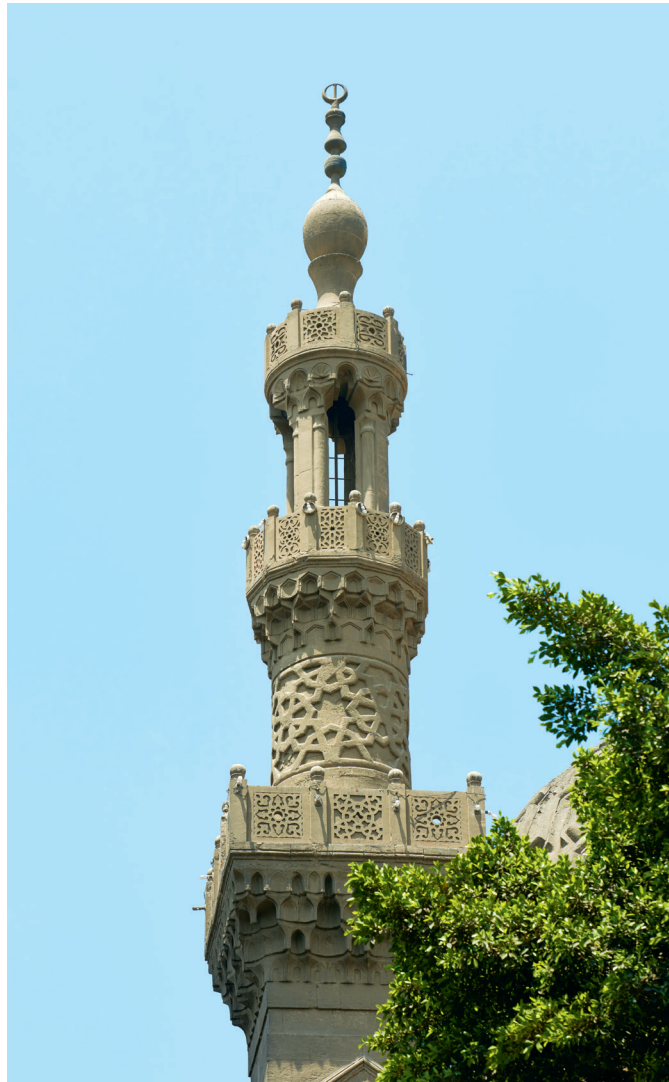
Fig. 15. Minaret of Tağrī Birdī mosque, 2015. Digital photograph.  
© Matjaž Kačičnik.

It must be noted, however, that the design didn't follow the eight marble columns, but instead used stone piers with attached columns (fig. 15).
